## YUGOSLAVIA

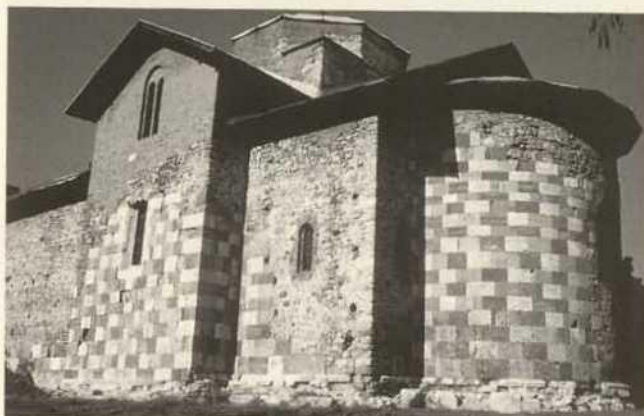
Banjska Monastery, south-eastern view of the church with three-coloured marble façades

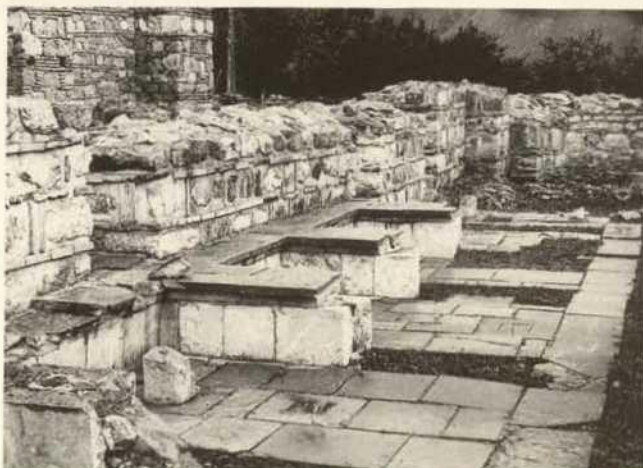
Banjska Monastery, remains of the refectory walls, seats and pavement

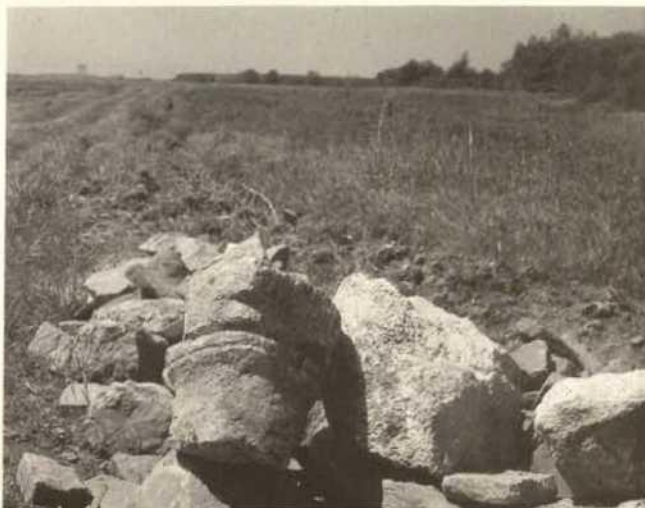
The situation in regard to the protection of archaeological sites of exceptional importance in Serbia has not changed much during the past year. The Roman town of Viminacium and the mediaeval settlement and cemetery in Čelarevo are still endangered by the nearby industrial plants that exploit mineral deposits (brick clay), exactly from locations where archaeological remains can be found.

Viminacium, remains of the Roman architecture on the ploughed road

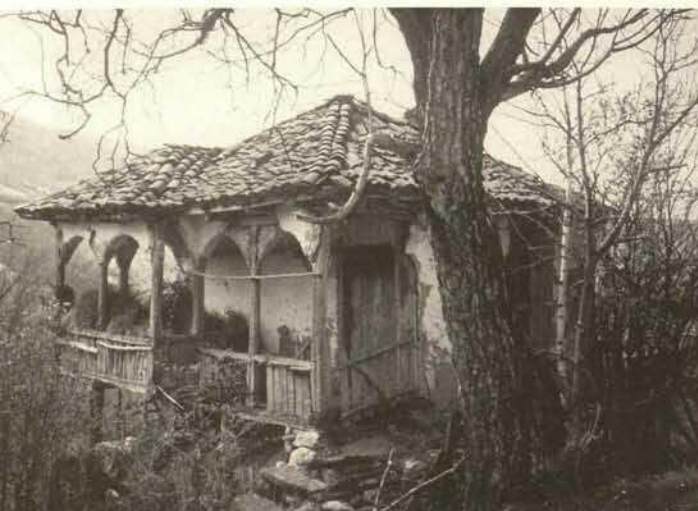
Village of Gornja Kamenica, 'house with arches' typical of Eastern Serbia, recently abandoned

Loss of original function and non-existing cultural property-management mechanisms are identified as very immediate dangers to monumental heritage as a whole, but especially in the case of vernacular architecture. Modern living conditions inevitably lead to the abandonment of traditional forms of housing, while the preservation of wooden architecture through a chain of open-air museums represents an excellent but unacceptably expensive conservation method. The only financially viable solution would be to devise new uses, which could ensure the survival and maintenance of this form, as well as other forms of built heritage.

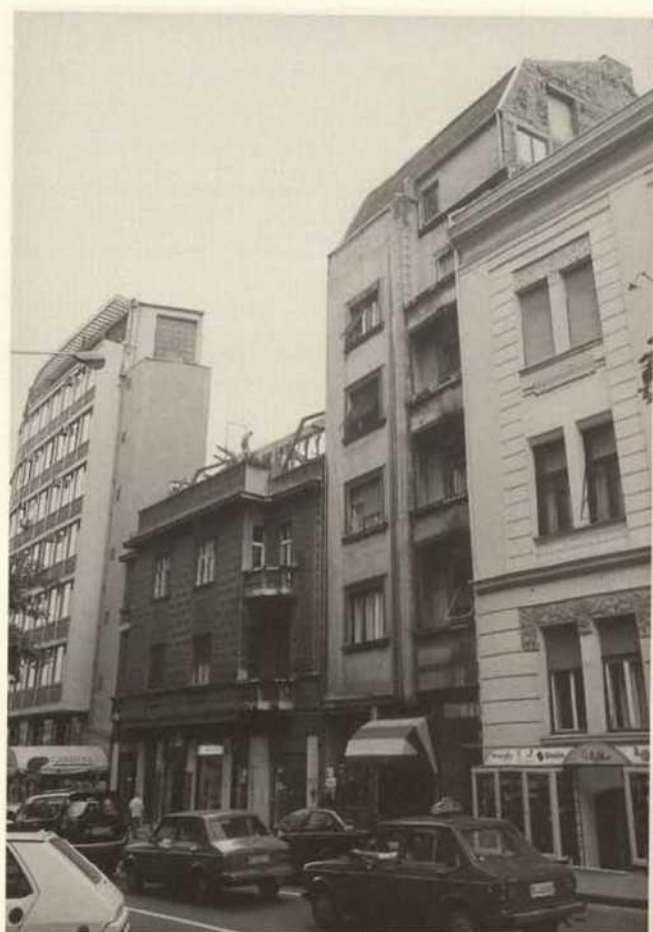
The 'insufficient age' problem, relevant to modern architectural heritage in general, is especially pertinent to historic towns and urban areas. Because this heritage most often dates to the 18<sup>th</sup>–20<sup>th</sup> century period, it has still not focused the attention of either experts or users. Both groups find it difficult and slow to adjust to the idea that buildings that represent their everyday environment actually possess the characteristics of heritage monuments. Though exposed to degradation processes like any other immobile cultural property, this heritage is neglected in comparison to heritage of a much greater age, which imposes greater respect and responsibility from the protection service. The growth of town population, migrations, the demands of modern life, political instabilities, economic crises, and pauperisation – all are open problems whose specific victims are the towns and their architectural heritage. Illegal 'wild' construction, building extensions, destruction, demolition, change of function, traffic expansion, development projects that disregard the original urban matrix – these are the most frequent risks facing this kind of heritage. Even though great efforts are taken to find a more adequate conservationist approach, to innovate the legal and administrative systems, to control planning, and to achieve greater co-operation between the protection service and urban planning, it is becoming increasingly difficult to protect the endangered urban heritage, while the preservation of its authenticity is becoming a prime professional task.

Belgrade, inappropriate interventions in the old city centre

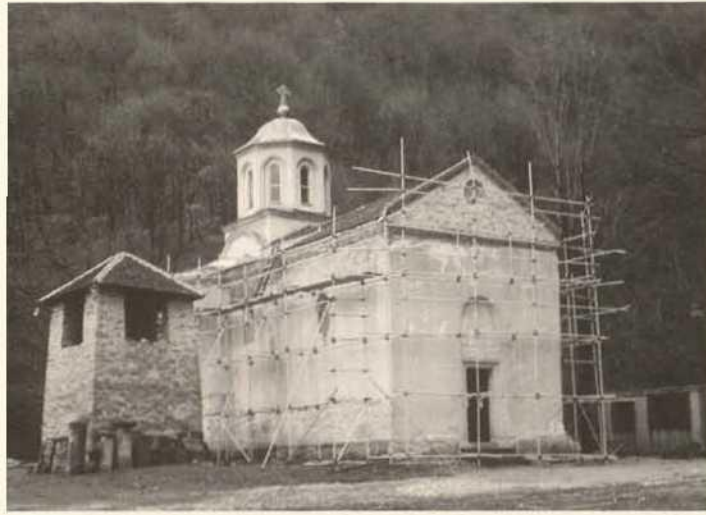
The damage is located in the upper zones of the building. As well as the roof that has toppled down, the static stability of the arches has been severely disturbed, and the ceilings were shaken loose, causing large segments of mortar to fall off. Visible damage and cracks were also noticed on the north wall of the church and the bell-tower. The construction work on the renewal of the roof structure, including the central cupola, was completed and the roof was covered. The final conservation and skilled craft works remain to be done when sufficient funding is found (new layers of mortar on the church walls, both on the outside and inside, floor panelling, reconstruction and conservation of the iconostasis, construction of drainage and pavement around the church).

Village of Ba, church of St. Elijah during the conservation works

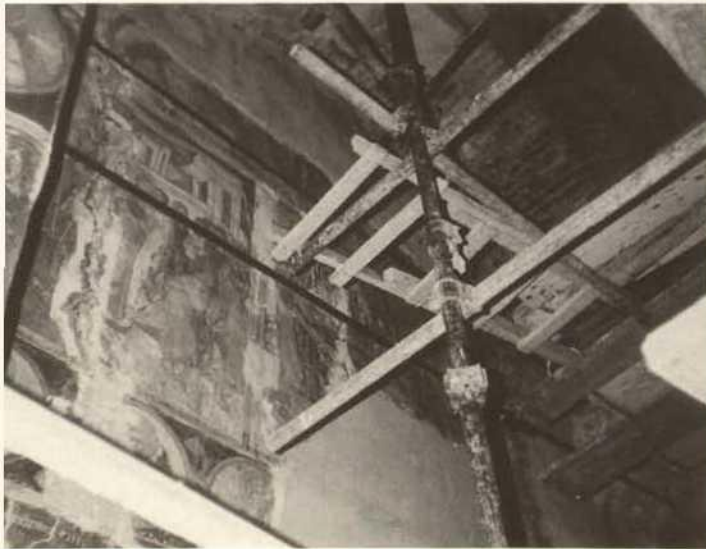
Petkovic Monastery, conservation work on mural painting

The frescoes in the church interior are in a very poor state. The characteristic damages that endanger the stability of the wall paintings are separation of the mortar layer from the wall (an estimated 50% of the painted surface suffer this separation), pulverisation of the painted layer, as well as the effects of moisture (both capillary and moisture penetrating through damage in the roof, at the juncture of the cupola and church nave). It is necessary to restore and conserve the wall paintings and to consolidate the mortar layer.

During the static repair of the church walls, a preventive conservation of the most endangered segments was achieved by injecting the separated layer of mortar, seaming the free edges of the damaged parts, and fastening the most endangered sections of the painted layer.

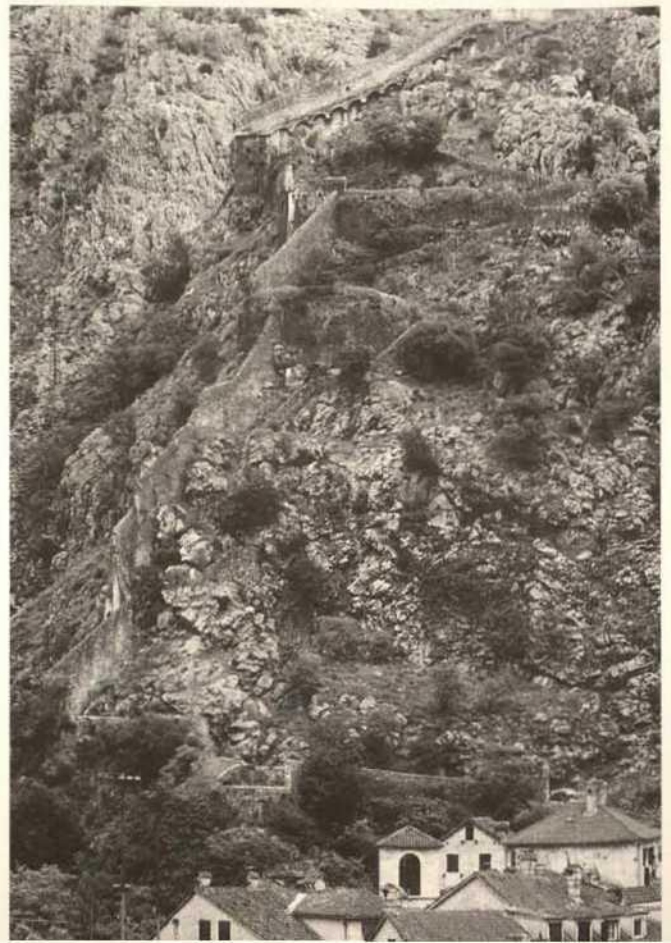
The natural and historic cultural district of Kotor was inscribed in the World Heritage List in 1979. The 1979 earthquake caused damage to the city fortification walls, churches, residential and public buildings.

A significant danger factor for the heritage in this area is the fact that 20 years after the earthquake, many significant monuments have still not been renovated, and their deterioration has further increased due to atmospheric effects, vegetation, and human factors.

Kotor, detail of natural and historic cultural district
