## ZAMBIA

### Risks Related to Natural Processes: Termites

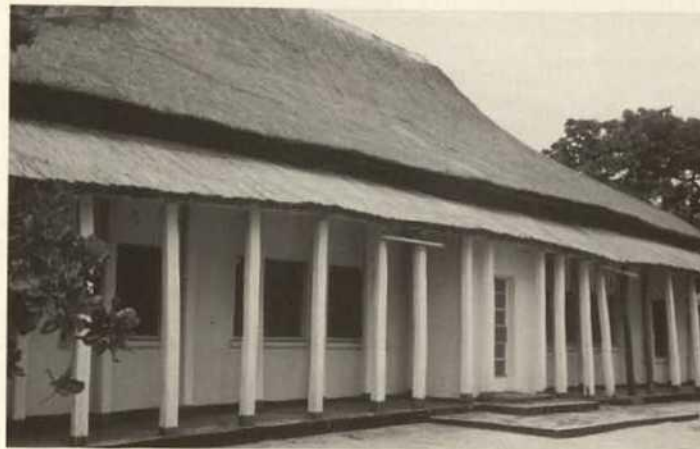
Barotse Royal establishment, Litunga's winter palace, Lealui, built in 1902. The roof has been severely attacked by termites.

Sadly, traditional methods of preservation of timber against termite attack have often been ignored in preference to modern chemical treatment. Mostly, these chemicals call for spot treatment of infested elements. Unfortunately, it is often impossible to reach all infested parts, especially those that are concealed. Fortunately, traditional methods of conservation are practiced in some parts of rural Zambia and some heritage buildings have benefited from this knowledge. The Litunga's Palace in western Zambia is one such case in point.

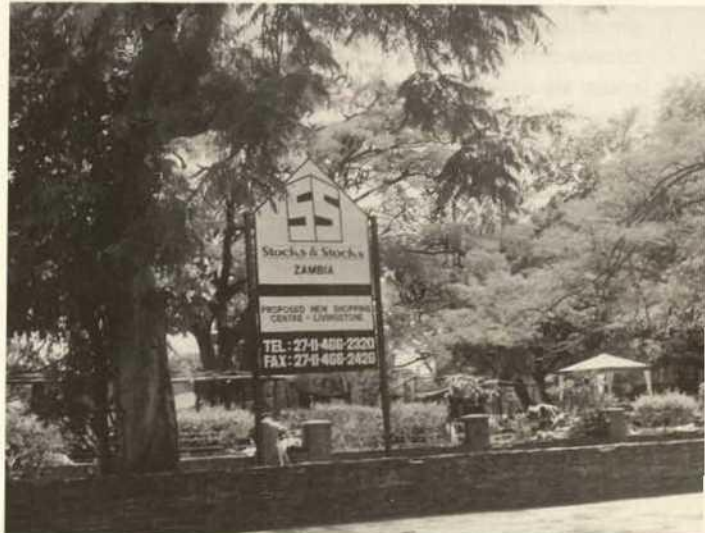
View of Mukuni Park from Musi oa tunya Street in Livingstone. The developer has put up a billboard to advertise the proposed development.

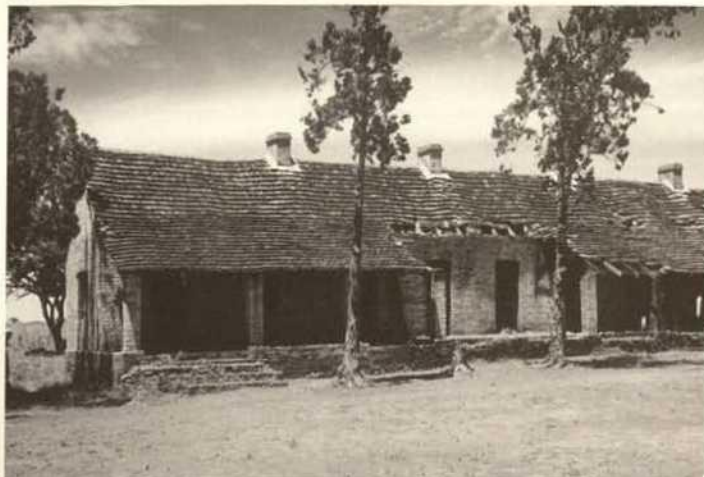
The derelict isolation ward at Mwenzo Health Center before restoration, 1995. An example of the effects of a combination of neglect and termite attack.

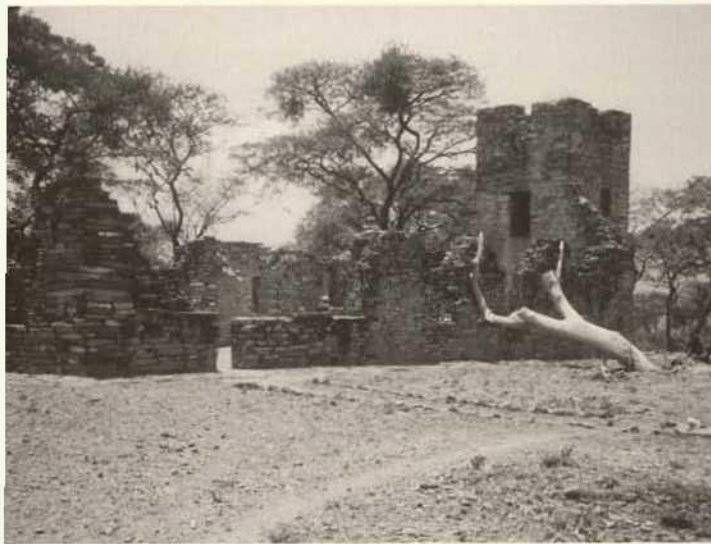
Niamkolo church ruin, built in 1896 – currently a national monument. The ruin suffered from vandalism by locals removing stones to repair their own houses.
