CANADA – HERITAGE @ RISK!

Case Study 1 – Threats to the structural integrity of Fort Prince of Wales

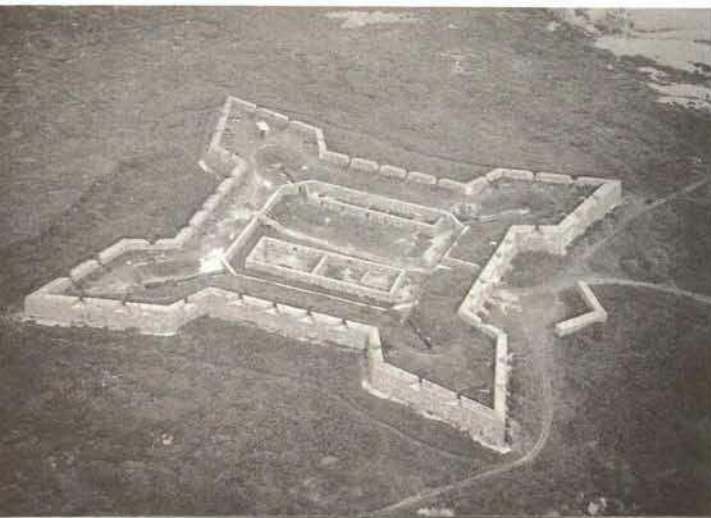
Bird's eye view of Fort Prince of Wales, fortress of Vauban type (1731–71), Churchill, Manitoba

sure control of the fur trade. The design of the fort was inspired by the Vauban fortification system. Despite the 40 canon heads in the fort's embrasures, part of the escarpments and bastions were severely damaged during the attack led by French General La Pérouse in 1782.

Beyond its history of 200 years, time and Nordic environmental factors have worn the fort's features to the point that its architectural and structural integrity are completely threatened. The extent of the physical, mechanical, chemical and biological threats are unpredictable as they depend on natural events such as water infiltration; melting snow; freeze-thaw cycles and their association with thermal movements; lateral pressures associated with the dislocation of stones or even wall collapse.

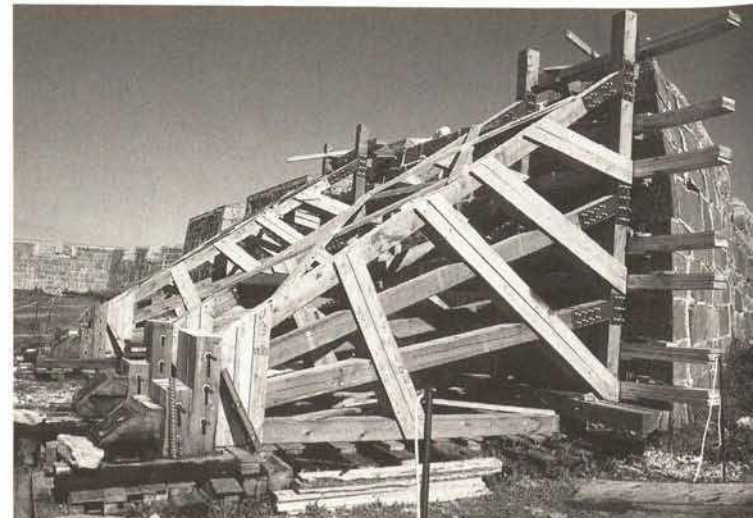
Shoring, Point of the North-West bastion, Fort Prince of Wales, Churchill, Manitoba

Strategic actions have been put forward to halt the deterioration process that has been unfolding for decades. They can be resumed as: emergency shoring measures; continuation of monitoring to detect movements in the masonry assembly; completion of material analyses; development of conservation options and an analysis table regarding impact on heritage values; and the choice of an option to aiming to minimize all threats and to protect the heritage values of Fort Prince of Wales.

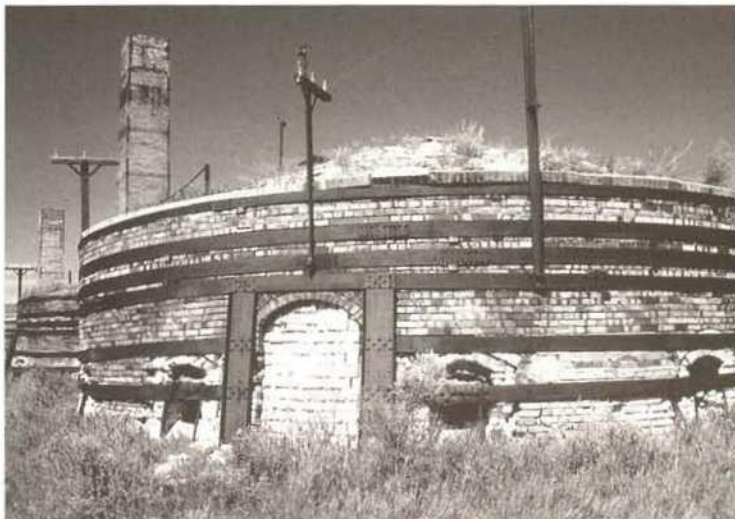
Typical deterioration, Kiln No 5, Claybank Brick Plant, national historic site, Claybank, Saskatchewan

After 90 years, the environmental conditions of the prairies are negatively impacting on the material features of the site, such as progressive disintegration of the brick and mortar. Monitoring permits the evaluation of impacts on architectural values, such as the movement of cracks, the deceleration of a slow dislocation of the brick, and to determine the inclination of the stacks related to the variations of changes in their centre of gravity caused by geotechnical pressures of the ground and the wind.

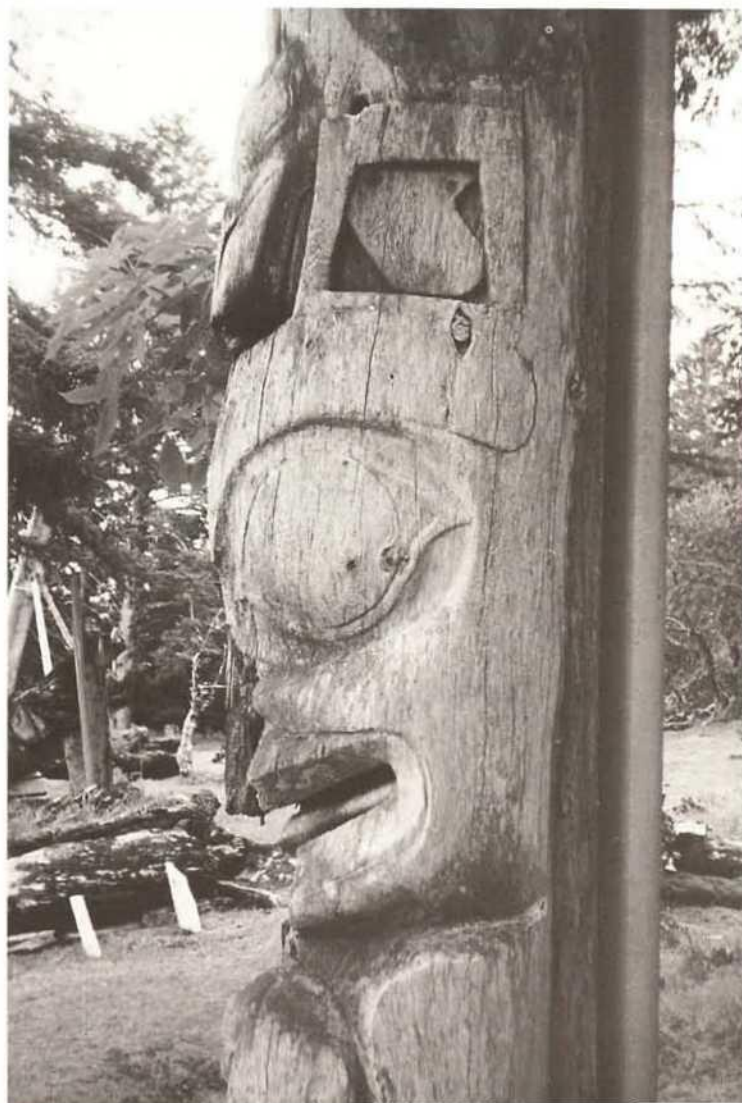
One of the totem poles on Anthony Island, supported by a metal bar

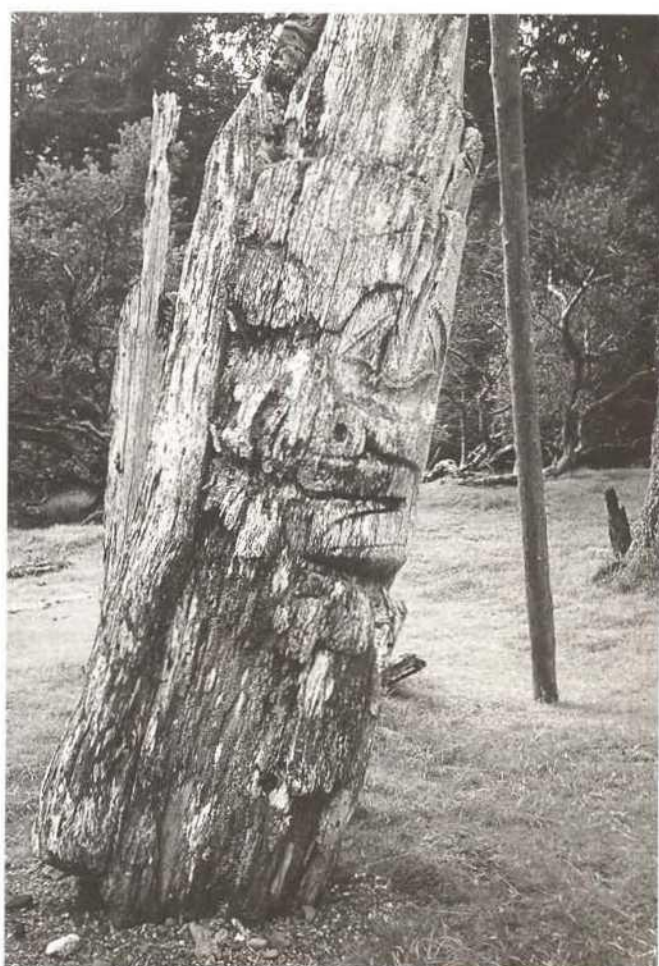
Severely weathered remains of a totem pole on Anthony Island

cess that is still respected by the modern Haida. Therefore, these unique testimonies will gradually disappear. The erection of new totem poles, which in Canada can also be seen in museums, is taught in newly founded wood carving schools (one of the most famous artists in this field being Bill Reed).
