ITALY – HERITAGE @ RISK!

Case Study 1 – Pompeii

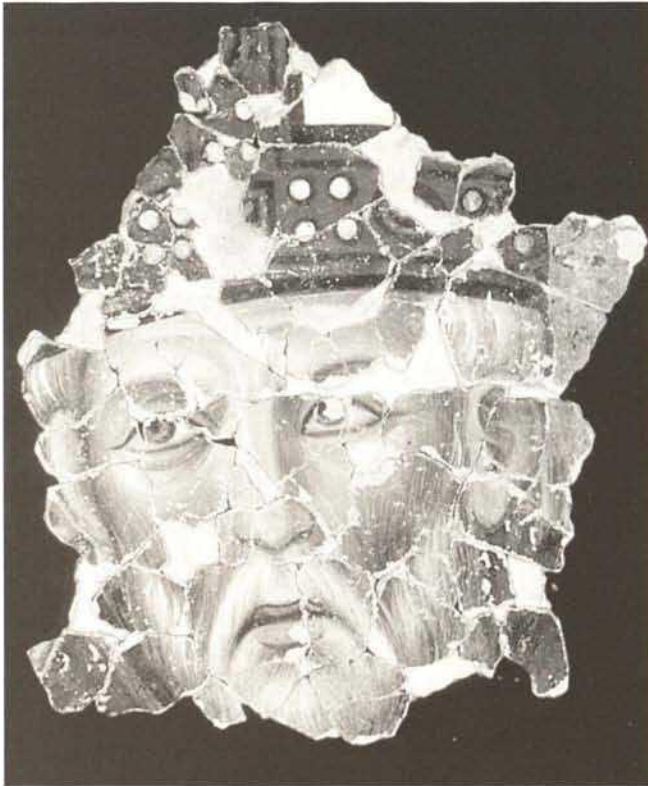
San Francesco in Assisi: reassembling the collapsed frescoes (S. Rufino's head)

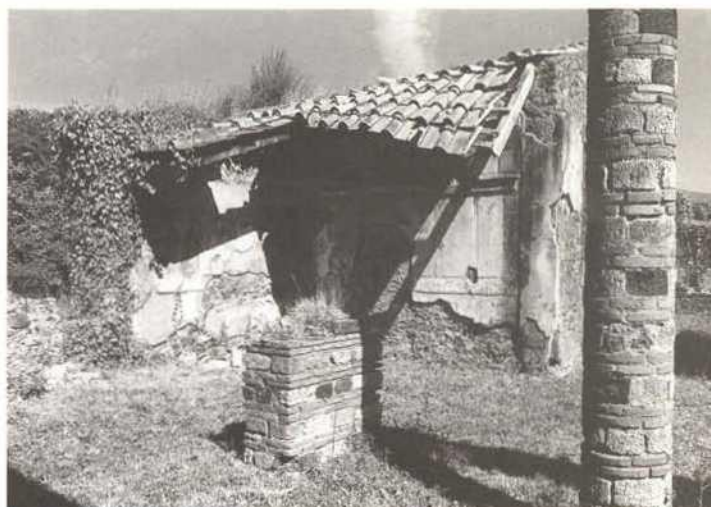
The protective roof in danger of collapse has been scantily underpinned by wooden supports. Such measures were carried out especially after the earthquake of 1980. Bricks from the roof have already fallen down, so that it no longer serves as a protection for the wall paintings. The measures have almost become obsolete and senseless.

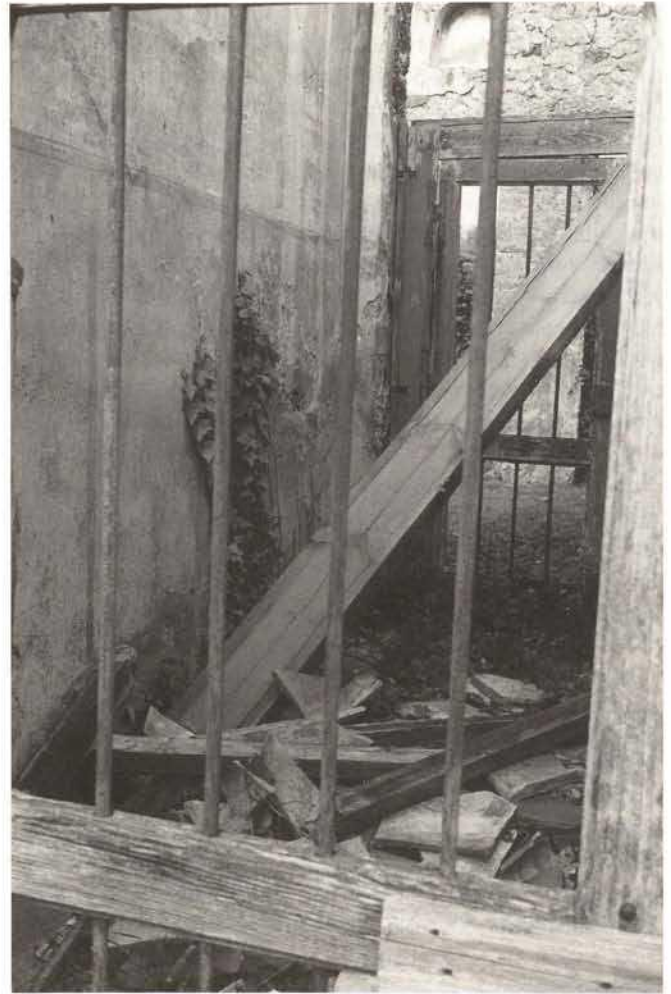
Condition of a decayed "taberna". The collapsed construction material is lying around and dilapidated. The "taberna" was excavated 90 years ago and was once decorated with well-preserved wall paintings.

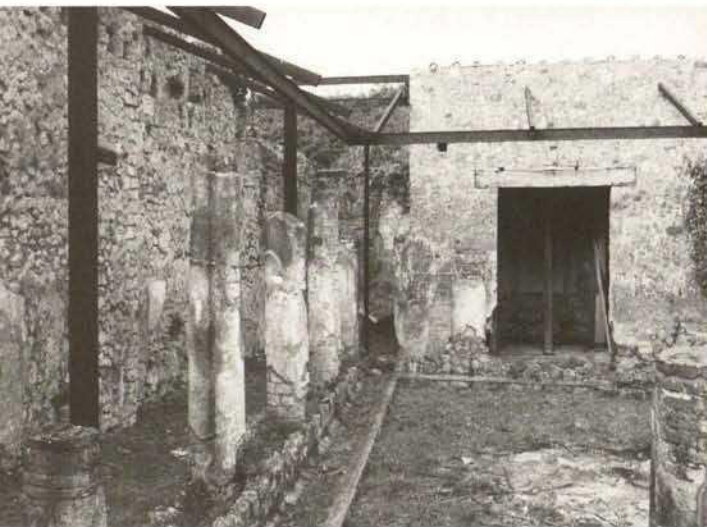
An example of an interrupted conservation measure. The peristyle of a house was to be protected by a roof, in order to reinstall the former architectural complex and to protect the wall paintings in the rooms nearby. The conservation project was given up for unknown reasons. The iron supports, unsuitable material for this purpose anyhow, have not been taken away and are corroding.

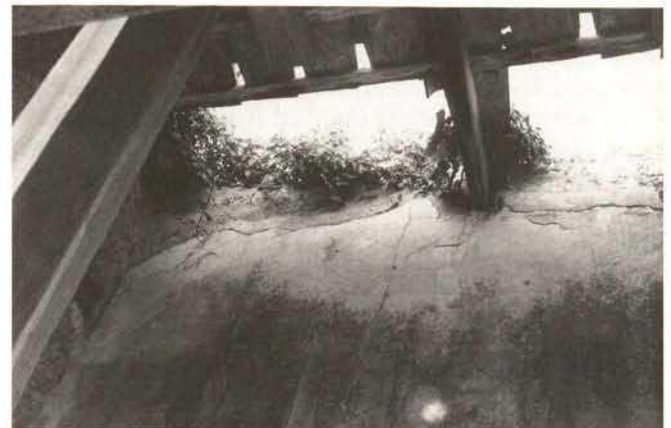
A gap in the protective roof. Ivy has come through and has already grown over the top of the wall.

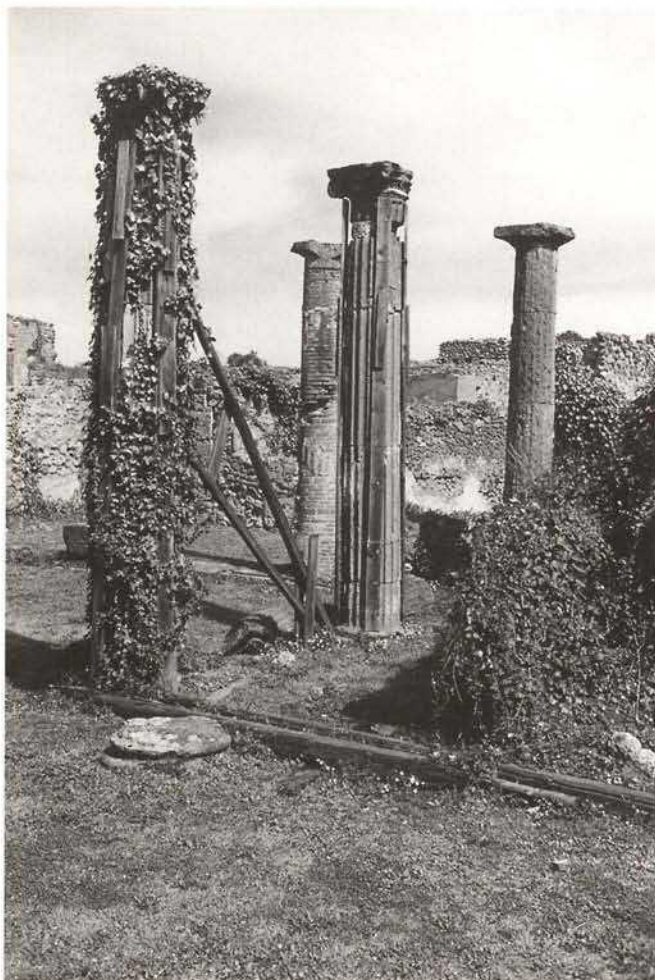
Scanty, temporary conservation measure bracing the columns of a peristyle house. After the earthquake of 1980 endangered houses and constructions were provisionally secured. After 20 years the temporary solutions are still in place, but have corroded or are slowly decaying, since the necessary measures have never been taken. Ivy growth is accelerating the process of decay.

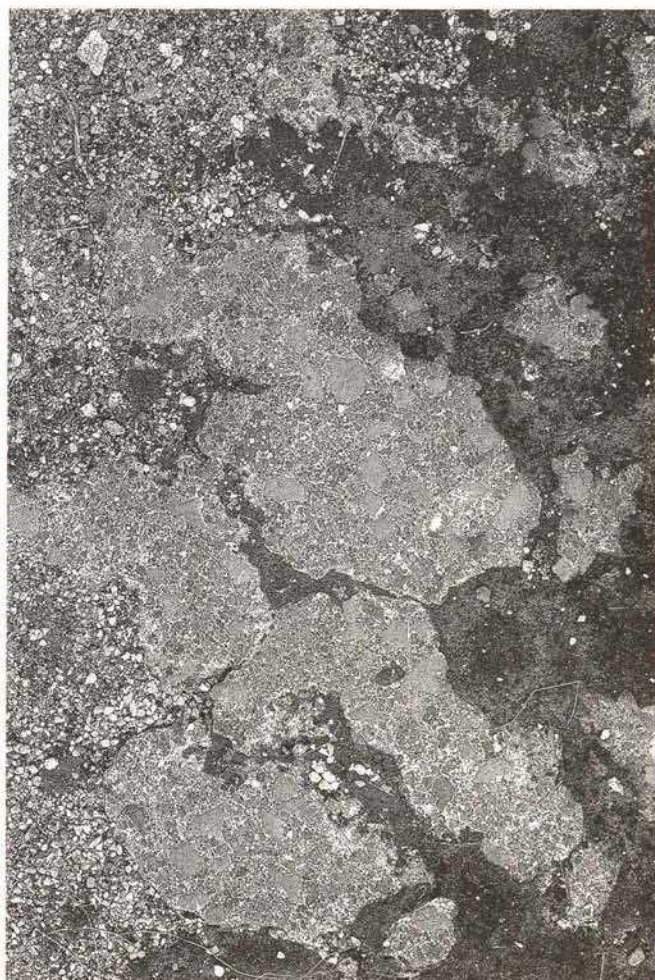
Remains of heavily damaged floors with inlaid brick fragments - the original floors in Pompeii are not only damaged by weathering but are often trodden on by the tourists (Casa dei Postumii).

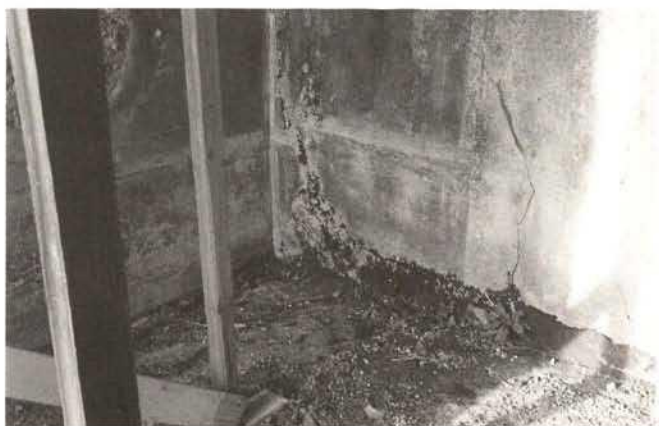
Destruction of the wall painting by moss.

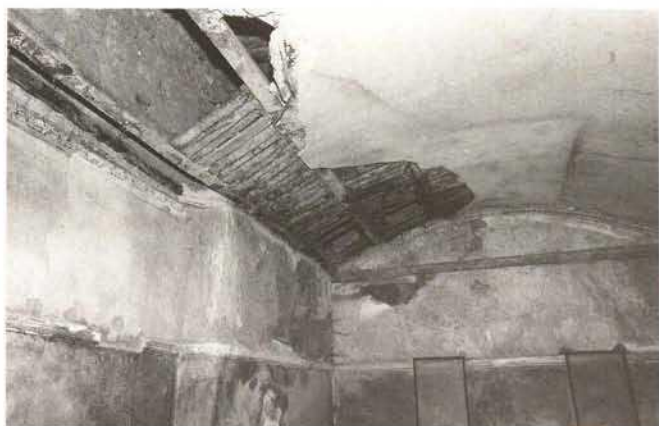
A lack of care taken during conservation measures leads to the decay of formerly well-preserved wall paintings. The barrel-shaped vault with its precious wall paintings, almost completely preserved 90 years ago, has collapsed due to a gap in the protective roof. Rapid deterioration is the consequence.

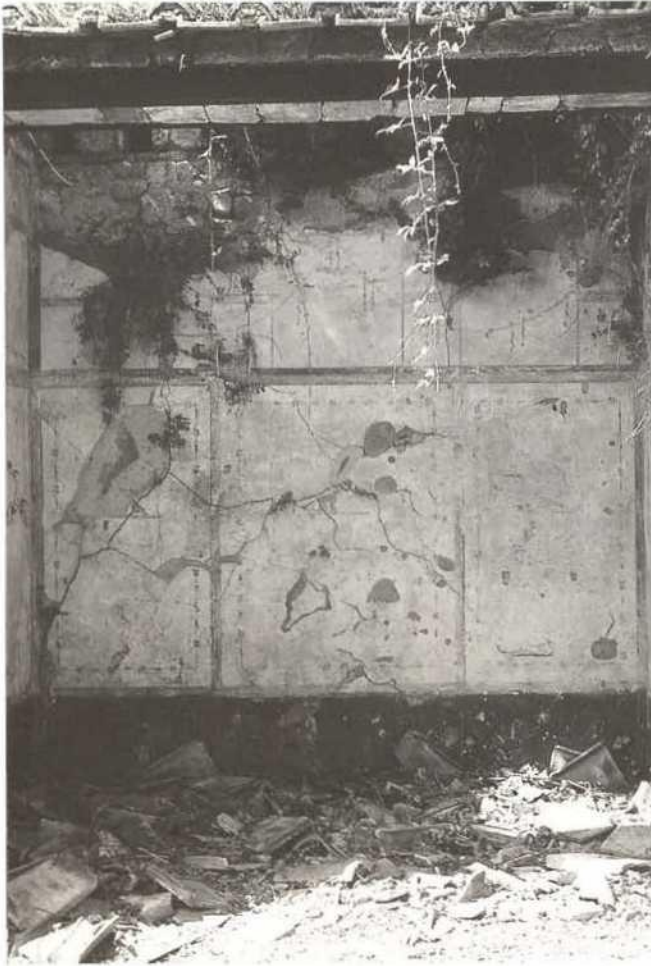
Room in a state of complete neglect, with interior wall painting already severely faded (Casa di Ifigenia).

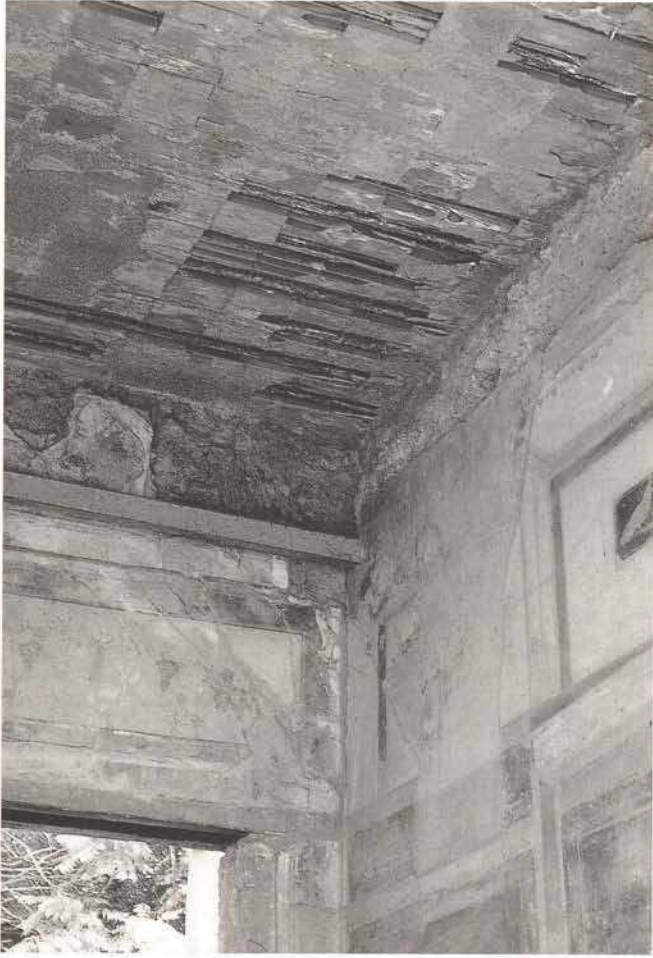
Decay of the modern ceiling construction (brick with iron reinforcements) above the original wall decoration which is already heavily damaged by pervading water (Casa Rebio Valente).

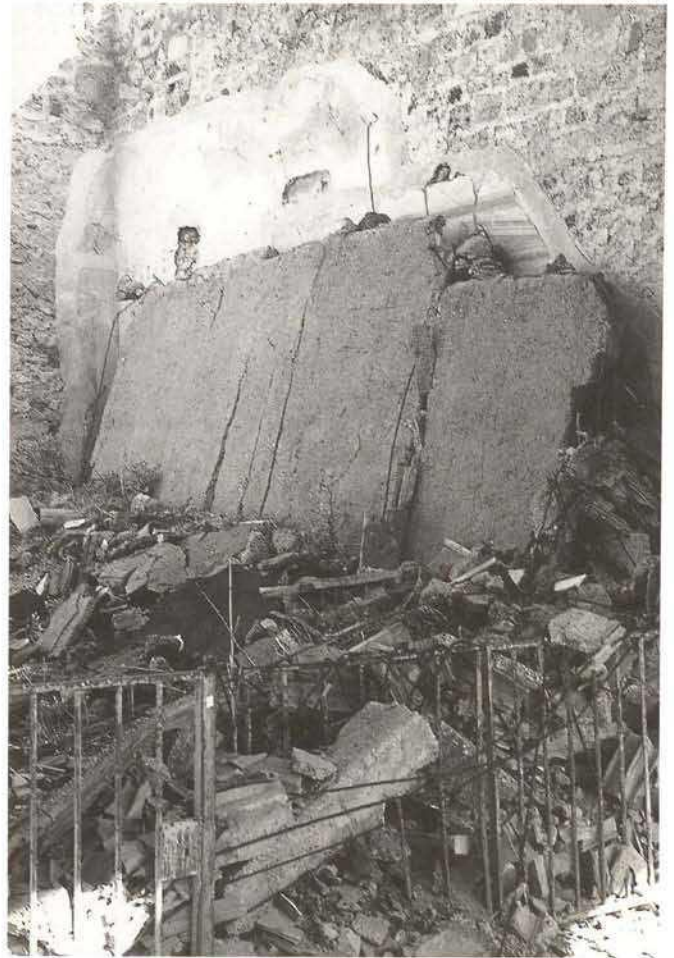
Collapsed parts of a reinforced ceiling of concrete and bricks, leaning against the wall painting behind, which itself is without any protection against bad weather (Casa Labyrinth).

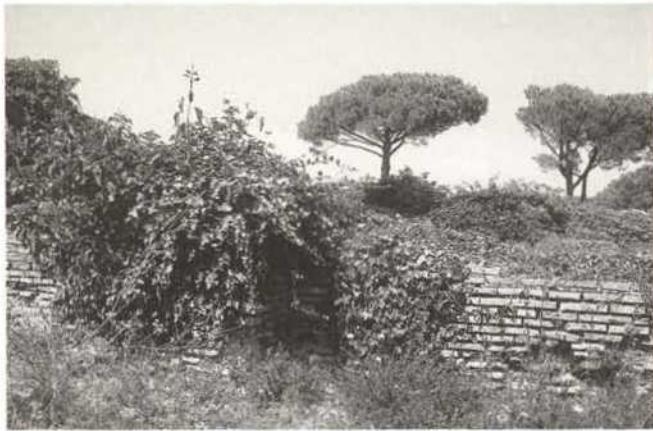
Ostia, walls overgrown by vegetation

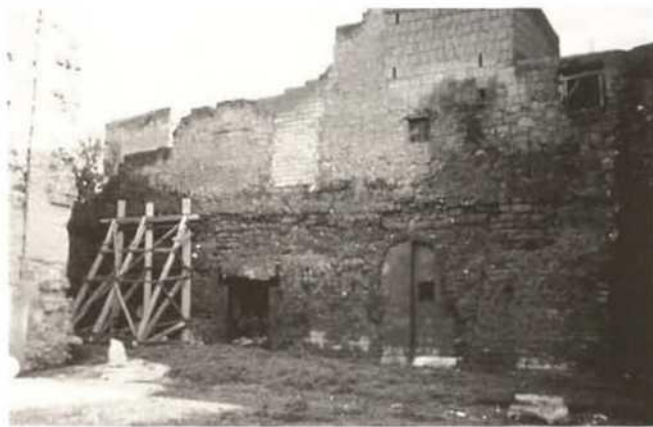
Cimitile, excavation area in the field of the *Basilica nova*, with masonry that is in danger of collapse and has partly been secured in emergency
