## SLOVENIA – HERITAGE @ RISK!

### Golden Altars

### Case Study 1 – Golden Altars – Suha near Skofja Loka, the Church of St. John the Baptist,

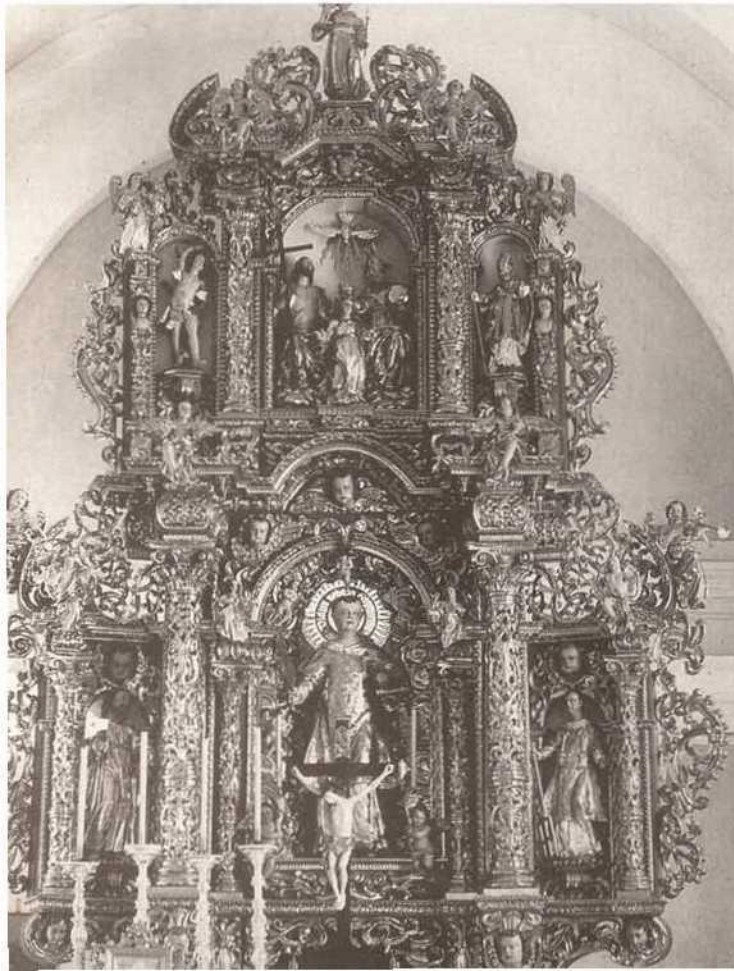
The rich wooden statues of the Golden Altars from the Church of St. Stephen, Suha pri Predosljah, a fine example of church decoration from the Baroque period.

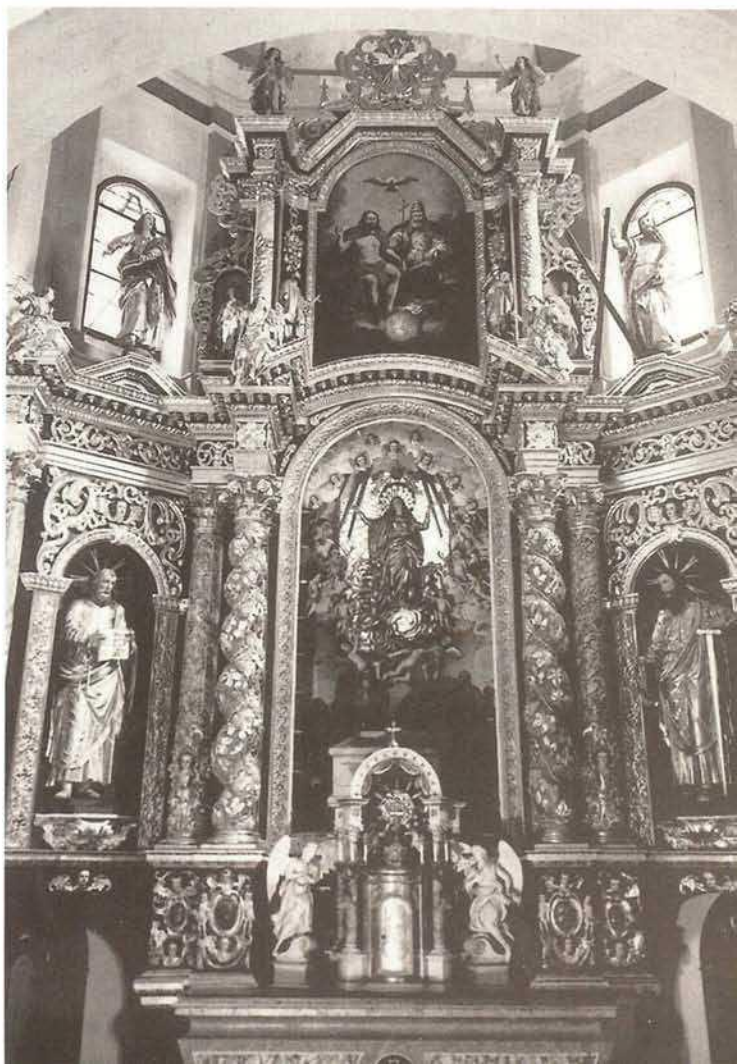
The central part of the Golden Altar in the Church of Virgin Mary, Nova Stifca near Ribnica, decoration of 17<sup>th</sup> century architecture.
