# ALBANIA

## Mural Art of Voskopoja

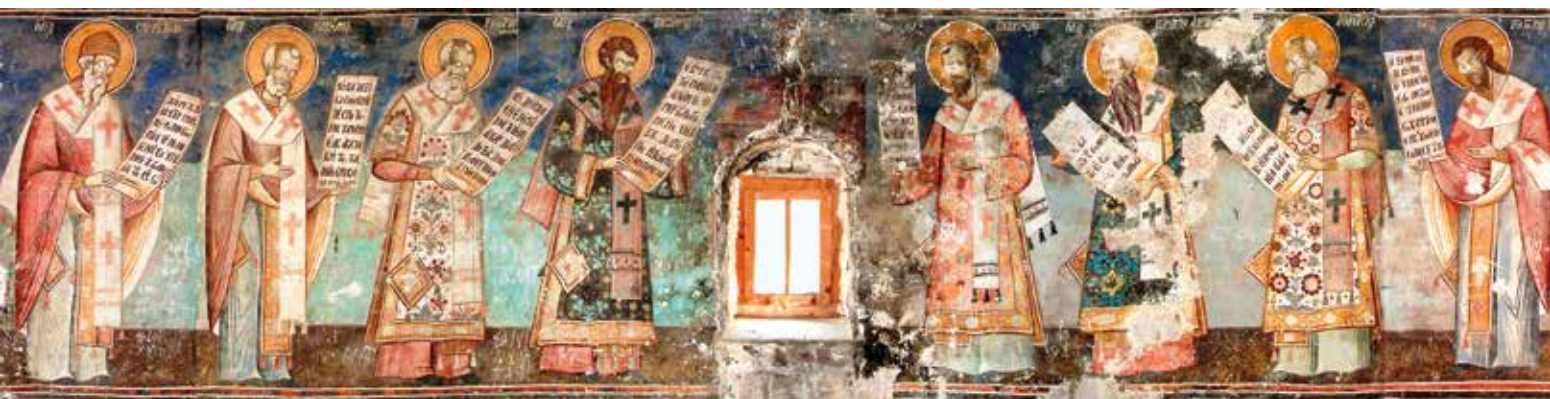
St. Athanasius Church, lower register of the apse, degradation of the paint layer

- The main cause of degradation to the surface is attributed to the winter weather, i.e. the freezing winter temperatures of the mountainous area where these churches are found. The weight of snow on the roof structure, which is covered with stone slabs, and the slightest movement can cause moisture infiltration. Defects in the roof during this period are almost inevitable. Consequently, the sensitive technique of mezzofresco has suffered.

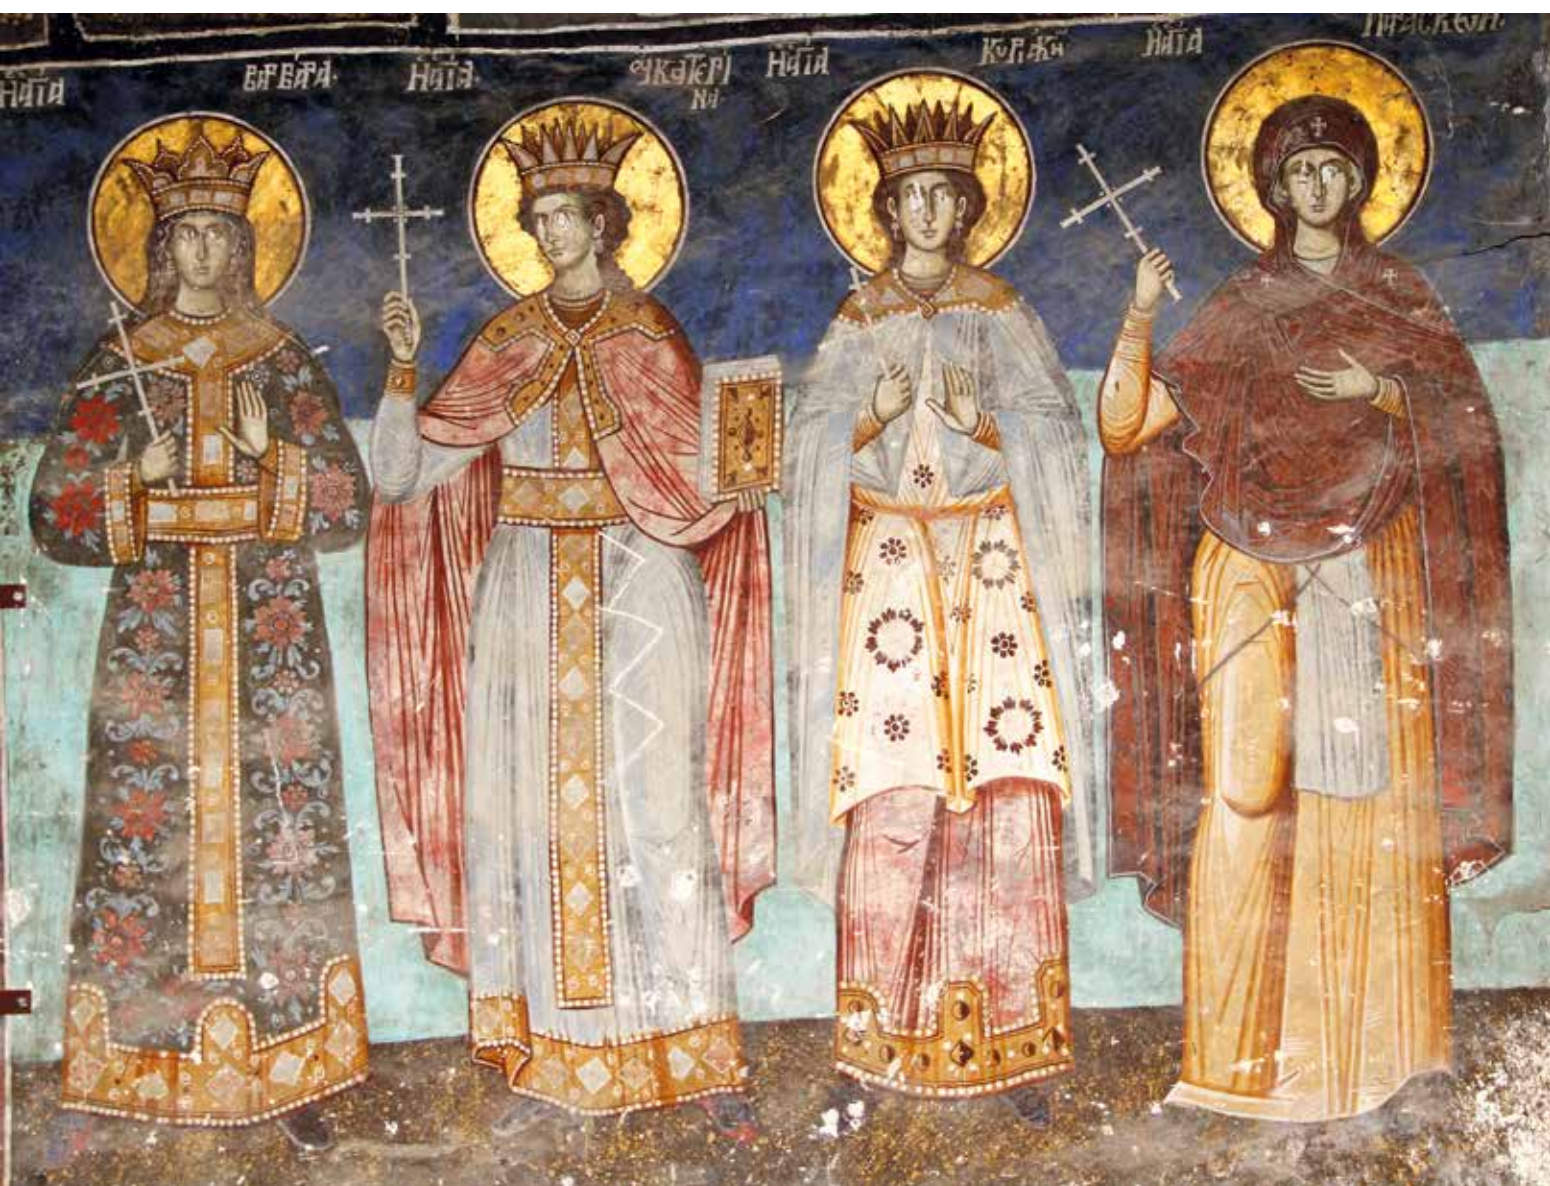
St. Athanasius Church, south wall, gold leaf applied on the halos of the saints

is made of lime, river sand, goat’s hair and a considerable quantity of straw. “Intonachino” is the last layer. Covering the entire surface, it is made of lime in order to prepare the surface for painting. An XRF analysis has shown the different compositions of the pigments. Some of them are earth colours, some are minerals, and others enamels. In some cases, we find that gold leaf was applied over the halos of the saints.

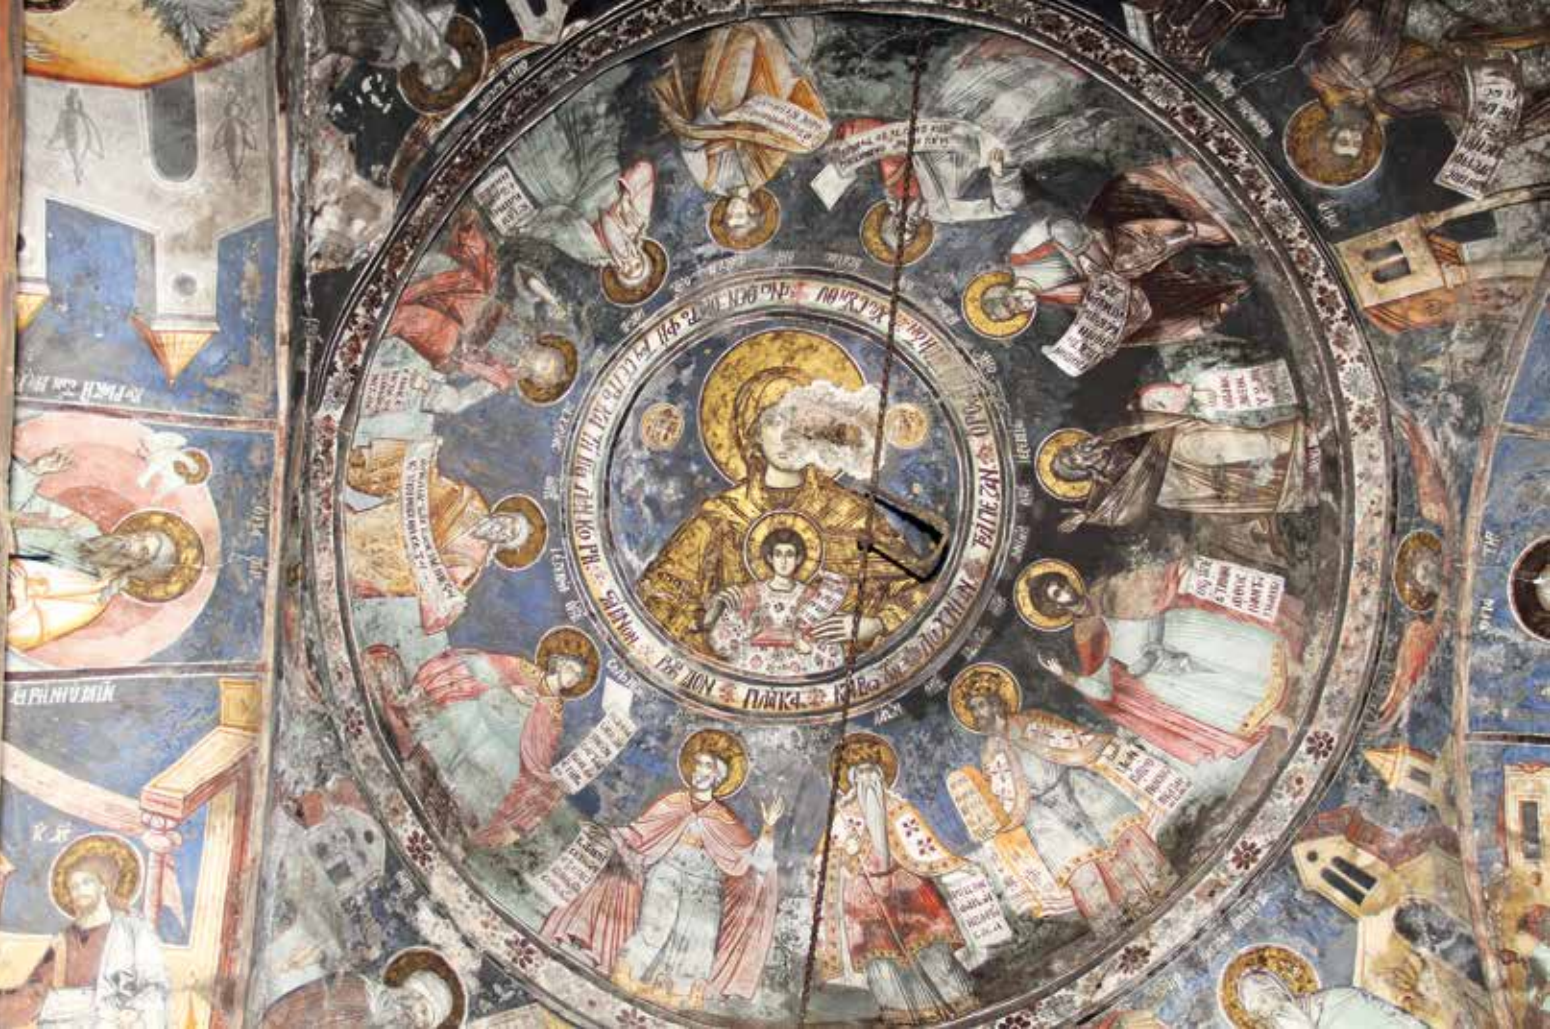
St. Athanasius Church, loss of the preparation and paint layers in the central cupola

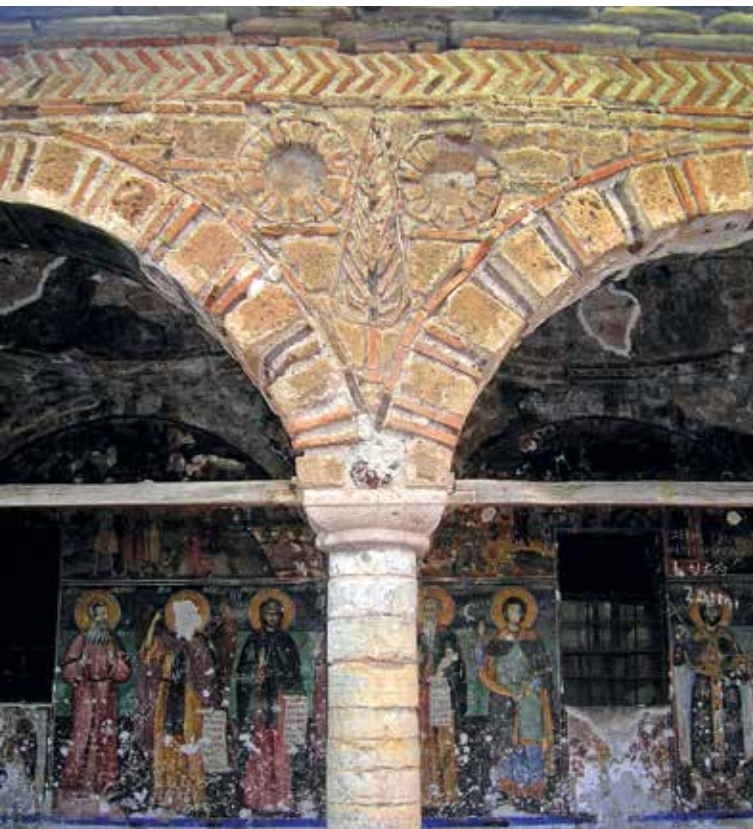
St. Nicolas Church, scratches and writings on the wall paintings in the portico area

- Other causes of degradation are numerous acts of vandalism, such as scratches and writings on the wall painting seriously damaging the integrity of the images and the material. This phenomenon is mainly present in the lower parts of the paintings inside the churches and especially in the porch areas. These “inscriptions” are mainly related to dates and names of people who want to leave a sign of their presence in that place. In certain areas, due to the density of scratches and damage, it is very difficult to perceive the images and scenes depicted.

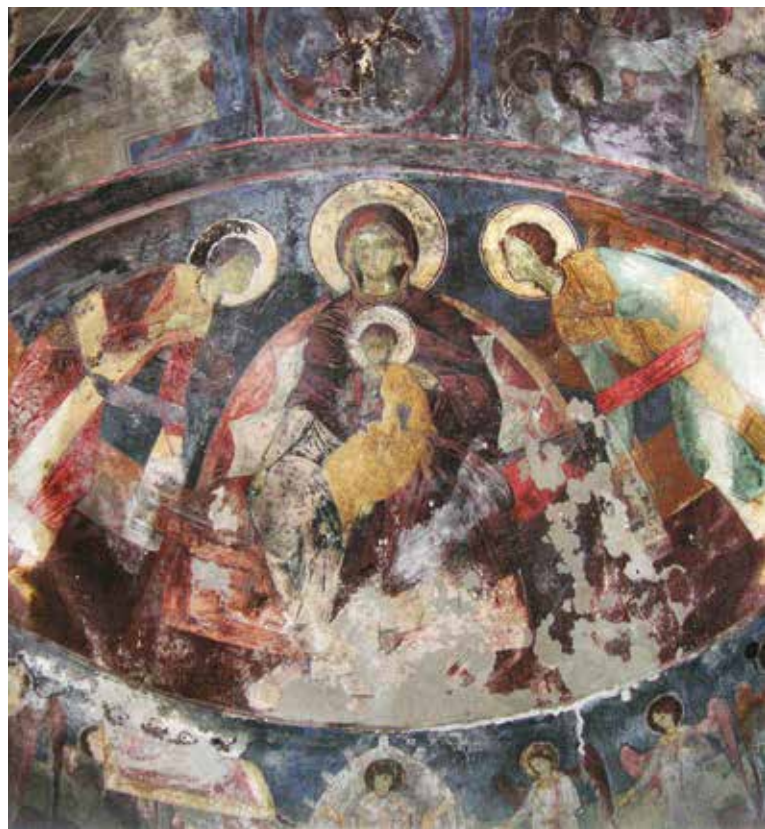
St. Nicolas Church, abrasion and loss of preparation and paint layers
