# ROMANIA

## Transylvanian Saxon Architectural Heritage: Two Towers of Fortified Churches Collapsed

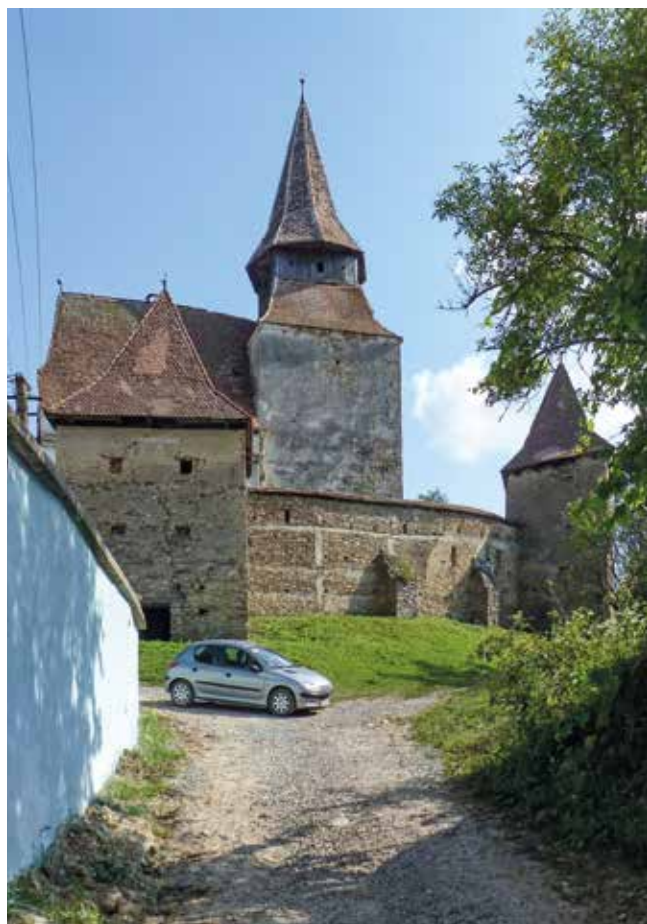
Fig. 1: The church in Roades before the collapse of the tower (photo C. Machat, 1998)

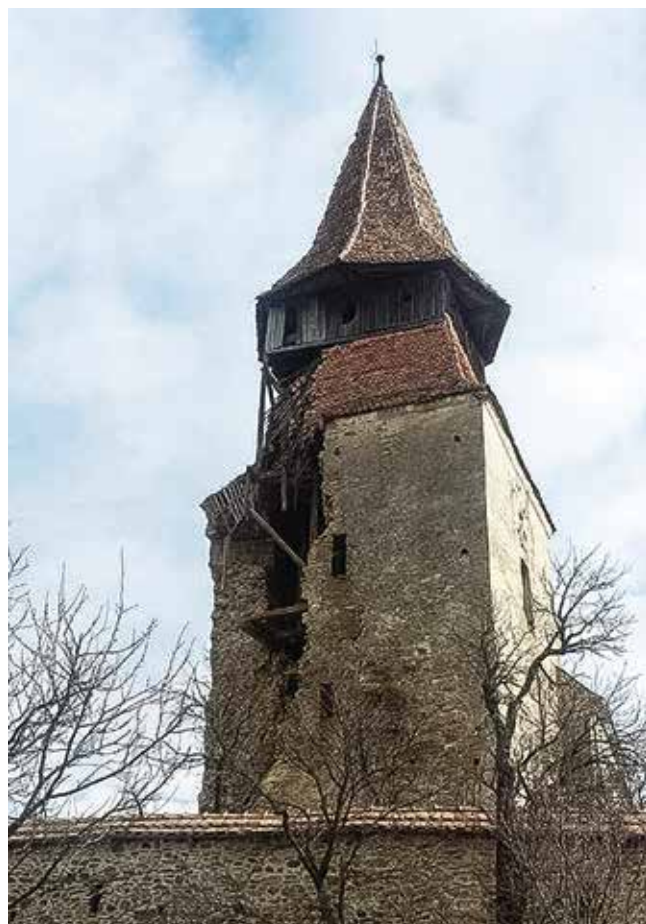
Fig. 2: The church tower of Roades after the collapse (photo A. Schnell, 2016)

ument the damages to the built heritage caused by earthquakes over the centuries. As usual unexpectedly the tower of the fortified church in *Rodeş/Radeln* collapsed partially on 14 February 2016, followed on 19 February 2016 by the tower of the church in *Rotbav/Rothbach*, which collapsed completely, destroying also a part of the western nave.

As a consequence, the newly established “Stiftung Kirchen-burgen” (Fortified Churches Foundation), which replaced the Coordination Bureau in 2015, appointed a structural engineer to examine the damages and develop a consolidation project for the tower in Rodeş. In Rodeş, only the northwest corner of the tower partially collapsed down to the first level, revealing the two wall layers: the inner one from the 14th century, reinforced in 1494 with a second one and raised to five floors with a wooden defence gallery. As no other damages happened and the ensemble of the church fortification (with surrounding circular walls and three towers) is in good condition, the first consolidation interventions of 2017 with new wooden gallery on the upper level (like the defence gallery from 1494) can be accepted as a first step towards reconstruction.

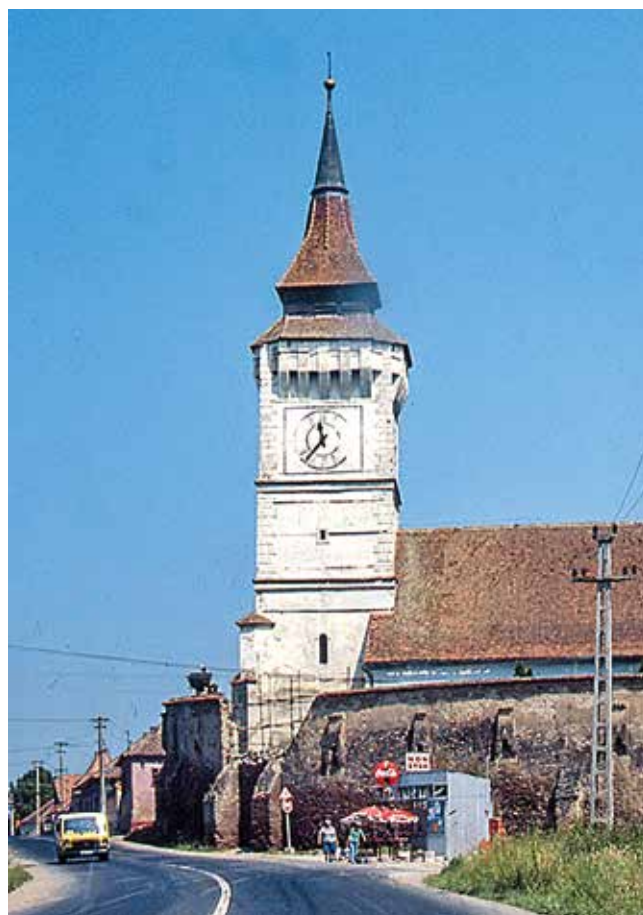
Fig. 3: The church in Rotbav before the collapse of the tower (photo C. Machat, 1998)

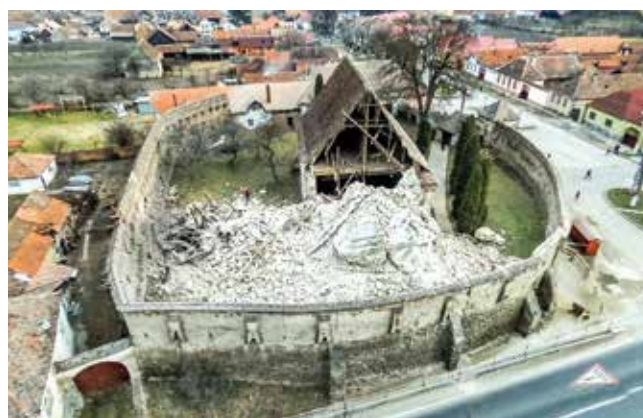
Fig. 4: The church in Rotbav after the collapse of the tower (© www.honigberger.com, Christian Chelu)

The situation in Rotbav is different. There the church fortification is positioned directly at the main road between Central Transylvania (North-West) and the *Țara Bârsei/Burzenland* (South-East). The church tower can be considered a landmark on this road, fortified in the 15th century with a defence gallery and machicolation, rebuilt after a fire in 1740 and shaped like the famous towers of the Black Church in *Braşov/Kronstadt* and the church in *Feldioara/Marienburg*. Being exposed all the time to all the trepidations produced by the growing heavy traffic and by the earthquake of 1977, which damaged large parts of Bucharest, the tower was seriously affected so that it had to be consolidated by a reinforced concrete structure. After the collapse, the western part of the church was closed in 2017 by a provisional wall, but first attempts for a possible reconstruction have already been made. The argumentation for this is based on the function of the church tower as a landmark. One can only hope that there will be no funding available for such a project as long as the numerous other church fortifications have not yet been preserved and consolidated. It will be interesting and important to see the results of a special project for the examination of the structural condition of 20 church fortifications developed by the Foundation and the Viadrina Europe University in Görlitz. It was funded by the German Federal Government and implemented in 2018–19.
