Safeguarding Heritage the People's Way Learning from the Indus Floods in Sindh, Larkana (City) and Mohenjo-Daro (Site)

Fariha A. Ubaid

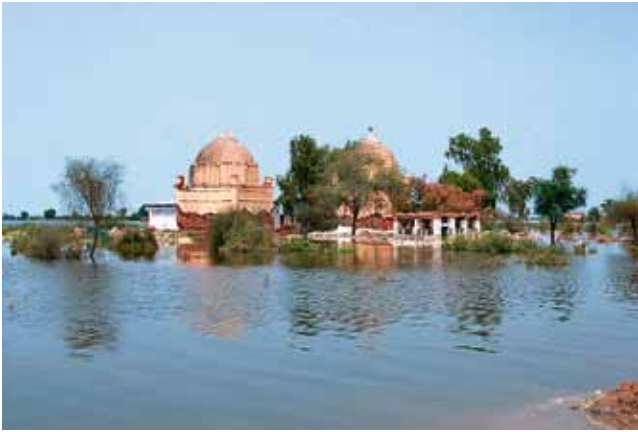
Fig. 6: Mosque and cemetery near Shahdadkot submerged in flood waters

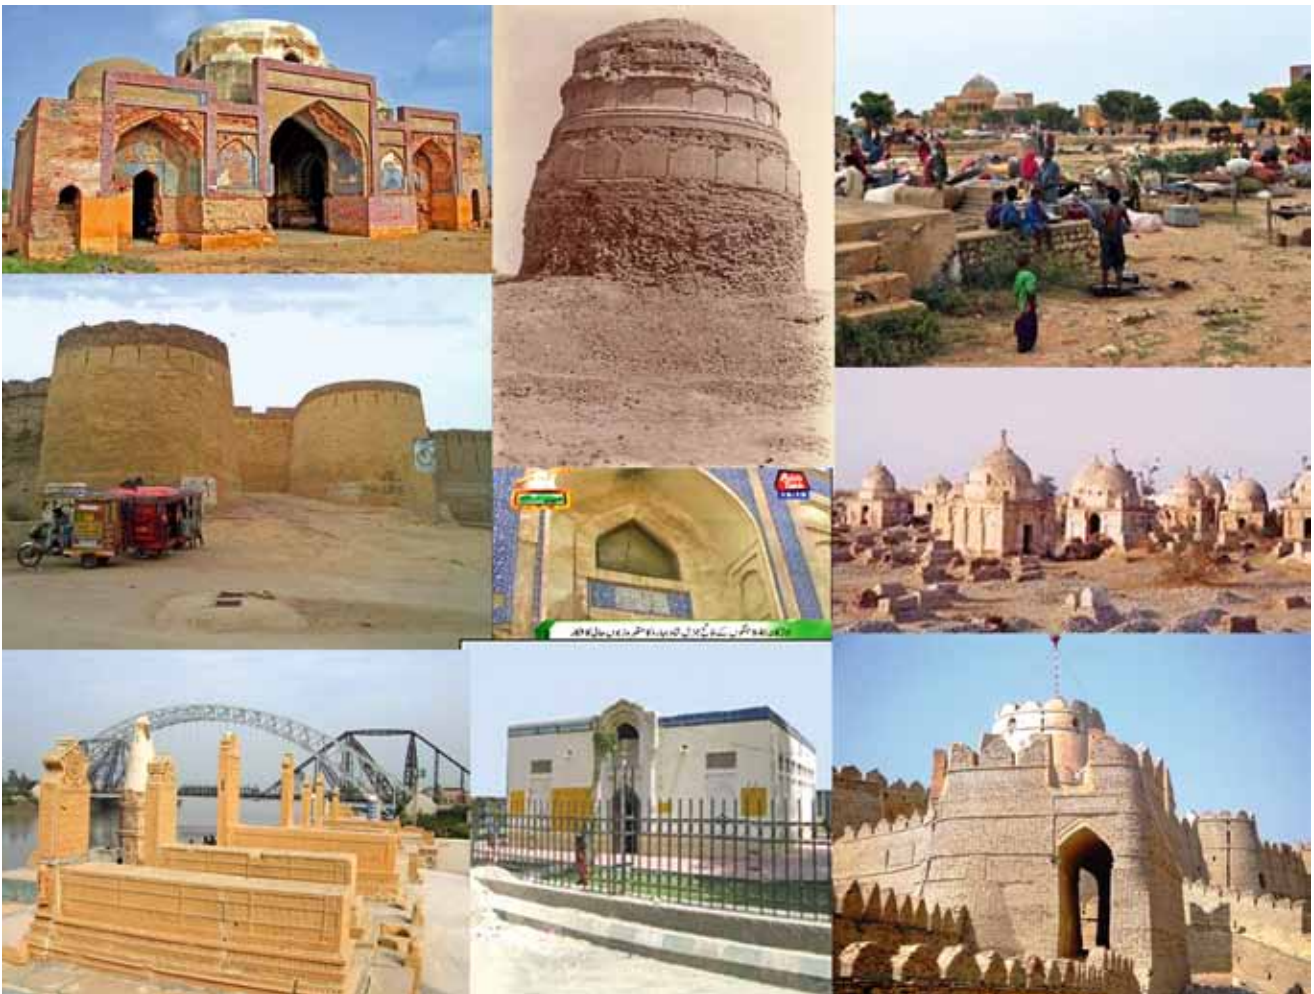
Fig. 7: Examples of the state of heritage sites, from left to right and top to bottom: Jami Mosque, Thul Mir Rukan, Makli, Umer Kot, Shahbaro Tomb, Kalhoru Tomb, Sathyan Jo Asthan, Tassar Building, Kot Dijji

In Sindh there are more than 150 protected archaeological sites and monuments. Also present are thousands of unlisted heritage properties in addition to the World Heritage sites of Mohenjo-Daro and Makli. The majority was affected directly or indirectly by the floods of 2010. Water stood stagnant around the monuments for months causing salinity and foundation decay. (Fig. 6) The rains lashed down so hard that exposed parts of structures collapsed. Furthermore, Internally Displaced Persons (IDPs) took refuge in the old structures causing further damage. (Fig. 7)¹³

Umerkot is located at the fringes of Tharparkar. It was the rains during flooding that brought the water in through the holes at top which caused the erosion of walls and produced cracks and bulging. Thul Mir Rukan is located in Moro Area. This millennium-old Buddhist stupa suffered greatly due to prolonged dampness. The top broke off at many places, the drum corroded and flooring got damaged. Excessive damage was also observed in Kalhoru Tomb located in Moro. Portions of the wall collapsed, the vaults in the seven-tomb cluster broke and the open graves deteriorated severely. At Kot Dijji, located in Khairpur, rainwater penetrated cavities

and potholes on the walls and seeped towards the bastions. A portion of Jaikhana (prison) roof and barracks also broke off. In Satyhan Jo Asthan at Rohri parapets bulged, some pillars collapsed and others started to lean dangerously. Rainwater penetrated into the entire structure through the cracks between the parapet and flooring, damaging the floor and widening the joints of the Kashi tiles. Jami Mosque in Dadu was stagnant with rain water for months¹⁴ and was at risk of collapse. Both Tajjar Building and Shahabaro Tomb of Larkana were submerged in water overflowing from the drainage and sewage lines in the city centre. And wherever water did not destroy the sites directly, the refugees did. A case in point is the World Heritage site of Makli near Thatta where more than 35,000 people found refuge with their cattle. The historic tombs were used as shelters for daily activities which impacted them severely. Similar was the case in Bhanbhore, where in one of the buildings known as the hotel the timber of the structure was used as fire wood. The districts of Shahdadkot and Jacobabad were flooded heavily due to a breach at Tori. Thus, most of the heritage there got severely damaged.¹⁵

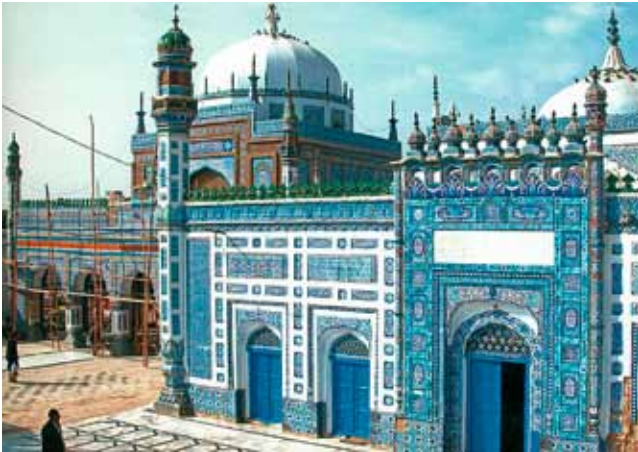
Fig. 8: Bhit Shah

It is interesting to note that on the one hand considerable damage was inflicted upon the listed monuments, but on the other hand people's places like Mai Makli's Shrine were protected by the people themselves. The Tombs of Khwaja Khizr and Sadhu Bela situated on opposing islands in the Indus near Sukkur received their share of flooding but were in good condition after the event. When water came in Bhit Shah it was drained by the neighbours of the shrine. (Fig. 8) These sites were preserved by the people themselves.

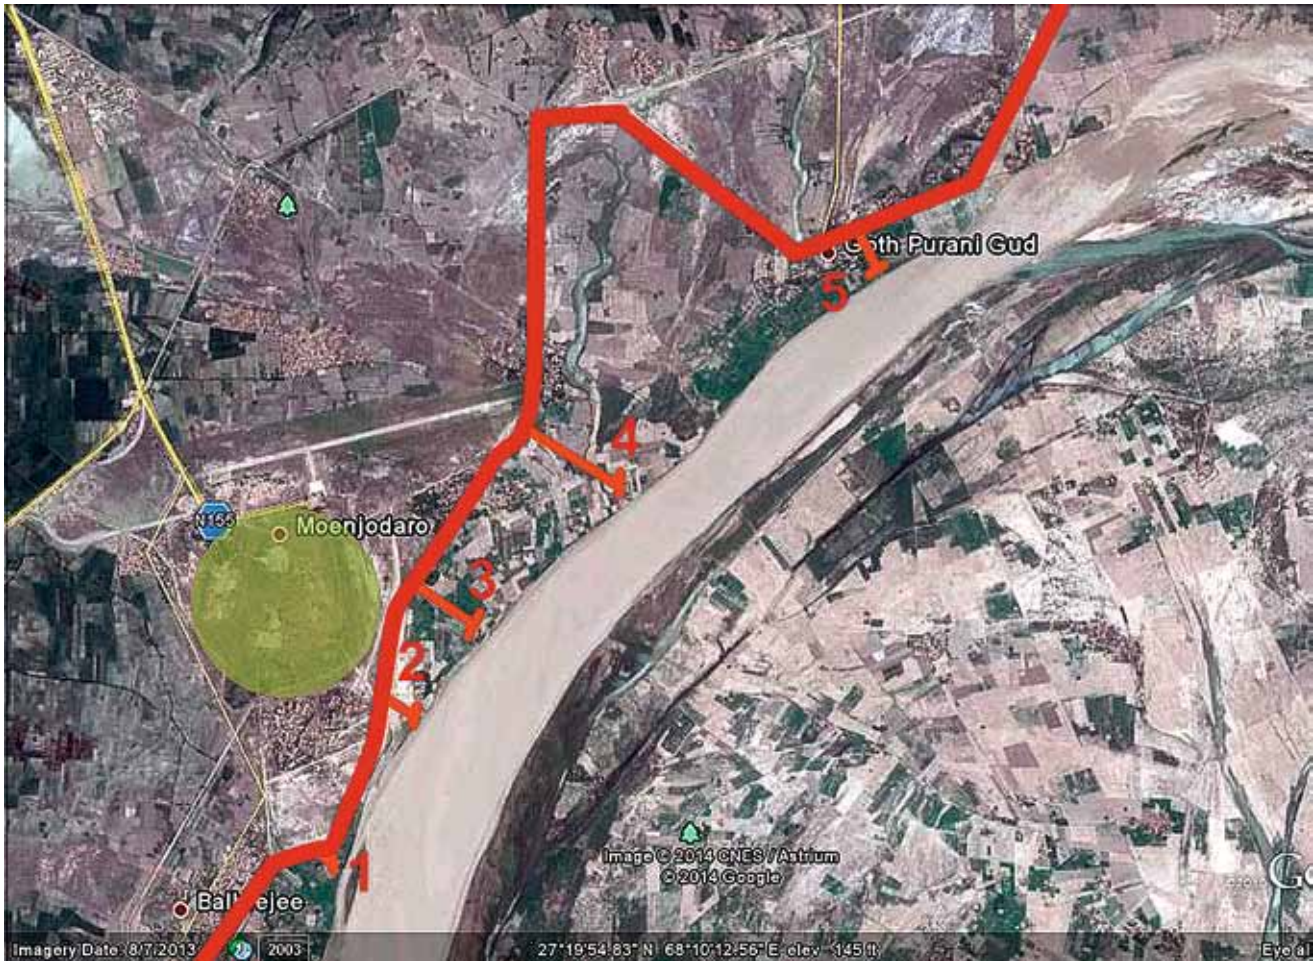
Fig. 11: Mohenjo-Daro, outer bund embankment showing five T spurs which divert flood waters away from the site

Legend has it that even in antiquity Indus floods were frequent around Mohenjo-Daro and several means were employed for protection. The massive brick structures raised the level of the settlement and safeguarded it from onslaught of flood waters.¹⁷ Today, the remains of Mohenjo-Daro are sheltered from the Indus waters by two circles of embankments: the inner and outer bund. (Fig. 11) The section and material of the embankment resemble the typical bund layout and design. It is made of mud and reinforced with stone pitching, which protects it from erosion and slumping. In the floods of 2010, spurs 1–4 withstood the

flood but the embankment between 4 and 5 showed potential breaches as stone pitching was not present.¹⁸ The army was immediately asked to strengthen this spot with sand bags, which proved effective.¹⁹ The site was also threatened by waters coming from the flooding in the West near Hamal Lake. (Fig. 12)

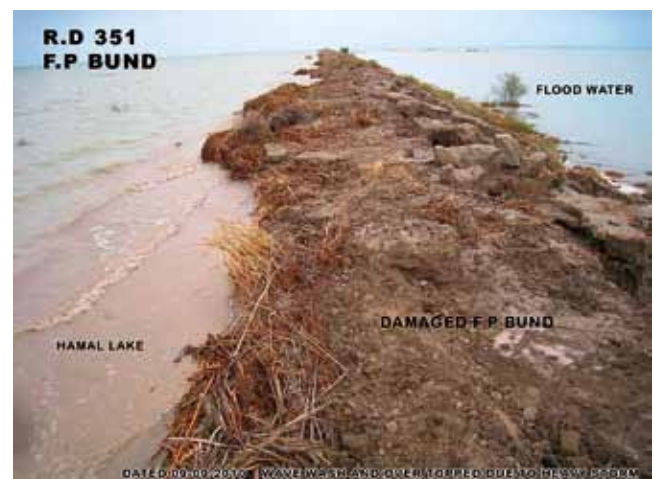
Fig. 12: Larkana, embankment between spurs 4 and 5, flood 2010

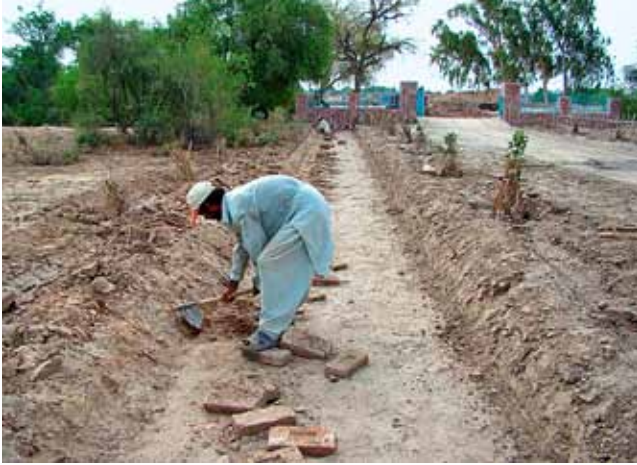
Fig. 13: Mohenjo-Daro, repairing of drains

Drainage is tackled in multiple ways. The site is enclosed by a circular drain which is maintained regularly. New drains are periodically constructed. Existing drains are desilted and cleaned. (Fig. 13) In addition, catchment basins become water catchers wherever water can accumulate. Barriers of brick and soil are created at the edge of the site and within it. (Figs. 14 and 15) They are effective in breaking the force of the water and divert it away from the walls. Water is prevented from seeping in by several preventive measures. The base of walls is protected either with mud filling or by sundried bricks. Gaps in masonry are filled with pure clay or the walls are topped by mud capping. In addition mud slurry work is carried out in the pre-monsoon period to further protect the walls.

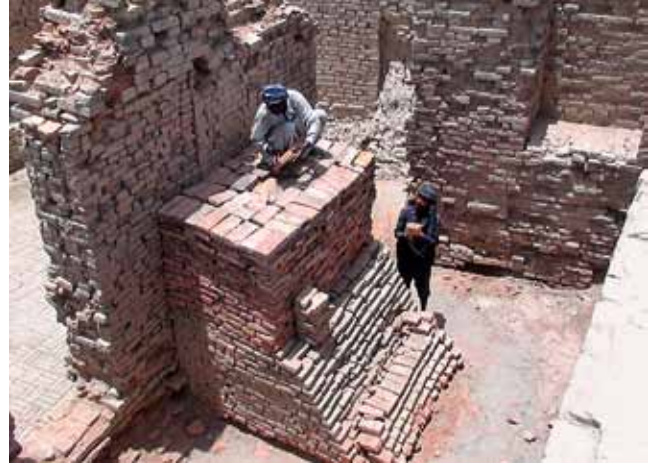
Fig. 16: Mohenjo-Daro, dry brick buttressing

Structures are stabilised by dry brick buttressing or steel/ timber shoring. (Figs. 16 and 17) This strengthens the walls and prevents tilting.

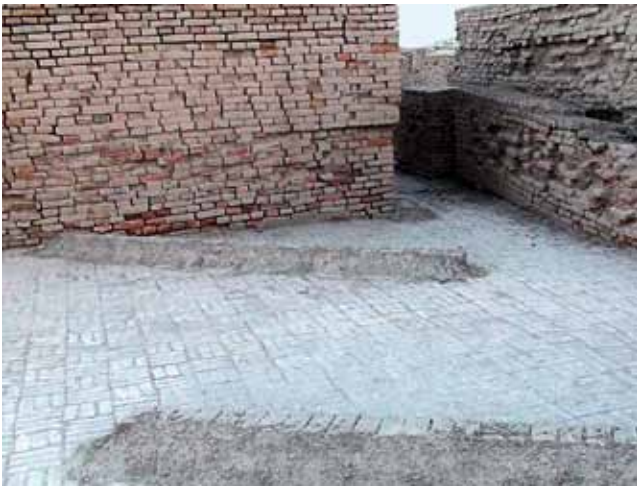
Fig. 14: Mohenjo-Daro, angular temporary barriers for preventing water flow

Currently several steps are being undertaken by the Department of Culture to protect Mohenjo-Daro from monsoon and dampness.²¹ They include drainage strategies, creation of barriers, and water and structural protection.

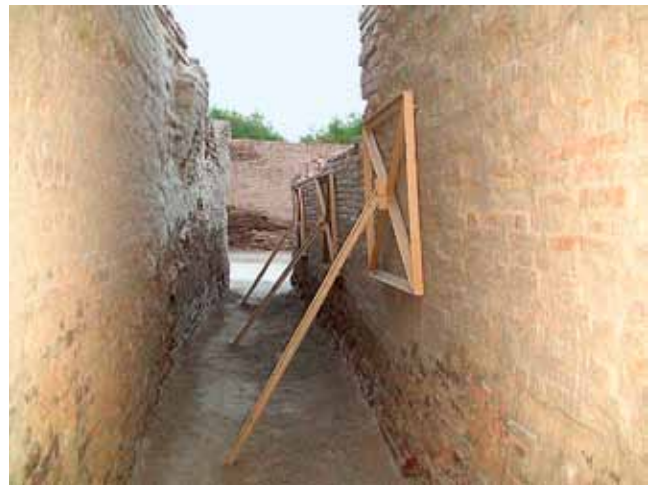
Fig. 17: Mohenjo-Daro, strengthening via shoring

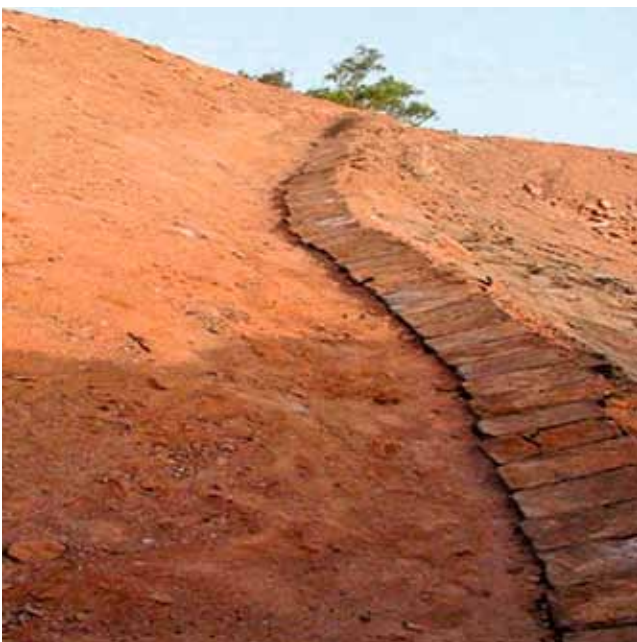
Fig. 15: Mohenjo-Daro, barrier at the edge of remains
