Preventive Measures for the Protection of Architectural Heritage Structures against Flooding

Miloš Drdácý and Zuzana Sližková

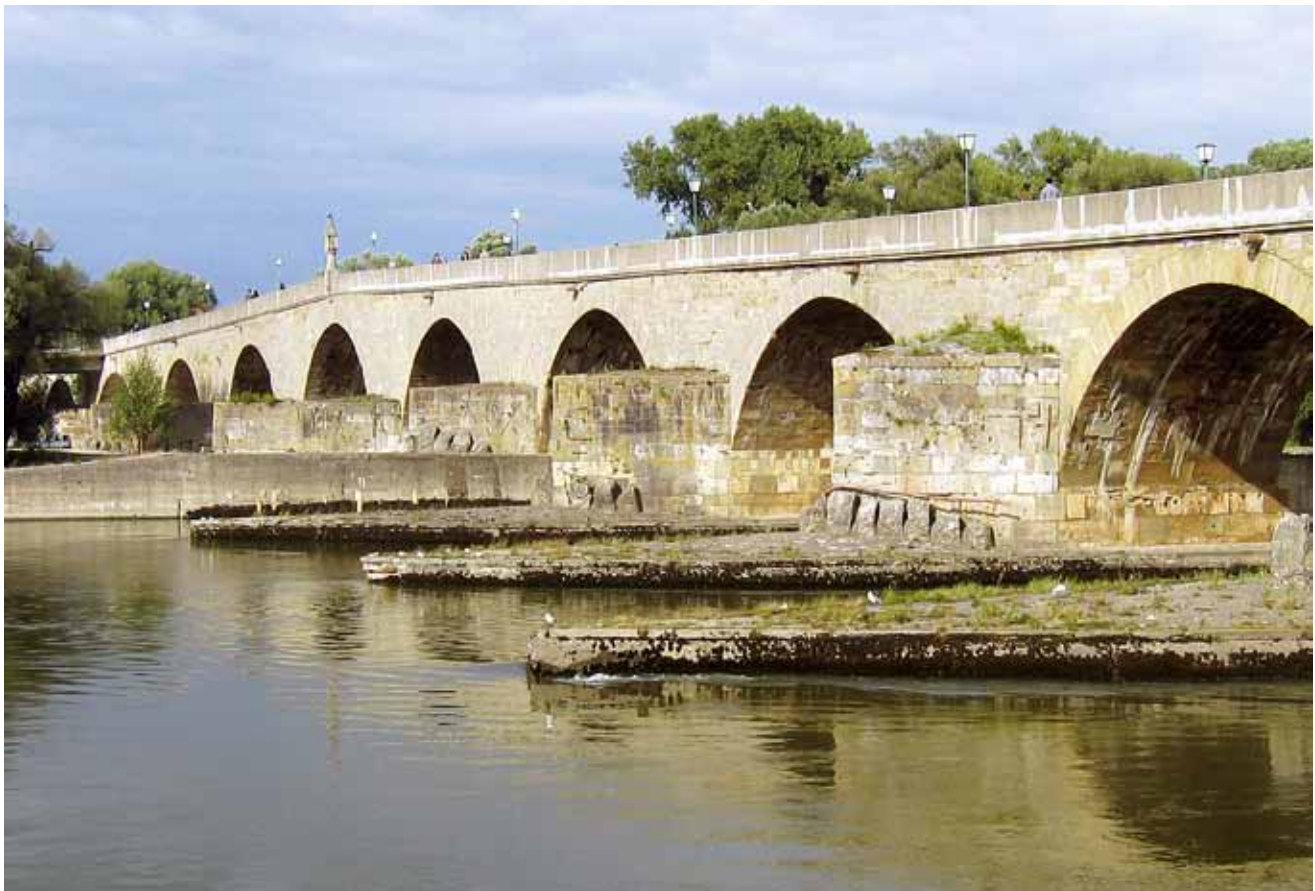
Fig. 2: Protection of bridge piers' foundations against undermining by means of small islets with a paved upper surface – a historical example in Regensburg (Bavaria)

Large bridges usually sustain floods quite well. However, they are under threat of partial damage, in particular their foundations and parapet walls (see free-standing walls). Only the foundations of bridge piers are extremely vulnerable. The undermining of foundations is a very frequent occurrence, which may cause collapse of some parts of a bridge. Undermining is prevented by improving soil characteristics under the foundations, and traditionally by means of deep barriers around piers and by creating small islets with a paved upper surface. (Fig. 2) Light chain or suspension bridges should be protected by decreasing potential water-stream loads; therefore the rails should be temporarily removed.

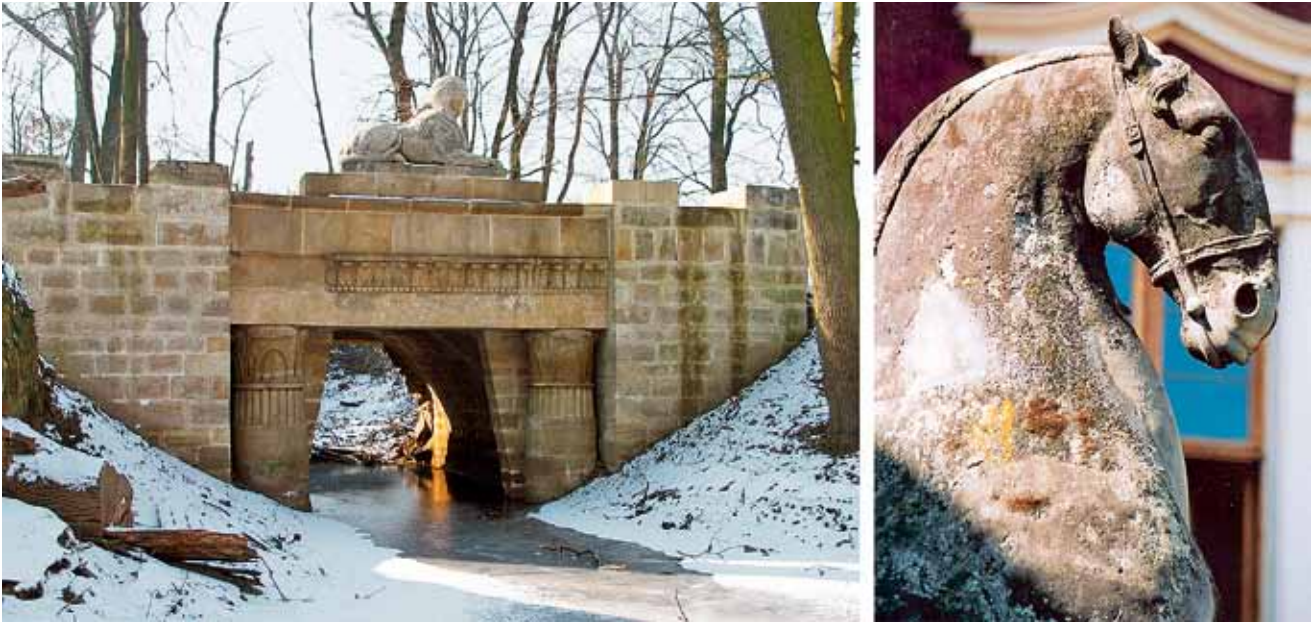
Fig. 3: Preventive restoration impact on the damage of monuments in the Château Veltrusy Park, near Prague: a) an appropriately restored bridge and sculpture, b) incorrectly restored sculpture

Z. Slížková analysed damage to historic objects in the Château Veltrusy Park near Prague which were severely damaged by the flood in 2002. There was a remarkable difference between objects which had been properly restored before the flood, e.g. a stone bridge with Sphinx (Fig. 3a), and objects which were neglected or incorrectly restored, e.g. sculptures on the Château’s monumental stairs (Fig. 3b). Even though the bridge was totally immersed in a high water stream, it only needed to be cleaned with water and low pressure steam. In 2004, some hair cracks and slight mortar disintegration were visible in masonry joints. After the next flood in 2006 the bridge was only slightly restored (colour retouching, plaster repair).

On the other hand, the sculptures were repaired long before the 2002 flood by applying Portland cement and polyvinyl-acetate consolidation, which substantially decreased the water and vapour permeability and kept the water inside the material. This increased the contamination with salts, biocolonization, surface detachment, and disintegration patterns up to a height of three metres. Freezing, moisture dilation and crystallization damage required a very substantial restoration intervention after the flood.
