Repairs of the Stuttgart Television Tower

Angelika Reiff, Berthold Burkhardt

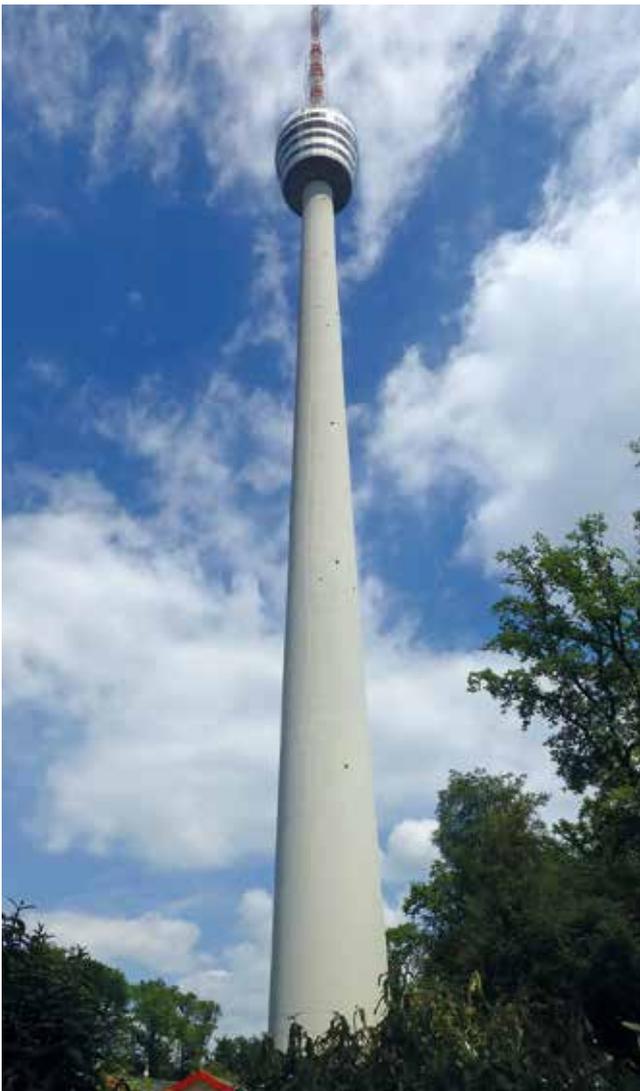
Fig. 1: The first reinforced concrete television tower in Stuttgart, 1953–56

viewing platform and a restaurant in the tower head were intended. Leonhardt, for whom the aesthetics of buildings were always a special concern throughout his life, considered a steel lattice tower ugly. Together with his colleague Walter Pieckert, Leonhardt developed a reinforced concrete tube designed to meet the structural requirements. Architect Erwin Heinle and interior designer Herta-Maria Witzemann, both also from Stuttgart, supported him in design and execution (Fig. 1).

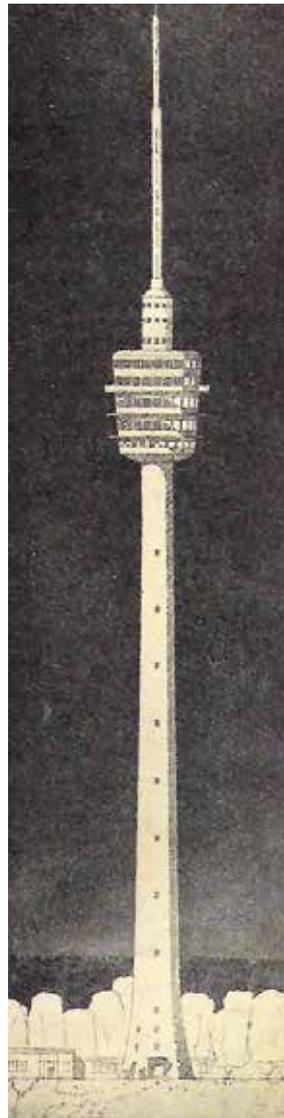
Fig. 3: Television tower in Dequede, GDR, 1956–59

In this context, one should also mention the television tower built in 1956–59 in Dequede in Saxony-Anhalt in the GDR, with a height of 185 m without antenna, planned by the project office of the Deutsche Post. This tower is similar to the television tower in Stuttgart, probably because Fritz Leonhardt was already involved as advisor during the planning phase. This tower has also been a listed monument since 1980 (Fig. 3).

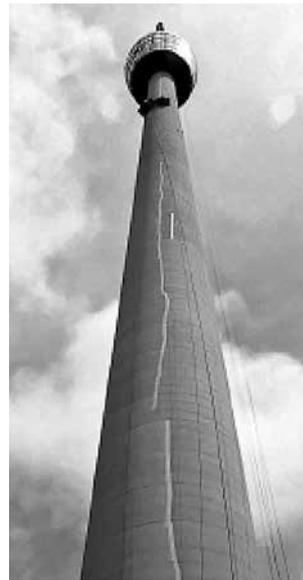
Fig. 6: Longitudinal cracks in the tower shaft

As early as the 1980s, the temperature fluctuations caused by the winter sun (up to 35 degrees on the south side compared to minus degrees on the north side) were diagnosed as the main cause of the cracks in the tower shaft, which were initially visible from the inside. The cracks were filled with synthetic resin and stiffened inside with steel rings. However, these measures did not prove to be long-term and the cracks increased to the outside of the reinforced concrete pipe.

In 1993, before a further extensive repair of the cracks and concrete spalling, an extensive inventory and damage investigation was carried out in the various areas of the reinforced concrete structure. In the tower shaft, cracks with a total length of 232 m were mapped according to position, length and width. Due to the seasonal and daily changing temperature influences, the circular shaft deformed into an oval shape, in the course of which continuous cracks formed, which can be seen structurally as joints (Figs. 6, 7).

The cracks were each milled out with an 18.0cm wide and 2.0mm deep groove. Pores and blowholes were exposed with a wire brush. After dedusting the cracks, the crack-bridging primer was applied by brush. Adhesive tensile tests on the primed surfaces proved that the measure was successful. The cracks were masked with adhesive tape and filled by hand in four operations. After the work was

completed, the entire tower shaft shell was water-blasted with high-pressure (working pressure 400 bar) to remove loose mortar parts and the cement paste layer on the surface. A considerable surface roughness and a high abrasion resistance were achieved.

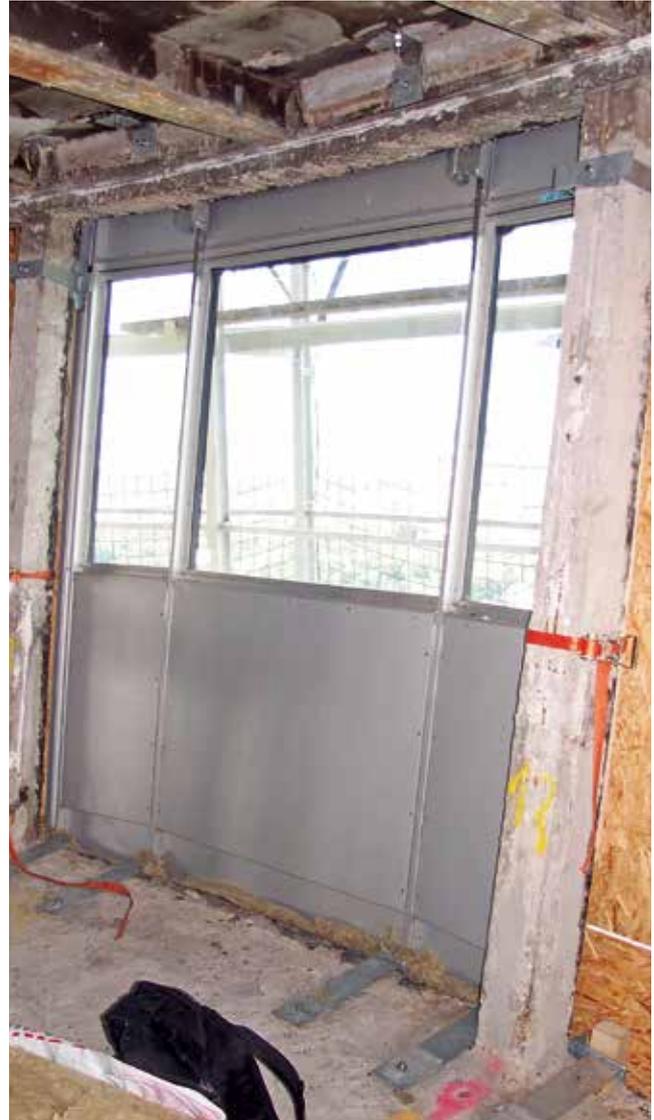
Fig. 10: Replacement of facade elements

This renovation measure was also preceded by a detailed documentation of the condition and a damage analysis. At the locations examined, strong corrosion was observed at the anchoring points of the façade construction and on the load-bearing steel parts. The aluminium sheets were examined for decomposition by pitting corrosion. Based on the damage pattern, it was evident that moisture was transported between the aluminium outer skin and the interior cover. One cause was assumed to be the missing vapour barrier on the inside of the cork insulation glued onto the aluminium outer skin. In a manner characteristic for the construction period, the aluminium posts between the interior and exterior were not thermally separated.

Corrosion at the connection and anchoring points made of steel angles as well as the desire for an energy-optimised façade by replacing the window elements in the restaurant area had persuaded the client and owner of the Südwestrundfunk tower to carry out renovation work on the top of the tower façade. The engineers' assessment was ultimately the decisive factor in the decision to renew the façade at the top of the television tower (Figs. 10, 11).

The new outer skin was constructed on the basis of the existing façade with thermally separated profiles and insulated panels. The new insulating glass consists of an 8 mm pane inside and a 12 mm pane outside with a 16 mm gap. The offices AIC Hapt GmbH, DS-Plan Ingenieure and Drees+Sommer, all from the Stuttgart area, were involved in the planning.
