Do Modern Materials Need a New Conservation Approach? Approaches to Restoring Sandwich Panels, Polyurethane Foam and Shotcrete

Steffen Obermann

I. The Berlin Circulation and Cavitation Tank

II. The Observation Deck in Binz (Rügen) by Ulrich Müther

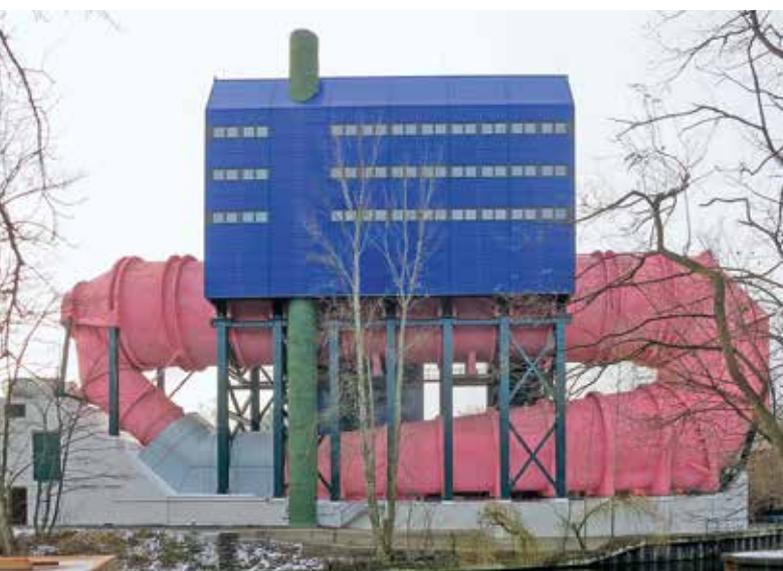
The first project is the Circulation and Cavitation Tank in Berlin (*Umlauftank 2*) (Fig. 1). This structure is situated on a prominent site in the heart of Berlin close to the main axis connecting the western and eastern parts of Berlin. The tank is visually well known, since one of the main railway and suburban train lines pass by directly. And yet to most citizens and visitors its function has been a mystery since its erection in 1974. Even if the pink tube indicates some technical operation is in operation, it neither reveals its purpose nor the medium circulating in it. The inner life of the blue box remains a secret as does the reason why it is propped up on top of the giant pink ‘serpent’ by a slender green steel structure (Fig. 2).

In fact, the Circulation Tank is a research facility, today operated by the Technical University of Berlin. The tank contains 3300 tonnes of water, the water being driven by a huge propeller and two ship diesel engines. The top part of the tube is only half filled. A large opening allows access to the water, which appears as a steady running flow. Depth and speed can be varied. This section allows hydrodynamic and maritime experiments in and under water with all sorts of vessels and propellers in model scale. The blue box with five storeys serves as a laboratory building. The pink tube is insulated by foam in order to keep the water temperature to some degree constant throughout the year. Scientific tests need stable conditions for comparable results.

*Fig. 1: Berlin, Circulation and Cavitation Tank
(© adb Ewerien und Obermann)*

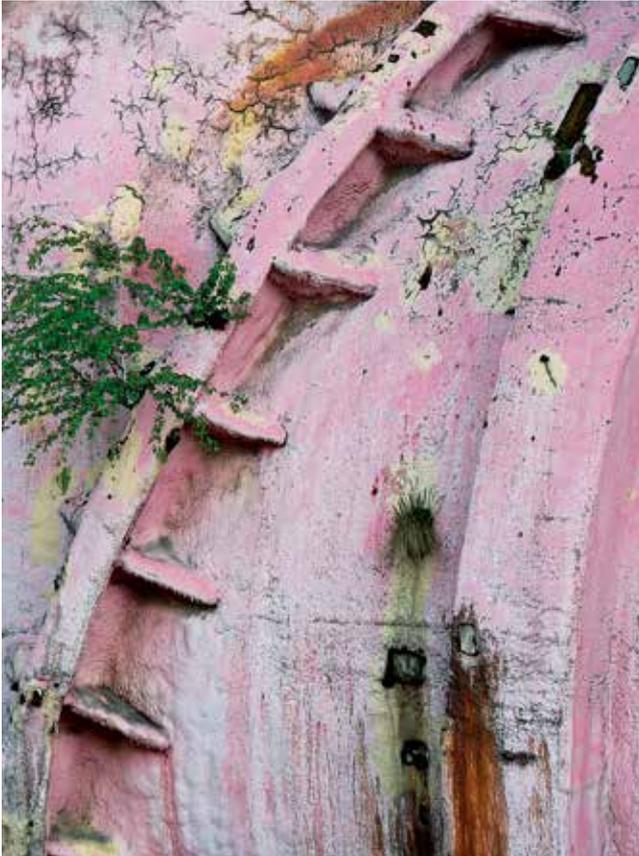
The tube is made of curved steel plates, 17 mm thick. The whole welded construction is covered with about 40 mm of polyurethane foam (PU foam), directly sprayed upon the steel and finally painted with a pink coating. Polyurethane foam is commonly used as an insulation material, which is mostly available as boards and usually covered and protect-

Fig. 3: Polyurethane foam with typical damages, 2013 (© adb Ewerien und Obermann)

ed by other weatherproof materials. It is not very resistant to UV light and tends to absorb water after several years. The condition in which the foam was found in 2013 before restoration was characterised by gaps in the coating and by the foam beginning to decay. Many parts of the surface showed cracks or even voids. In some gaps, vegetation had started to grow. Earlier repairs with inappropriate materials such as mortar were also found. Mortar fillings did not coalesce with the PU foam.

The attempt to repair the pink foam in a traditional way was more successful. Repair samples had also been tested in advance. The repair of masonry had been the role model, although solid stone appears as the complete opposite to the unstable polyurethane foam. Responding to the two main categories of damage, two major repair principles were implemented. First, damaged spots were cut out down to the steel bottom. That was handily achieved with a simple kitchen knife. Preferably rectangular outlines were carved out, just as it is commonly done to repair stone. To guarantee a durable bond with the adjacent foam an undercut was formed, similar to mortar-based repairs in masonry. The void, wider on its bottom than on the surface, was filled by spraying in new foam. The two-component material turns from liquid into stiff foam within seconds. While hardening, the foam expands. Spraying foam needs experience in order to anticipate the amount and allow for expansion. In most cases the new infill expanded slightly over the edges and had to be cut back. Finally, a quick and very thin overspray was applied to adapt to the typical granular texture (Fig. 6).

The second repair principle applied to areas with single cracks or a network of cracks which did not need to be cut out deeply. A survey had shown that the cracks usually ended at a depth of only a few centimetres. Those areas were ground down to the sound material. The recesses were lev-

elled by overspraying fresh foam. Finally, and after washing the remaining surface with water, the pink coating was added.

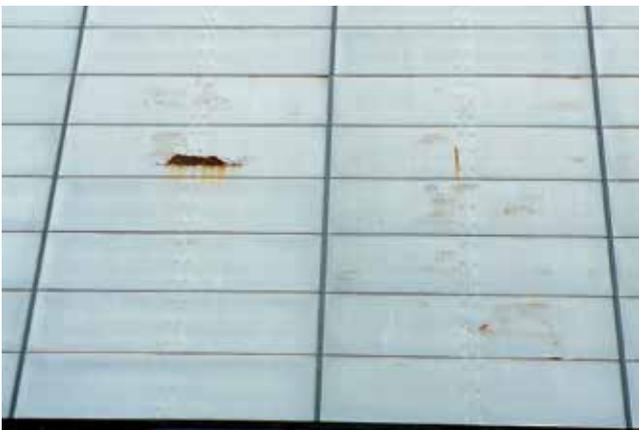
Fig. 4: Sandwich panels with faded coating and corrosion, 2013 (© adb Ewerien und Obermann)

The façade of the laboratory building is made of sandwich panels. They were industrially produced and consist of a core of polyurethane foam in between two layers of galvanised steel sheets. The outward sheet is coated in blue, the one towards the rooms in white. The panels had lost their colour in the more than 40 years of their existence. The coating had not been renewed since construction. More concerning than the loss of colour were the spots of corrosion that on some of the panels appeared to be covering large areas (Figs. 3 and 4).

be scrutinized intensively. A special device allowed inspection of the depth of the panels. The *eddy current method* is an electronic method used for example to detect fine cracks in components of aeroplanes. This instrument was able to identify transformations on the rear side of the steel sheet facing towards the PU core. Since the detector has the size of only about five centimetres it took several weeks to inspect all panels centimetre by centimetre.

The result was disastrous. Two lessons had to be learned: First, the steel had separated from the foam in many places, forming a gap. The result was loss or at least severe reduction of the stability of the panel as a self-supporting structural element. Second, and even worse, the outer steel sheets were corroding on their internal side attached to the foam. Despite the galvanising, most corrosion found had developed from the inside and not as previously assumed from the outside of the panel. The results of the *eddy current method* detection were validated by openings. At the end of the process, the result was that all panels were identified as being at least partially damaged although their appearance from outside had suggested a good condition. There was not a single sound element found on any of the façades. The first assessment of the visible damages had been completely misleading and wrong.

This painful process of learning culminated in the realisation that there was no possible repair method for corrosion within the compound element of a sandwich panel without its dismantling and complete destruction. The intention of a thoughtful repair ended in the exchange and renewal of all sandwich panels. That they are still being produced in the same way, in the same dimension and colour, was cold consolation.

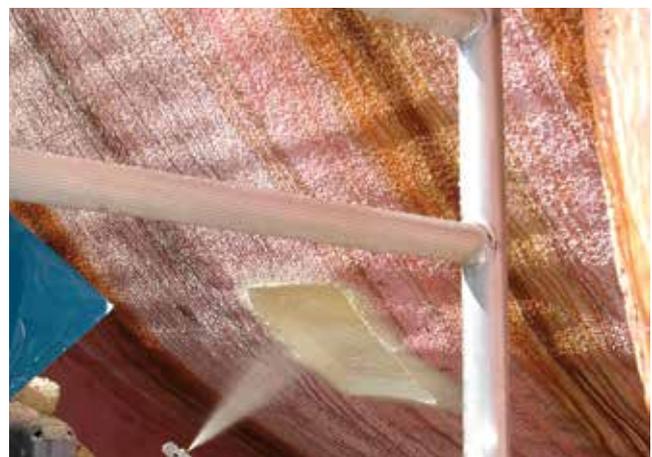
Fig. 6: Fresh foam being sprayed into the prepared voids (© adb Ewerien und Obermann)

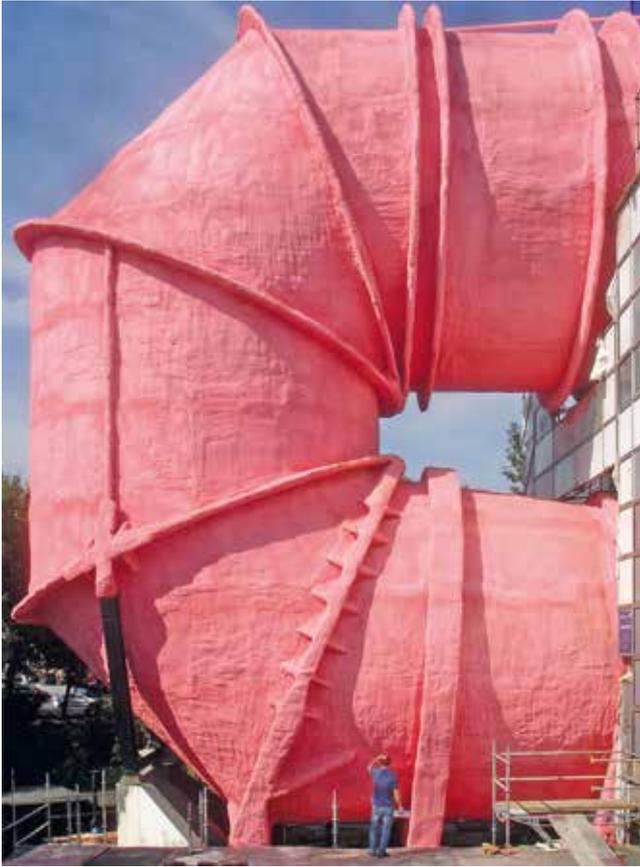
The result is that most of the foam has survived and especially its irregular hand-crafted character. On closer inspection, the repair work can be clearly perceived. A closer look also indicates that the foam is not a high-quality material. The emblematic character of the large-format building, however, emerges to its full effect only from a distance (Fig. 7).

Fig. 7: Polyurethane foam after restoration, 2017
(© adb Ewerien und Obermann)

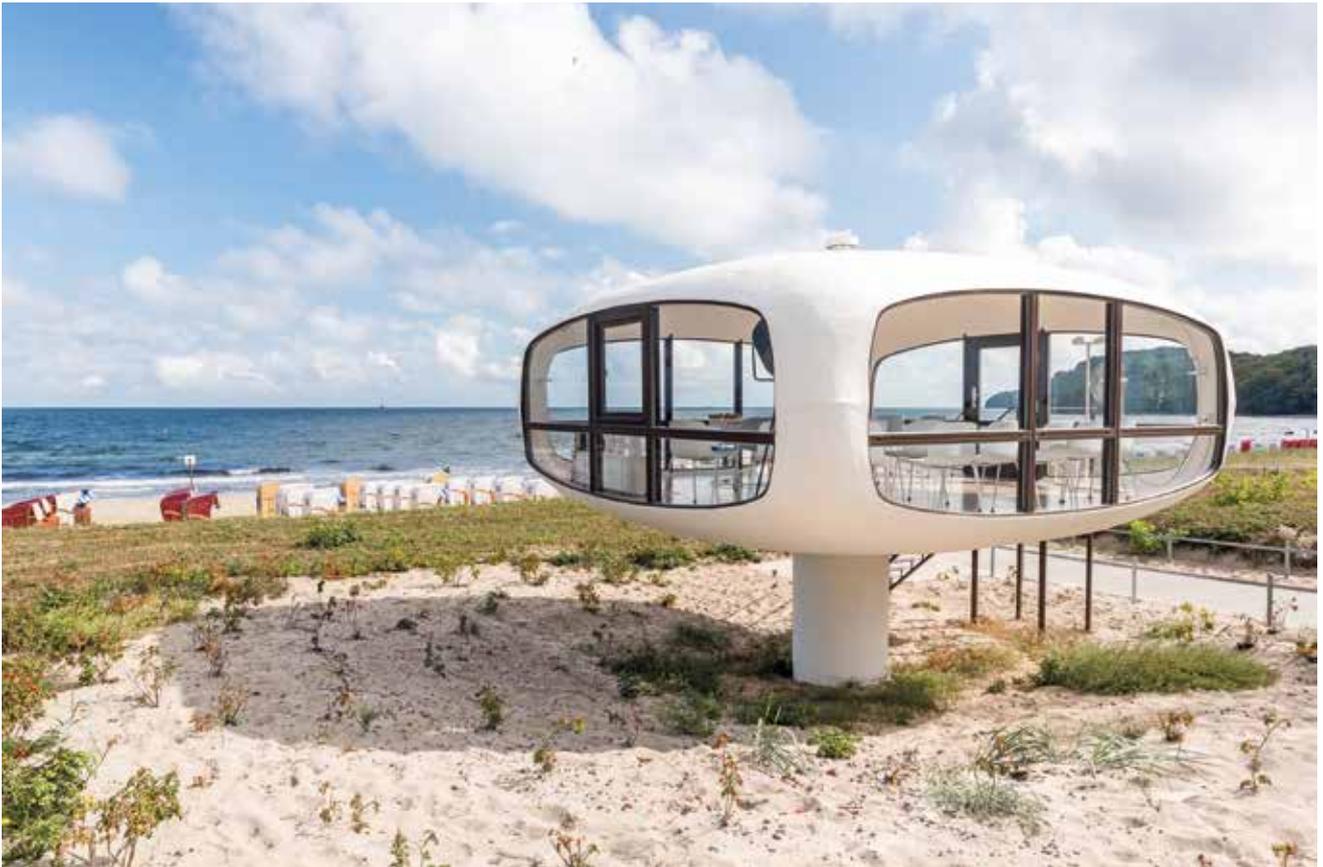
Fig. 9: Observation deck for lifeguards at the beach of Binz/Rügen (© Wüstenrot Stiftung)

his favoured material. Concrete was shot on a fine mesh of steel and reinforcement, sometimes even without a wooden shuttering. In this context a series of trial constructions were created from which he could gain experience for taller buildings. One of those experimental buildings was an observation deck for lifeguards – often referred to as “rescue tower” – at the beach of Binz (Rügen), built in 1975. In this case the shape is not a hypar shell: the shape is bent in two directions, but not in the opposite ones.

shell was planned and most probably realised with a thickness of only seven centimetres. Six years later Mütter was commissioned to provide a second observation deck further down the same beach. Instead of building the identical structure he tested out the limits of material and geometry and reduced the thickness of the shell down to only four centimetres.

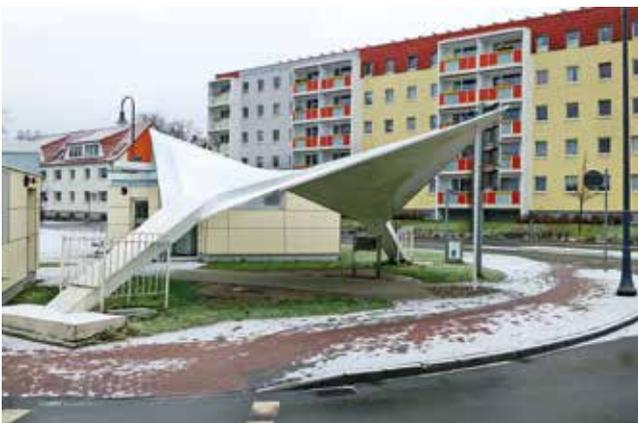
Müther combined the hypar shells in different ways to outstanding spaces. A single hypar shell could serve as an open but covered space, as for instance a bus stop (Fig. 10). Two, three or four hypar shells of larger size were arranged to

Fig. 10: Hypar shell for small-scale experimental structure: bus stop in Binz/Rügen (© adb Ewerien und Obermann)

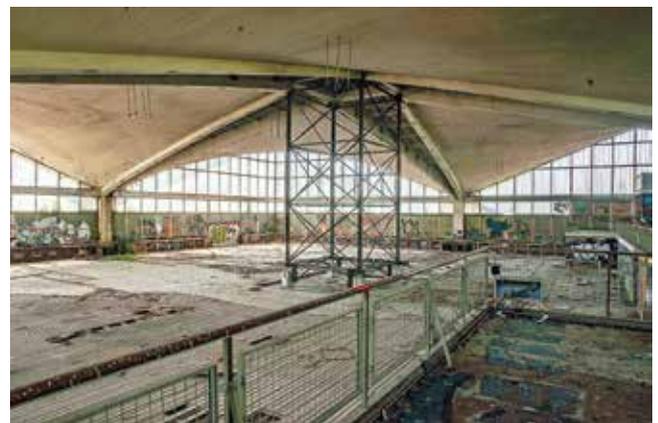
Another proof that his work belonging to the recent past is still in danger is a multi-purpose hall in Magdeburg whose future is uncertain. It consists of four hypar shells (Fig. 11).

Fig. 11: Multi-purpose hall in Magdeburg (built 1969); endangered structure of four hypar shells, with temporary support in the centre (© Sebastian Schmidt)

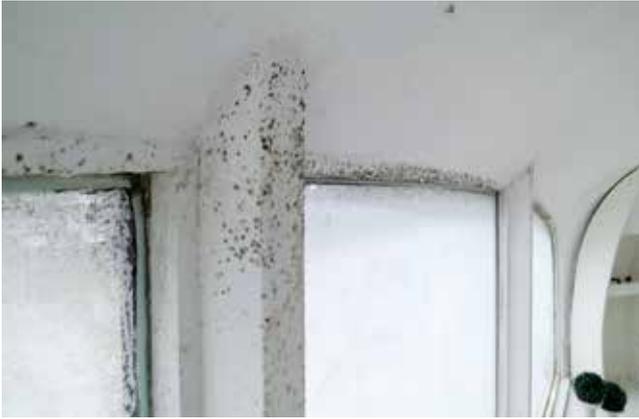
Fig. 12: Inside the deck before restoration (2015): frozen condensation on the windows, water and mould on the concrete shell (© adb Ewerien und Obermann)

From a structural point of view, it is a superb work. In some other respects, however, it is a failure. This becomes clear in winter. The windows are frosted, water drips from the ceiling and all surfaces are wet and mouldy. Due to the extreme dampness the wooden window frames had rotted from inside and out. Heating and ventilation were non-existent. Only four centimetres of concrete, rapid weather changes at the coast, no insulation and no space for heating cause severe problems to the inner climate and serious harm to the fabric (Fig. 12).

First: Instead of single glazing, double-glazed panes with a thickness of only 12 mm were inserted without any effect on the frame dimensions. A sample was tested and positively evaluated in respect of appearance, colour and reflection. The completely decayed frames were reconstructed in thermally processed timber, which promises high resistance towards rot.

Second: To avoid or minimise condensate on the concrete surfaces two options were explored. The first option was a plaster with highly insulating characteristics. A notable physical effect on the room climate would have afforded a layer of several centimetres on the inner side of the concrete shell. This corresponds to the thickness of the concrete itself. It would have been impossible to hide this extra layer at the windows. The other option was to install very thin electric heating wires which were set into a filling of only a few millimetres and which could fade out at the windows. Neither wires nor filling is visible at all. Electronic sensors for temperature and dampness decide when to slightly warm up the shell in order to avoid condensation. With computer-based climate simulations it became clear that these two measures on their own would not be sufficient.

The third component was the most challenging. The idea was to warm up the building slightly and to provoke air circulation. A pipe of about fifty metres length carries air into the building. The air is pre-warmed in a distant and existing facility building and remains warm because the pipe runs below ground at more than a metre in depth. The air runs into the building through a new duct within the shaft of the tower and disperses under the floor. It leaves through slim gaps in
