Buzludzha Monument/Bulgaria – “It’s Big Stuff”. Ways to Conserve a Ruined Dissonant Monument

Thomas Danzl

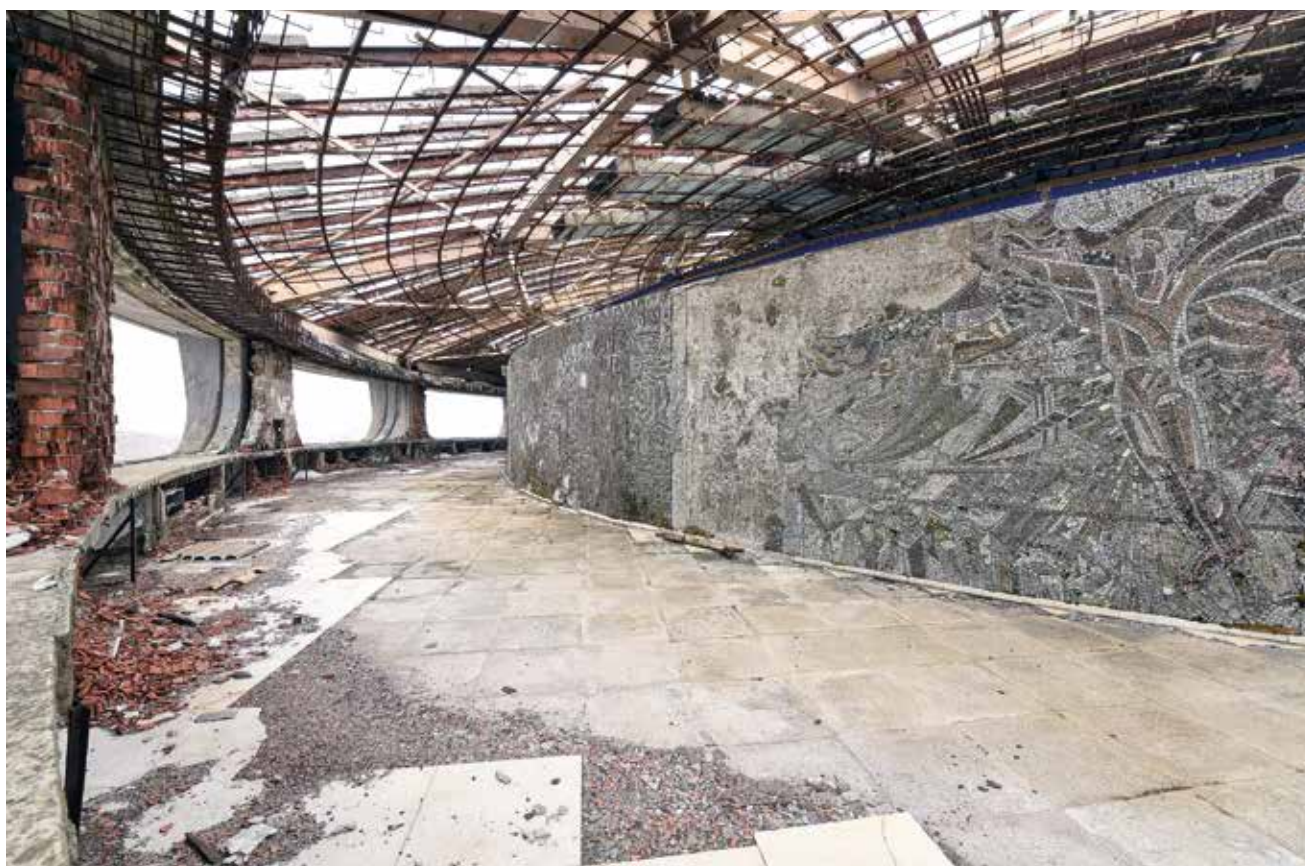
Fig. 1 Main Hall, outer ring, mosaic with natural stone tesserae, condition 2019

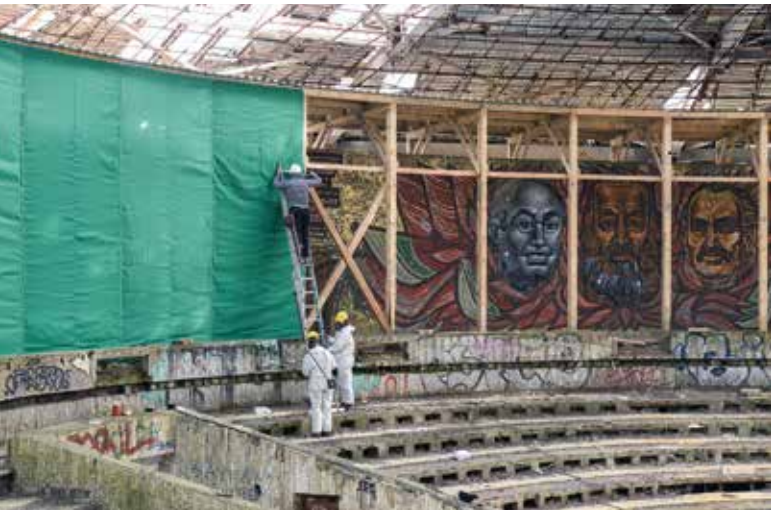
Fig. 2 Main Hall, inner ring during the enclosure works, 2020

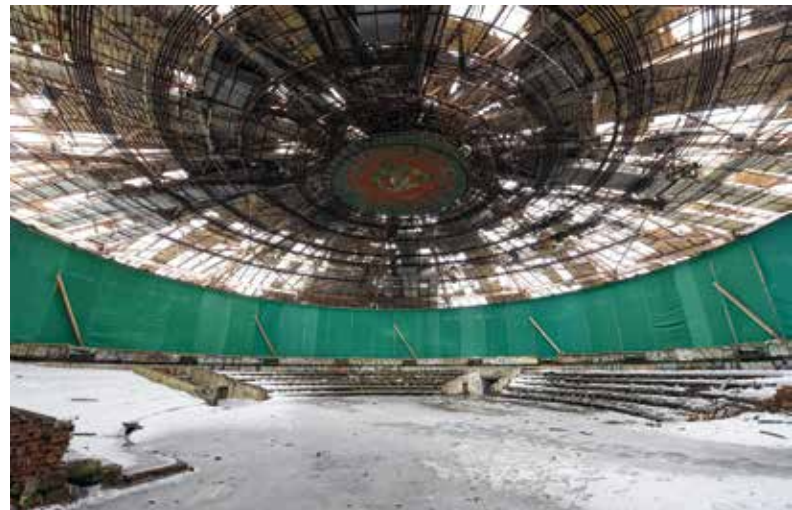
Fig. 3 Main Hall, inner ring after the realized enclosure, 2020

mosaics. The project “Emergency measures to stabilize the mosaics of Buzludzha”, funded by the Getty Foundation, managed to install a protective shelter over the most endangered mosaics of the monument, i.e. those of the inner mosaic circle. Another main goal of the team was to preserve the most endangered mosaics of the outer ring in September 2021 before wintertime further accelerated decay processes.

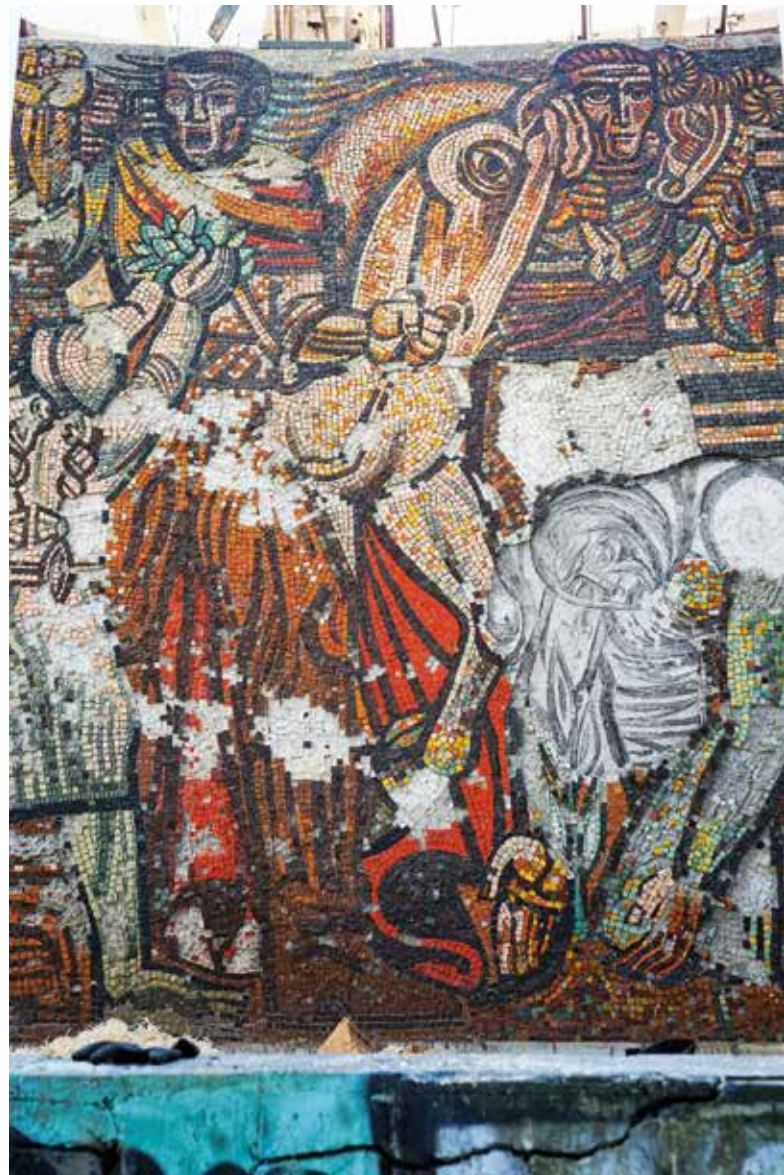
Fig. 4 Main Hall, inner ring, detail of the glass mosaic showing partial loss of tesserae and exposure of the black sinopia

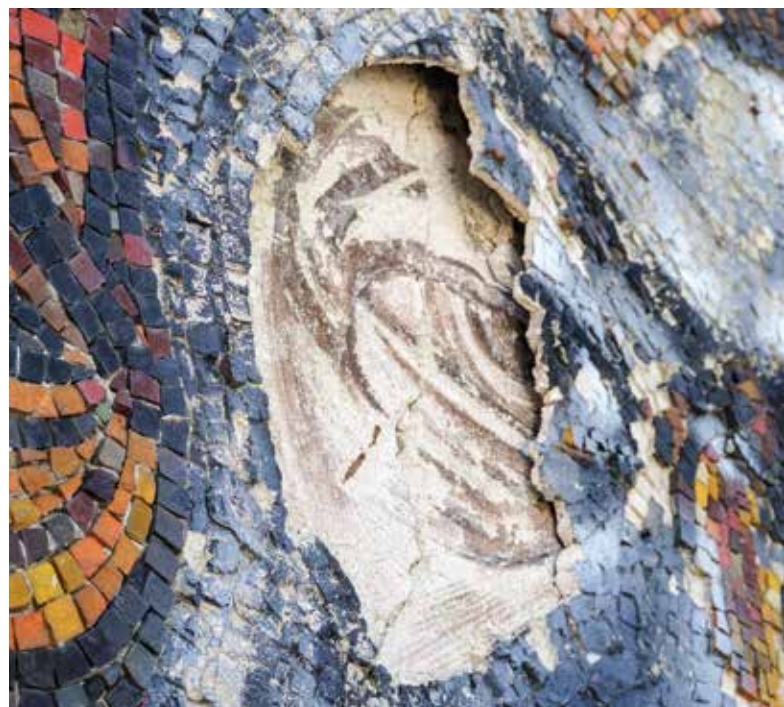
Fig. 5 Main Hall, inner ring, detail of the head of Marx before the left side of the face fell off, June 2019

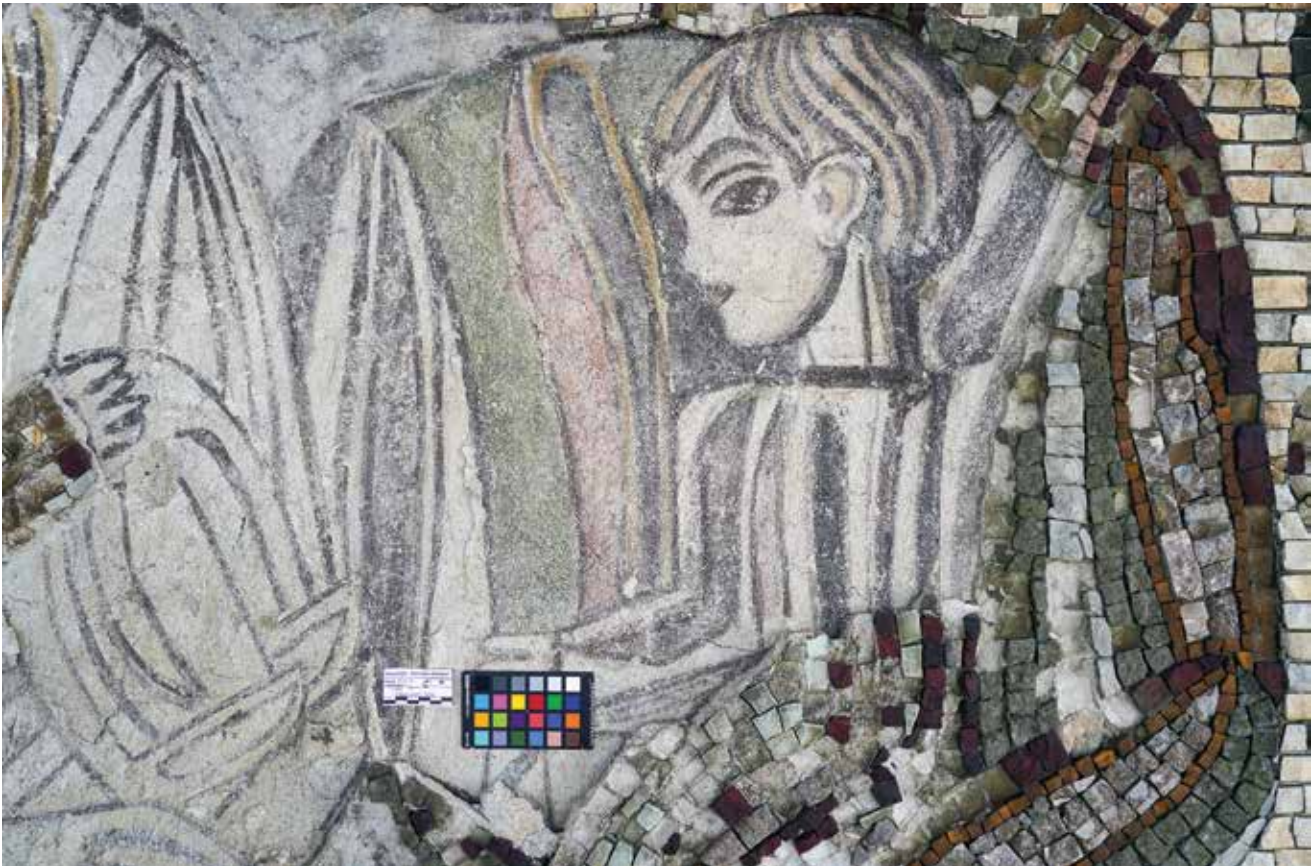
Fig. 6 Main Hall, outer ring, mosaic with natural stone tesserae and a multi-coloured sinopia

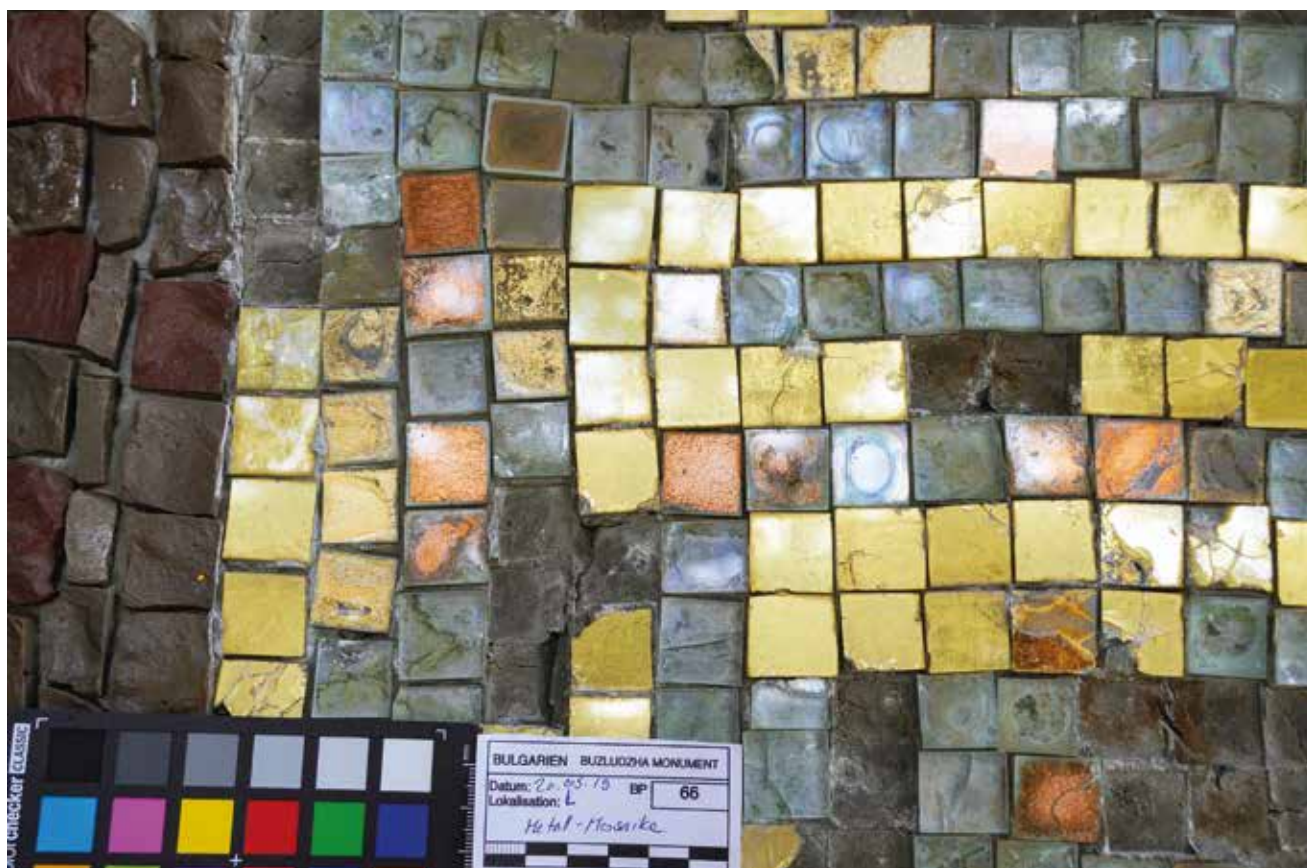
Fig. 7 Main Hall, inner ring, “gold-like” glass mosaic with metal foils of different alloys

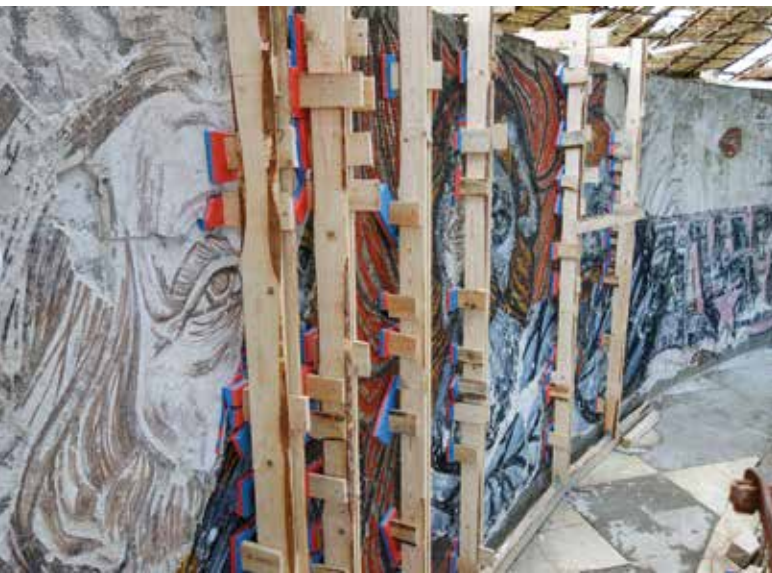
Fig. 8 Main Hall, inner ring, detail of the head of Marx after the left side of the face fell off and during mechanical securing of the hollow mosaic, September 2019

This campaign focused on the mapping of all the hollow and detached or otherwise damaged areas of the mosaics securing the mosaics’ edges by means of filling mortars, conserving the preparatory drawings – sinopia – in an adhesive and cohesive way, documenting and saving detached or fallen sinopia and mosaic fragments by storing them for future possible uses and to keep the detached areas of the mosaics in place by means of non-invasive mechanical means.

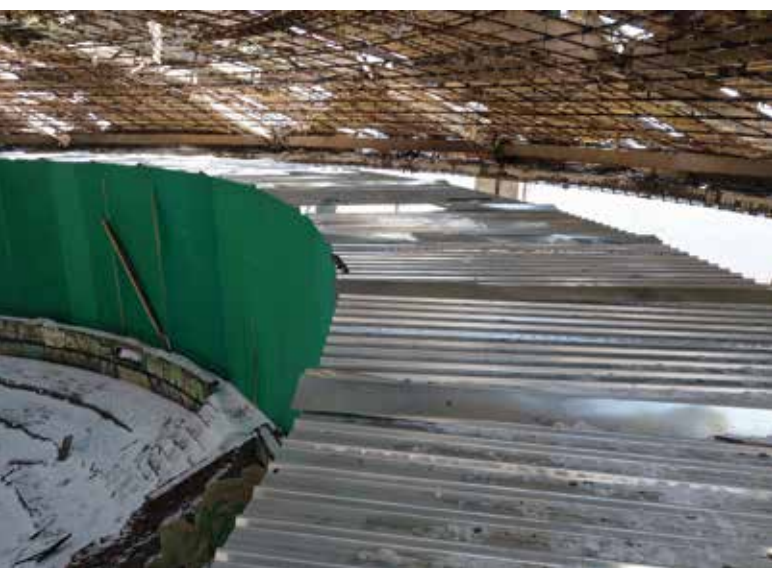
Fig. 9 Enclosure, October 2020

Regarding the roof and the missing protective effect of this due to its bad state of disrepair, the most practical way to slow down decay and to guarantee a holistic attention for all the material aspects was to introduce a continued control of the microclimate in the surrounding of the mosaics. Video cameras were installed along with a shelter that consisted

of a metal construction and the hanging of a water repellent fabric to protect from direct contact with liquids or frozen water, heavy winds and snows and, finally, to lower the risk of condensation phenomena.

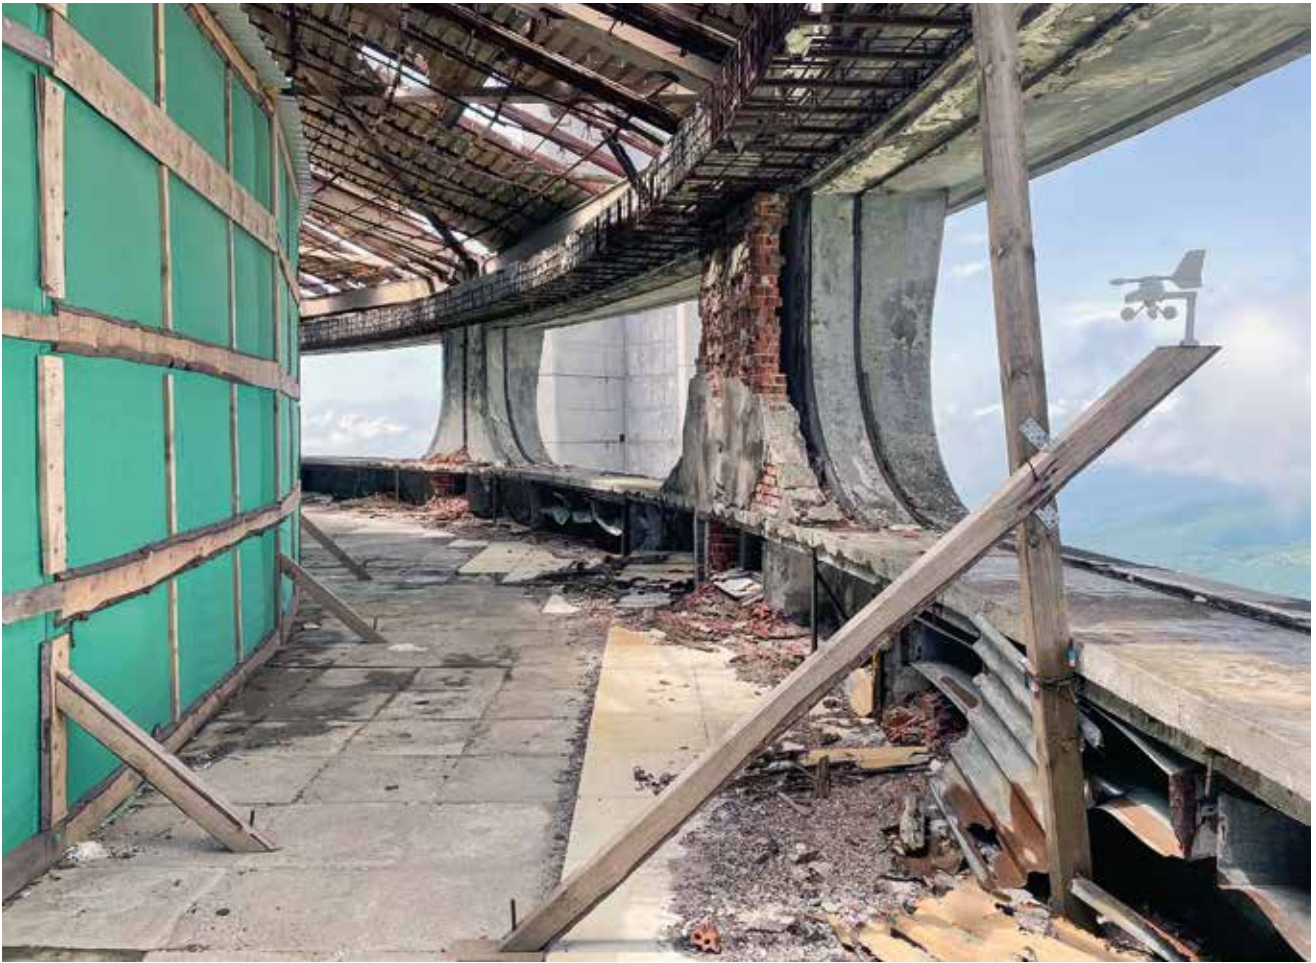
Fig. 11 Main Hall, outer ring, enclosure with weather station, 2021

In the absence of the financial means to build a new roof, this could only be achieved by excluding the direct influence of water through a preliminary protective roof. The hope to isolate the internal climate from the external climate

by means of an enclosure and to completely stop the direct exposure to abrasive and erosive factors also played a role. “Classical” conservation-restoration methods of wall paintings and mosaics – such as edging repair – had to be adapted to the special material techniques applied in the early eighties of the 20th century when these mosaics were created.
