The Conservation of the Cultural Heritage Sites of the Exhibition of Achievements of National Economy (VDNH) in Moscow: Mosaics, Paintings, Sculptures

Yulia Loginova

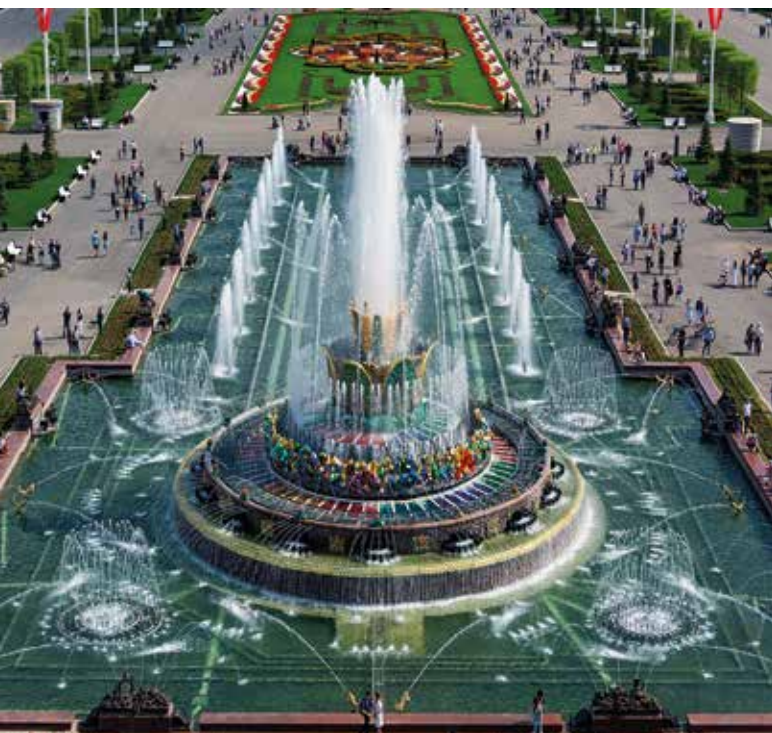
Fig. 3 Fountain "Stone Flower"

The Stone-Flower Fountain is one of the main fountains at VDNH. It was installed in 1954; by 1990, the structure was severely dilapidated and was operated at half-capacity. The restoration began in 2018. Specialists restored the historical colour palette based on preserved mosaics. The total weight of the smalt used was around eight tons. The restorers carefully selected over 120 shades of smalt from surviving samples.

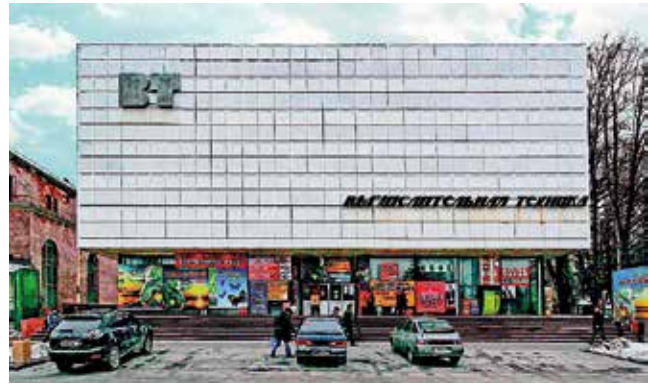
Fig. 4 Pavilion No. 14 (former pavilion of the Azerbaijani SSR) before restoration

Pavilion No. 14 (former pavilion of the Azerbaijani SSR) is one of the pavilions on the left-hand side of Central Avenue which underwent “modernisation” at the end of the 1960s with the help of hinged facade boxes. After the facades were dismantled, it turned out that the modernisation of the Azerbaijan SSR pavilion had been carried out relatively gently – its original appearance was virtually unaffected. During documentary research and consultations with the National Museum of Art in Baku, experts found the preserved original plaster casts and later copies of sculptures cast in bronze. Based on the available original plaster casts, plaster moulds were made to make copies of sculptures. The original sculptures were made by the Azerbaijani sculptor F. Abdurakhmanov for the official opening of the Azerbaijan pavilion in 1954.

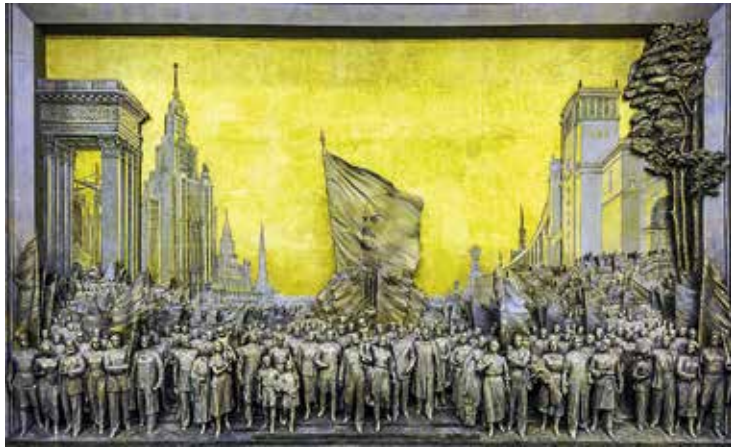
Fig. 7 High-relief “Hail to the standard-bearers of peace, the Soviet people!”

ard-bearers of peace, the Soviet people!”), which had been obscured by a temporary partition. The sculptures and background had numerous minor mechanical damages, but overall the work was well preserved. It is the biggest and most memorable art work from the All-Union Agricultural Exhibition of 1954. The high-relief depicts a triumphal march of the Soviet people, the total number of which reaches up to 1500 people moving in a single formation towards the viewer. The high-relief is made of plaster and tinted bronze. It covers 88 square metres and is only 73 centimetres deep.

The restoration began in 2015 as an “open restoration” behind clear glass. Visitors were able to see it, in particular participants and guests of the 6th Moscow Biennale of Contemporary Art. In March 2016, the restored high-relief was unveiled.

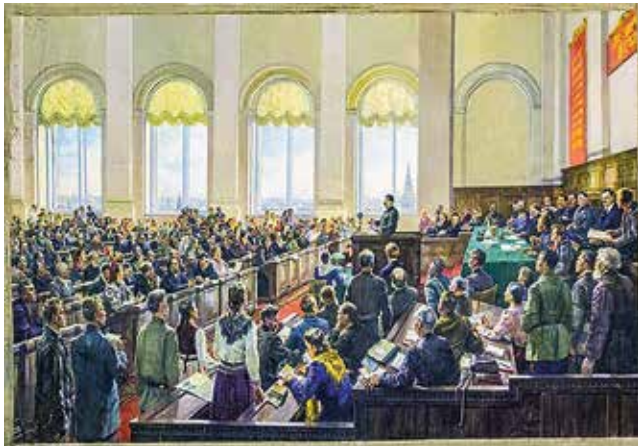
Fig. 9 Canvas “Stalin’s speech at the Second Congress of Kolkhoz Farmers and Shock Workers”

Because of Stalin’s death, a struggle broke out within the Soviet leadership. The most ceremonial images of the leader were tacitly withdrawn from the decoration of a number of pavilions. This also affected a huge painting by the painter Aleksandr Mikhailovich Gerasimov, which depicted Stalin’s speech at the rostrum of the 2nd All-Union Conference of Collective Farm Workers in 1935. The painting had been mounted on the wall of one of the halls of the Central Pavilion, but it was removed, wound onto a shaft and hidden in the basement until the pavilion opened. The painting was only discovered at the end of July 2014.

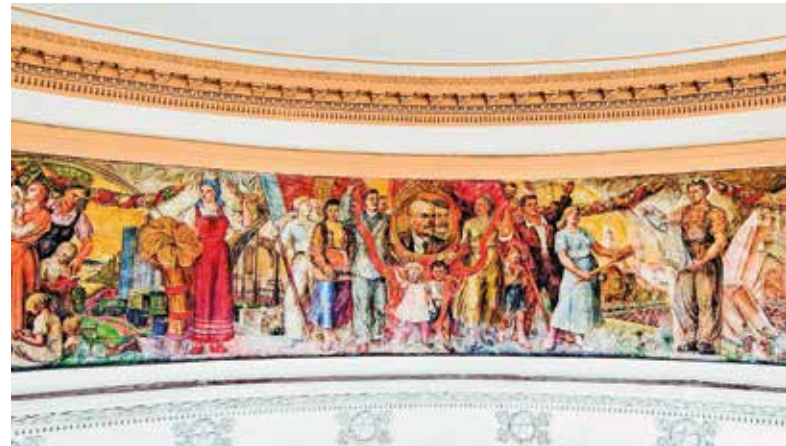
Fig. 10 Panoramic mural “The Belorussian people have built socialism”

The Belorussian SSR was considered the third most important Soviet republic. The reconstruction of the Belarusian pavilion began in 2008, earlier than the other pavilions. The remains of the fresco “People of Belarus built Socialism” above the main entrance of the pavilion were found during the works – it had been hidden under a thick layer of plaster since the mid-1970s and was thought to have been lost. It had been clogged with plywood sheets for more than 30 years. The lost sections were restored on the basis of surviving photographs. The restoration of the mural was completed in 2015.

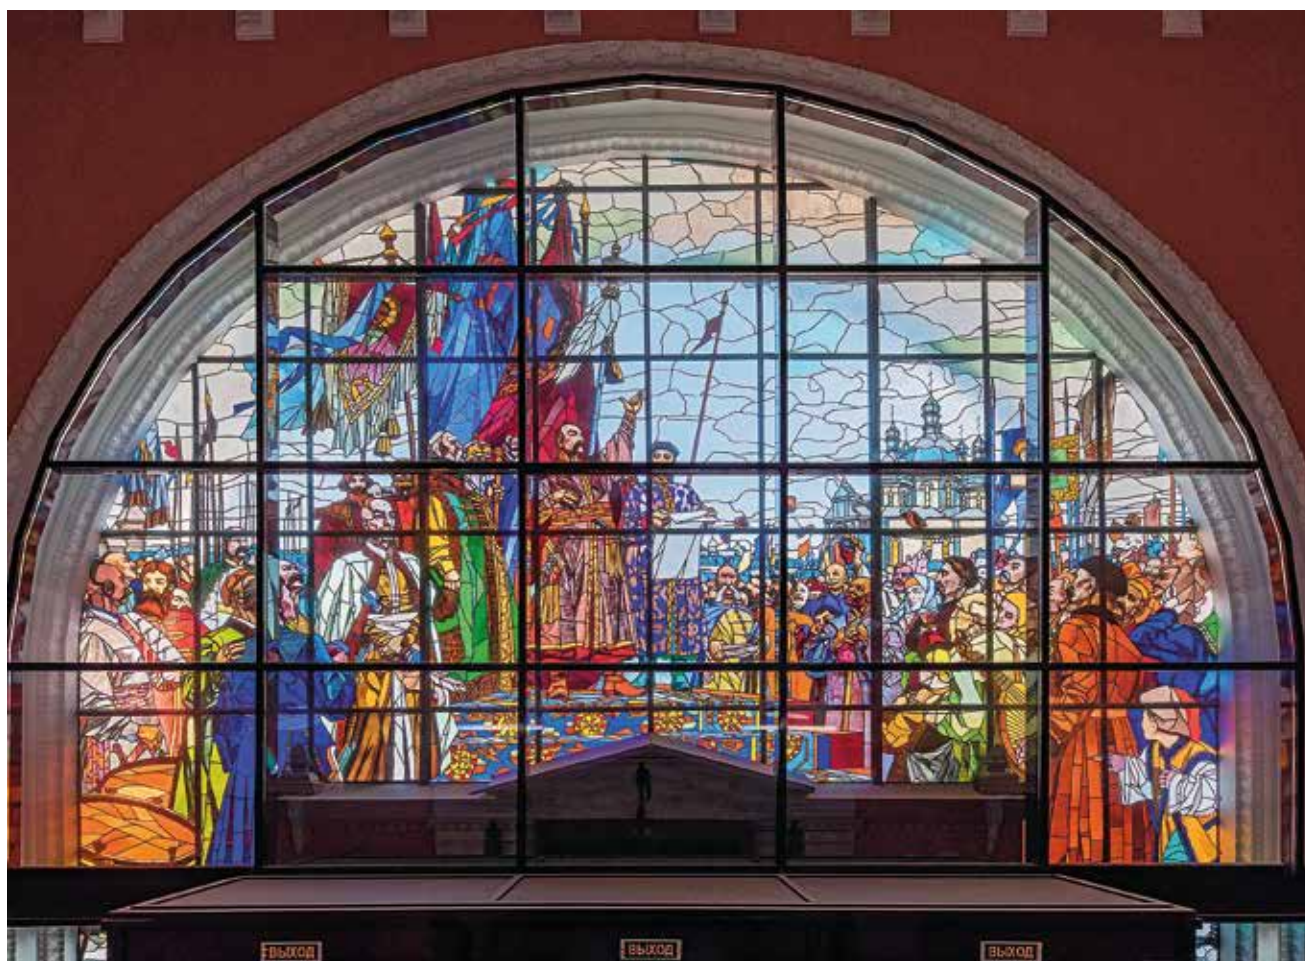
Fig. 11 Stained glass “Pereyaslavska Rada” in Pavilion No. 58 Agriculture (former pavilion of the Ukrainian SSR)

The plot of the stained-glass window “Pereyaslavska Rada” in Pavilion No. 58 “Agriculture” (former pavilion of the Ukrainian SSR) was based on a painting of the same name by Mikhail Khmelko, dedicated to the 300th anniversary of the annexation of Ukraine by Russia in 1954. The restoration of the 39.5 square-metre stained glass window began in autumn 2017 and was completed in April 2018. It had never been restored in the last 70 years. In order to clarify the state of conservation of the stained-glass window, all elements and pieces of glass were examined and conservation maps were made before the restoration work began, and then all 50 large fragments were dismantled. A team of six craftsmen worked on the restoration, so the work was done in a short time, and at the end of February 2018, all 50 fragments, each containing up to 200 single elements, were transported to the pavilion and installed in phases to their historic location.
