The Burial and Resurrection of Kiev's Wall of Memory

Sarah Maâfi

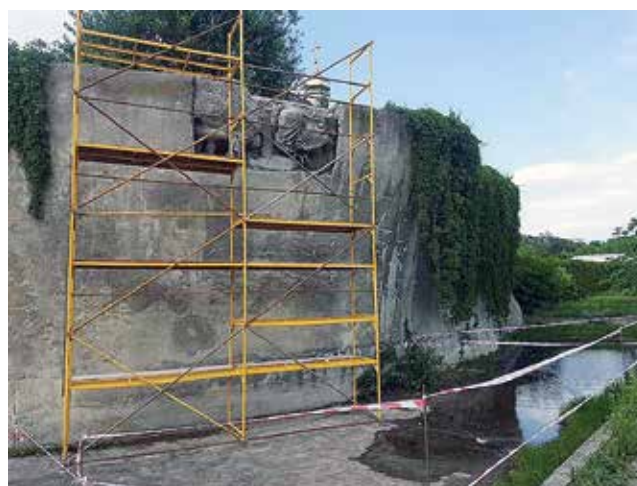
Fig. 1 A part of the concrete top layer was removed in 2018, revealing the relief of a face gazing upwards

In 1981, in the same year that the Buzludhza monument was opened in Bulgaria, the Wall of Memory, a 214-metre-long funerary relief at Kiev's Baikove Cemetery, disappeared under a layer of concrete due to censorship by the Soviet Regime. It was only recently, in 2018, that a few square metres of the monumental concrete relief were uncovered again as part of the Kiev Art Week (Fig. 1), following a campaign by artist and co-creator Volodymyr Melnychenko to reinstate the work.

Being able to lift a small part of the sacrificial layer in 2018 must have been a vindicating moment for Melnychenko. However, we must question whether this was the right decision for the monument. Creating an opening may have left the relief vulnerable to water penetration, which could accelerate the hidden damage caused by a freeze-thaw cycle. In addition, as the artwork was created by more than one hand over a period of seven years, there is no guarantee that the concrete mix and application would have been homogeneous. One could argue that despite Melnychenko's successful proof of concept not all parts of the Wall of Memory will survive exposure – or should even be exposed.

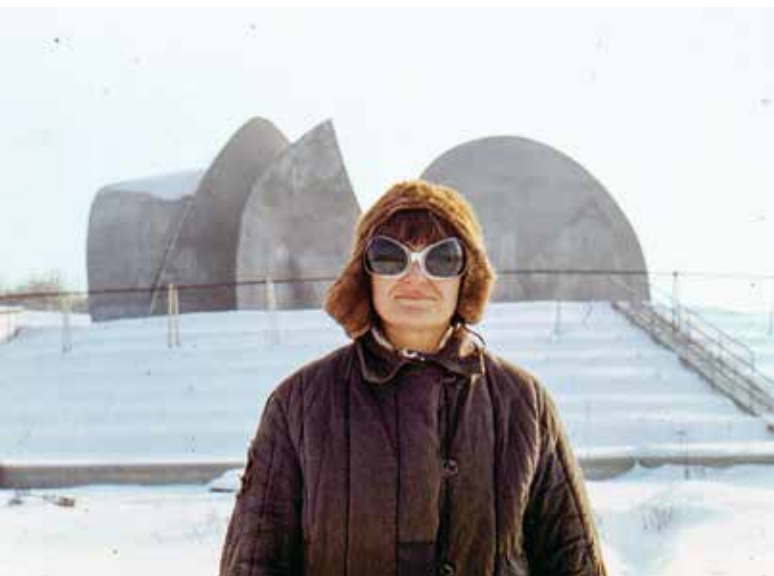
Fig. 2 The artist Ada Rybachuk in front of the crematorium in 1976, a futuristic edifice composed of concrete shells

Together, Miletsky, Rybachuk and Melnychenko created a *Gesamtkunstwerk* – an integration of different fields of art and design – that combined architecture, landscape, interior design and sculpture in an ambitious whole, creating a building made of elegant white concrete shells embedded in carefully designed steps (Fig. 2). The most striking part of the ensemble was the Wall of Memory, a 214-metre-long concrete relief. Normally, such a complex relief would be made in parts in the studio and attached to the wall on site, but for cost reasons the artists worked simultaneously with the concreting and formed the steel reinforcements by hand so that everything, wall and reliefs, could be cast in one piece.⁴

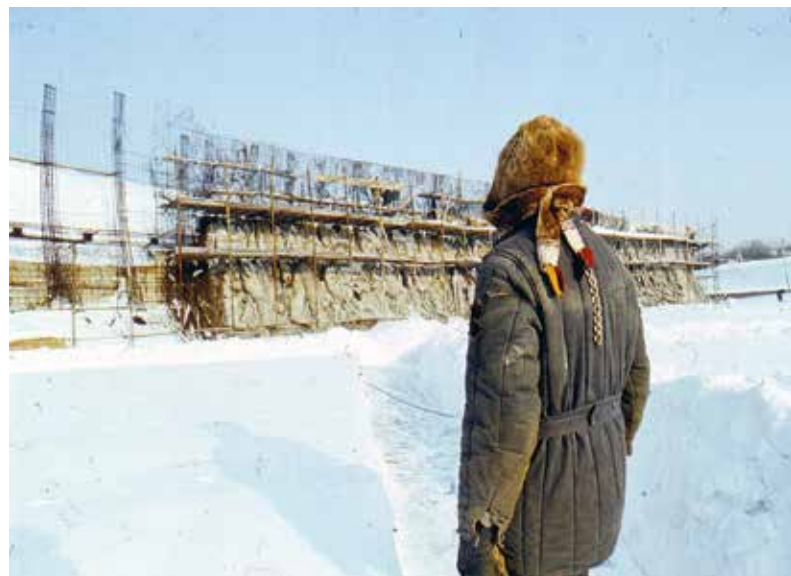
Fig. 3 Ada Rybachuk standing in front of a part of the Wall of Memory, the scene “Defence of the Homeland”, in 1977–78
