Ivan Srša

## Shouldn't We Consider the Experience of Old Masters? On the Approach to Historical Painted and/or Decorated Façade Plaster in Croatia

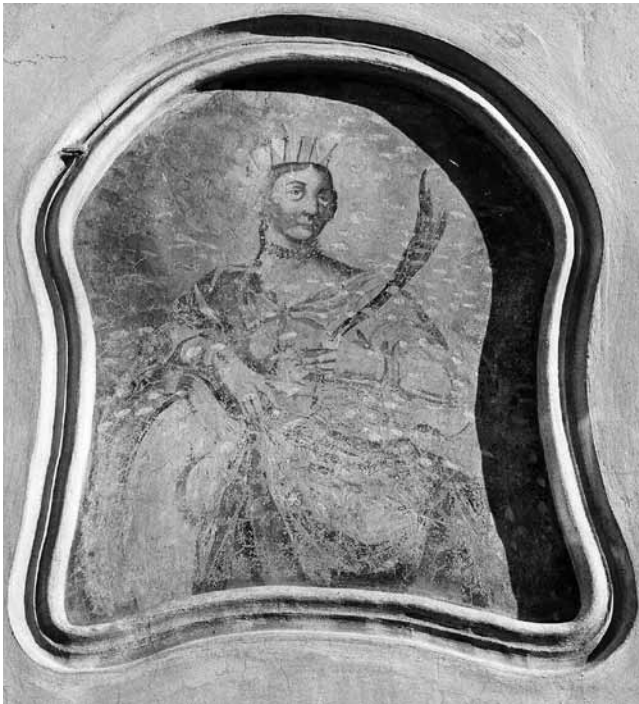
*Fig. 13-2: Varaždin, Fresco painted on western façade of the house in Gajeva st. 16 (Paraloid B72), state in 1974*

It was believed that the mechanical properties and ageing qualities of Paraloid B72 as a synthetic fixative were entirely satisfactory,<sup>18</sup> and its application in Croatia was first recorded in 1966 (Figs. 13-2–13-3).<sup>19</sup> Between 1966 and 1986, it was used more rarely than the much more problematic Calaton.

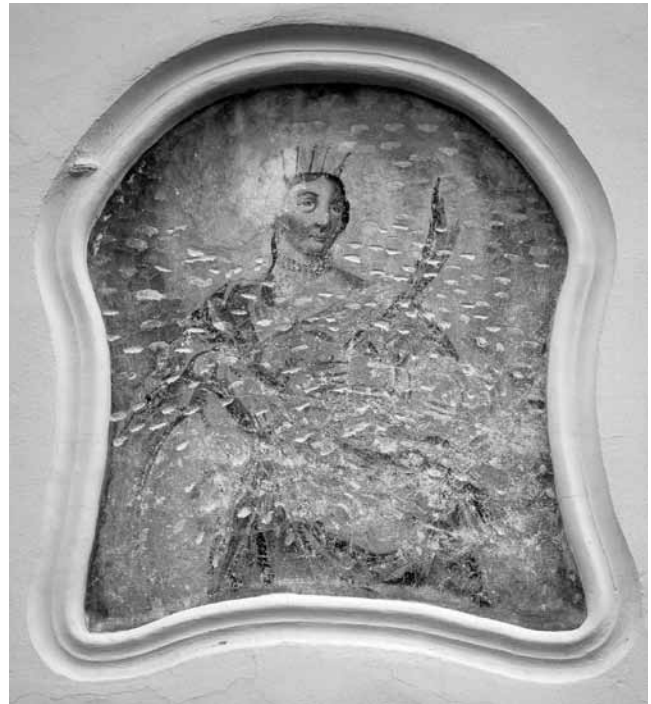
*Fig. 13-3: Varaždin, Fresco painted on western façade of the house in Gajeva st. 16 (Paraloid B72), state in 2011*

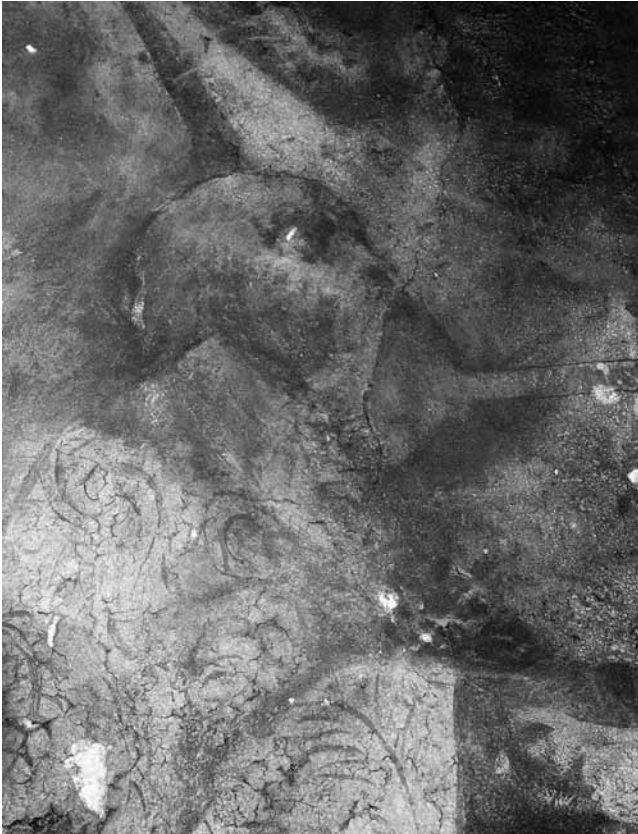
Fig. 13-4: Zagreb, Fresco painted above the door on the eastern façade of St. Mary's church, state before restoration in 1972

Among the synthetic resins that have been widely used in Croatia in the restoration of wall paintings, two additional materials are worth mentioning: Calaton CB (CA)<sup>20</sup> and Primal AC33.<sup>21</sup> The application of Calaton in conservation has been discouraged since 1975,<sup>22</sup> but unfortunately it was used in Croatia until recently, while Primal AC33 was in use up to the time when it stopped being produced several years ago. The first recorded use of Calaton CB, and of Paraloid B72, dates from 1966.<sup>23</sup> Besides on interior wall paintings, Calaton was also applied on façades in 1972 and 1978 (Figs. 13-4–13-6).

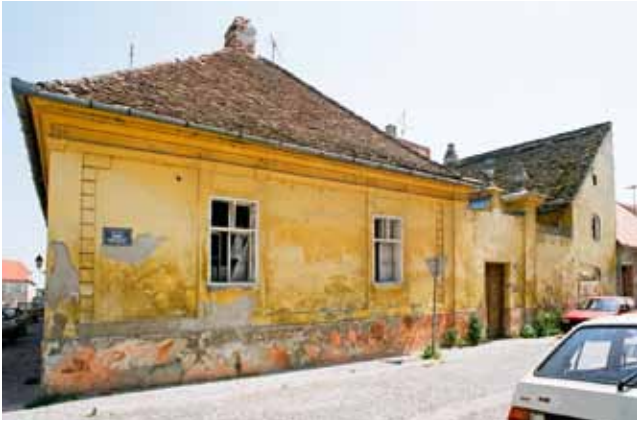
*Fig. 13-11: Osijek, Miller's house, state before renovation 1996*

Decorated façades cannot be taken to the safety of museum premises with controlled microclimates and displayed for visitors like paintings or sculptures, except in the form of drawings, models, photographs or some contemporary medium (film, video, holograms, computer programs, etc). However, they can be protected in situ, under a new layer of plaster that will cover and thus protect them from weather conditions and air pollution.<sup>62</sup> Such a substitute new layer, which can be periodically replaced, thus allowing monitoring of the condition of the historical layers, could be used for painting replicas of those historical decorative elements a critical interpretation would select for presentation (Figs. 13-1, 13-11–13-12).
