## The World Heritage City of Prague and its Jewish Cemeteries: Values and Conservation Strategies

Vlastimila Hamáčková and Petr Justa

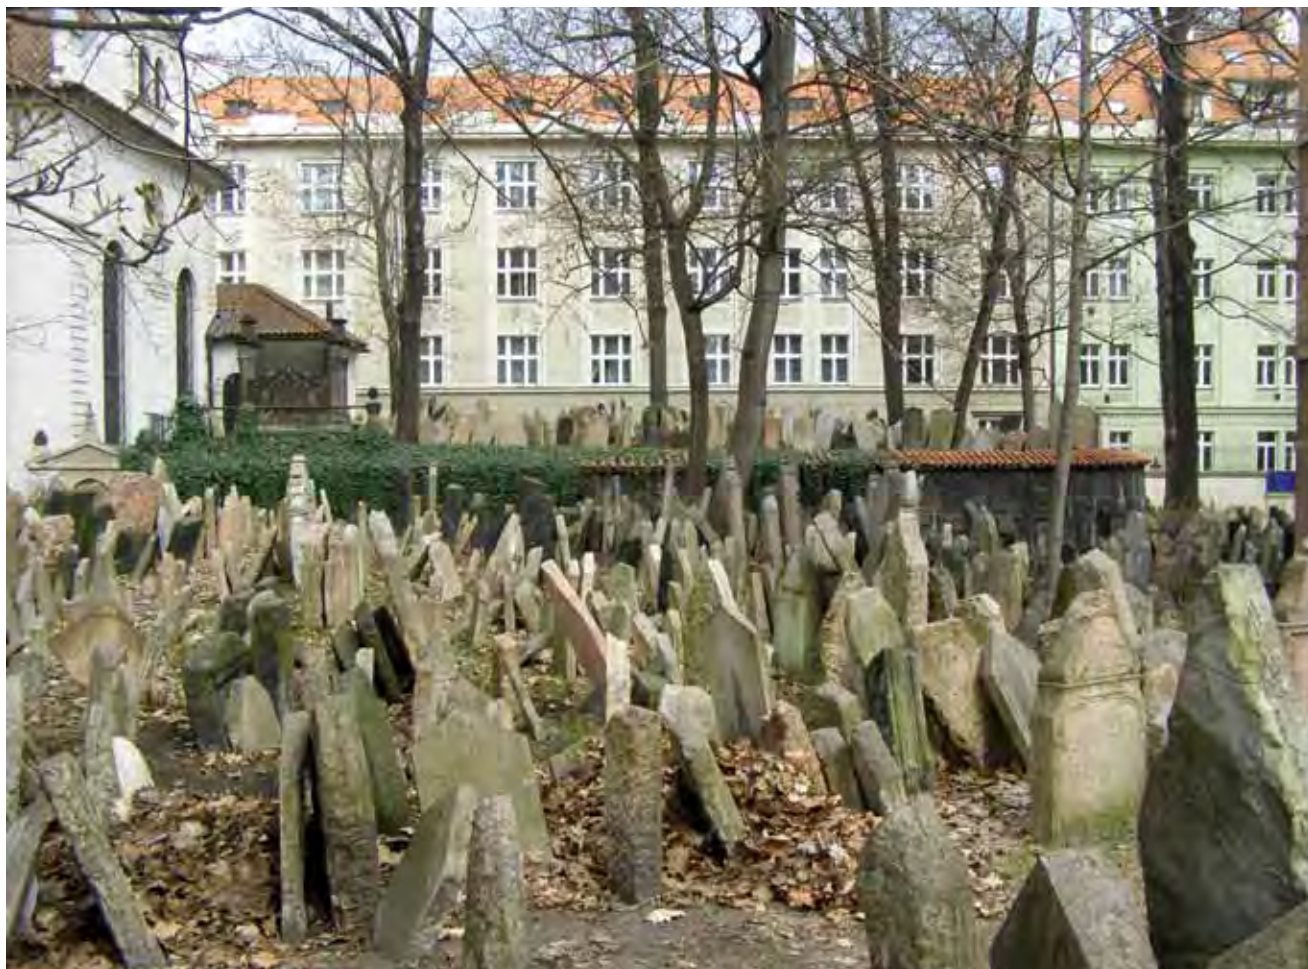
Fig. 2 Old Jewish cemetery, Mefele mound (photo: P. Justa)

the early 20th century. The exhumed remains were re-buried on the *nefele* mound near the Klaus Synagogue. This transfer is commemorated by a memorial tomb situated at the top of the mound.

The cemetery was enlarged several times, but in spite of this it was unable to cope with the needs of the Jewish community and it was necessary to add further layers of earth. It is presumed that there are several burial layers on top of each other. The picturesque clusters of tombstones from various periods are the result of the raising of older tombstones to the upper layers. In certain parts of the cemetery, however, these clusters were formed by the transfer of tombstones from the liquidated north-western part, which was used as a new construction area for the Museum of Decorative Arts in

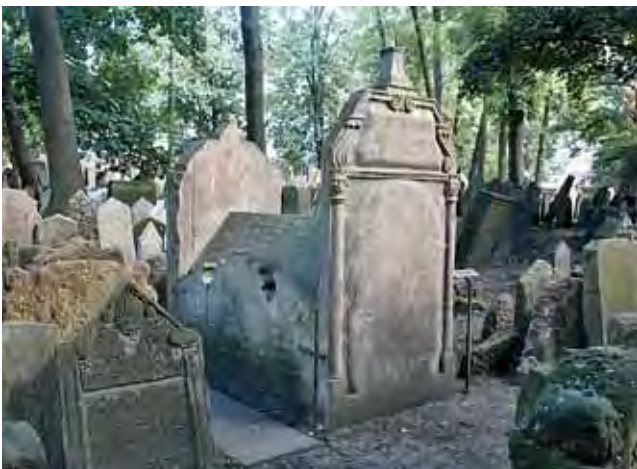
*Fig. 4 Tomb of Rabbi Maisel before restoration (photo: P. Justa)*

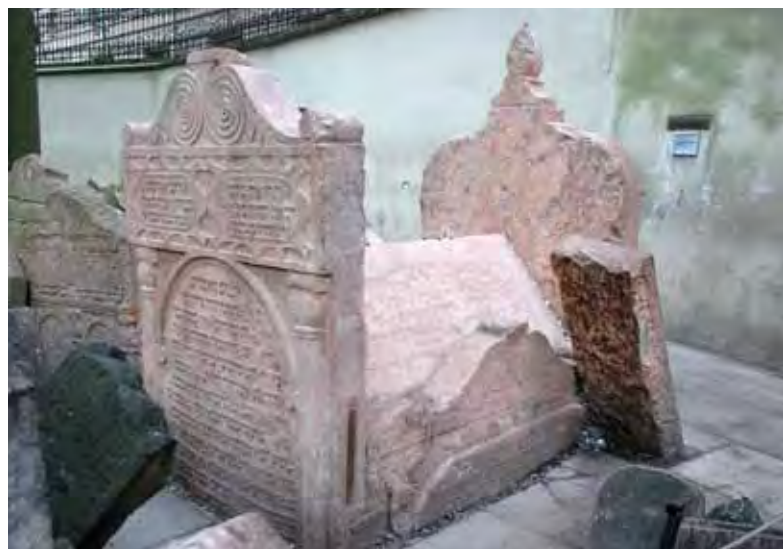
*Fig. 5 Tomb of Rabbi Löw after restoration (photo: P. Justa)*

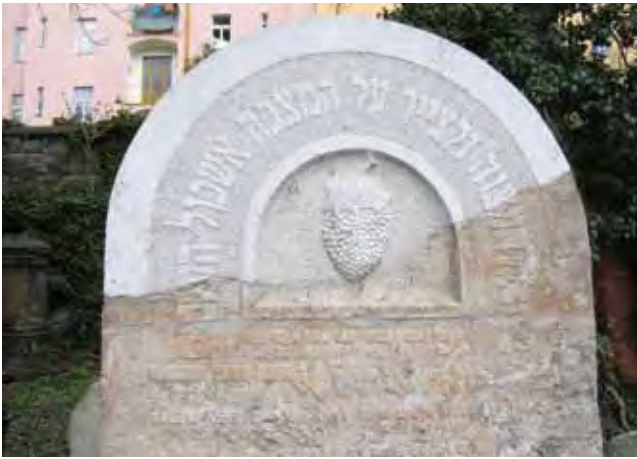
*Fig. 6 Rabbi Fleckeles, reconstruction of the front part of the tomb (photo: P. Justa)*

In the early 1960s, it was decided to liquidate the devastated cemetery. The considerable area of the cemetery was converted into a park and only the oldest, northern section with the most precious tombstones was preserved. Unfortunately, in 1985 more devastation occurred when a new TV tower was built in the park, leading to additional destruction of several graves in the remaining cemetery. Only in 1999 the cemetery was handed over to the care of the Jewish Museum. The Museum arranged the construction of a new cemetery wall and organised the general conservation project. Since 2000, the cemetery has been continuously renovated. Approximately 150 tombstones have been restored and around 300 other ruined tombstones saved, including the seriously damaged tomb of Rabbi Eleazar Fleckeles (deceased 1826).

Adhesives based on epoxy resin were mostly used for gluing broken parts together. The cleaned and/or glued gravestones were consolidated. Gravestones with experienced deep degradation or stones threatened by splitting were injected with low viscose synthetic resins, partially filled with marble powder. For more extensive fillings the mineral grouting material based on natural hydraulic lime was used. The hydraulic lime-based putty was used for supplements and plastic retouching, the mechanical properties of which are comparable to those of the original stone.

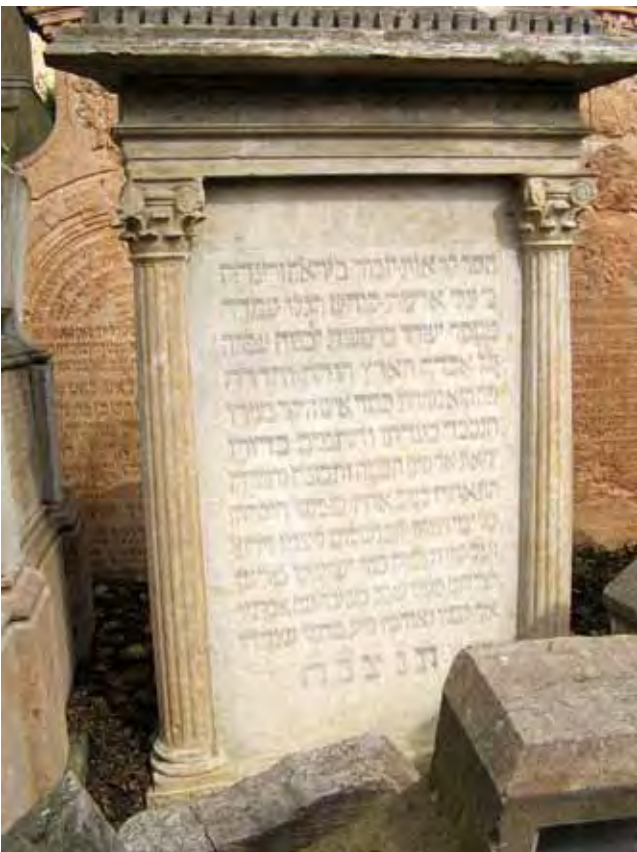
*Fig. 7 Colour retouching, highlighting of the text (photo: P. Justa)*

Colour retouching was carried out to a minimal extent. The declarative value of inscriptions and the highlighting of decorative motifs in reliefs were rehabilitated. Water-repellent treatment of gravestones was concentrated only on the horizontal parts of stone or on parts exposed to the direct impact of rain.
