From the Mogao Grottoes to the Margravial Opera House in Bayreuth.

Case Studies on the Impact of Visitors on the Moisture Balance of Historic Rooms

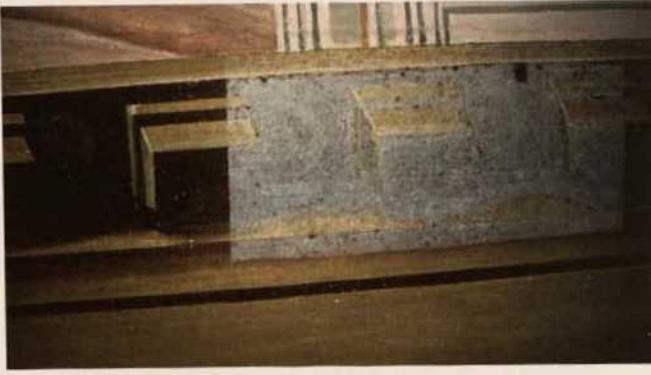
Fig. 1. Pommersfelden, Castle Weissenstein, the Marchini-rooms: Microbiological colonization of mural painting surfaces / Schloss Weissenstein, Marchini-Räume: Mikrobiologische Besiedelung von Wandmaleroberflächen.

Excess moisture is the major risk for the microbiological damages, e.g. through fungal and bacterial colonization. Mural paintings in the Marchini-rooms, Castle Weissenstein in Pommersfelden were widely covered by white efflorescences, which were identified as fungal mats and mechanically removed (Fig. 1). Organic materials such as paper, textiles or leather are especially susceptible to microbiological attacks.

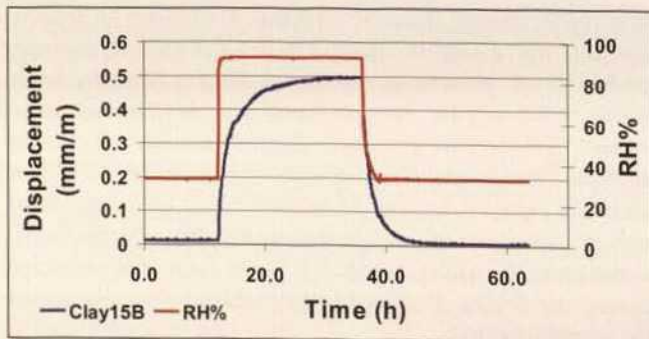
Fig. 2. Unidirectional displacement (hygroscopic dilatation) of adobe as a function of relative humidity and time / Eindimensionale Längenänderung (hygroscopische Dilatation) eines Lehmziegels als Funktion von relativer Feuchte und Zeit.

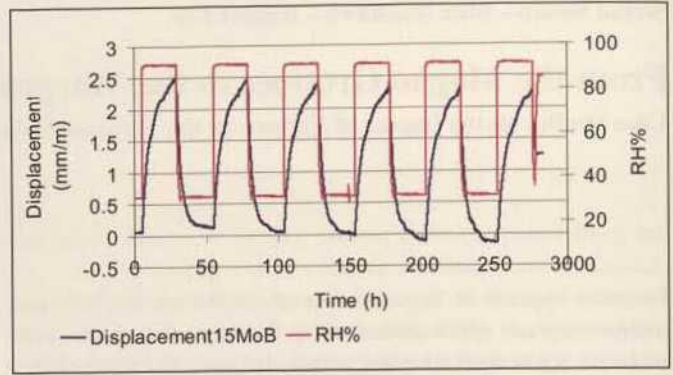
Fig. 3. Unidirectional displacement (hygroscopic dilatation) of montmorillonite rich adobe as a function of relative humidity and time / Eindimensionale Längenänderung eines Montmorillonit-reichen Lehmziegels als Funktion von relativer Feuchte und Zeit.

Through the cycling experiment expansion and shrinkage amount to a similar magnitude in a reversible way (Fig. 3). Dilatation ranges from 150 to 3100 $\mu\text{m}/\text{m}$, depending on the type of clay. Montmorillonite bound adobe reached 20 times higher dilatation than kaolinite bound, which can be attributed to the different CEC (hydration of interlayer cations) and surface area (osmotic swelling) of montmorillonite and kaolinite.

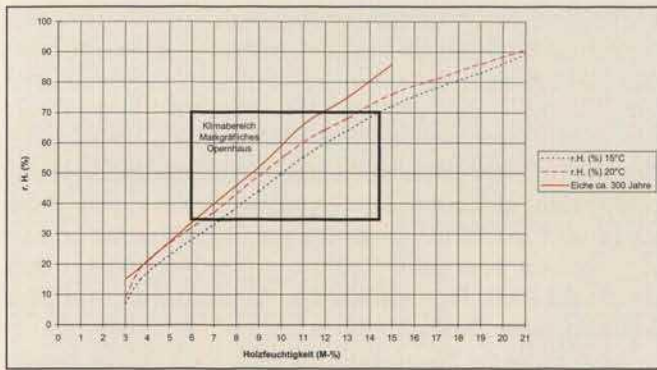
Fig. 4. Moisture equilibrium curves for wood as a function of relative humidity / Ausgleichsfeuchtekurven für Holz als Funktion der relativen Feuchte (nach Wendehorst, 1975 und Legrum, 1994).

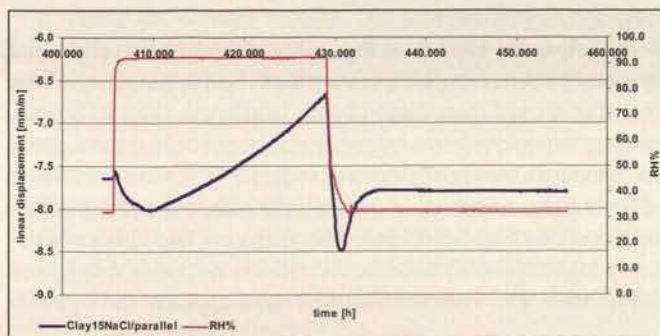
Fig. 5. Displacement of NaCl laden adobe (Clay15NaCl) during one cycle of relative humidity / Hygroskopische Dilatation eines mit Kochsalz befrachteten Lehmziegels während eines Feuchtezyklus (30–90% relative Feuchte).

The situation changes drastically, when the presence of hygroscopic salts comes into play. Concerning a sodium chloride laden adobe, five processes are competing during changes of ambient relative humidity (Fig. 5): With RH values exceeding the point of deliquescence for NaCl at 75%, a preliminary dilatation, typical for non-contaminated materials, can be recorded, which is soon balanced and converted into shrinkage due to the subsequent dissolution of NaCl in pore spaces. Then the expansion due to the swelling of wet clay minerals becomes the decisive process and continues without reaching equilibrium until the end of the wet phase.

During the drying phase, the material first shrinks quickly due to the contraction of the clay minerals. This is then converted into expansion due to the recrystallization of NaCl in the pore network and the resulting pressure. Crystallization and dis-

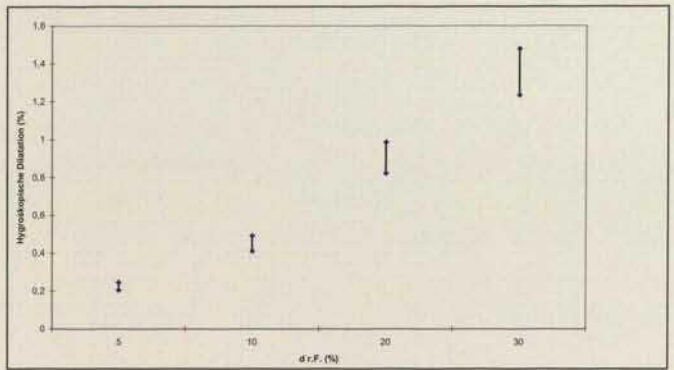
Fig. 6. Hygroscopic dilatation of wood as a function of relative humidity changes / Hygroskopische Dilatation von Holz als Funktion von Schwankungen der relativen Feuchte (nach Wendehorst, 1975).

Against common understanding, maintaining the relative humidity constant at 55% can not prevent dilatation phenomena of wood under temperature variations (Fig. 6). At 15°C and 55% RH a wooden object is equilibrated to a moisture content of 11%. With an increase in temperature e.g. to 20°C, the RH of the environment would have to increase to 60% RH in order to suppress dilatation phenomena caused by the subsequent variation in the moisture content of the wood.

Changes of 10% RH can cause a dilatation in wood of 0.5% (Fig. 6). For canvas under these conditions dilatations coefficients of 0.05–0.1% were determined.¹² The amount of resulting dilatation increases exponentially with higher variations of RH. The damage progress is expected to increase by the dis-

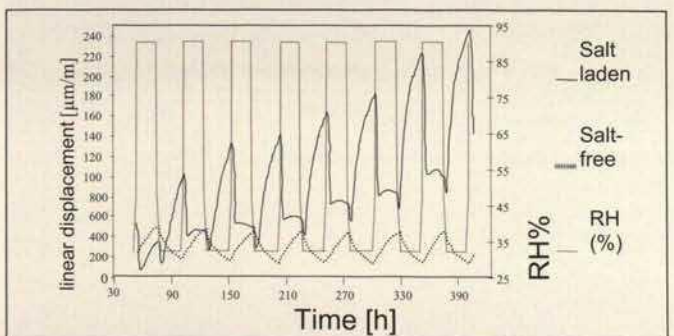
Fig. 7. Dilatation (µm/m) as a function of time and RH for salt-free and salt-laden Umm Ishrin sandstone / Hygroskopische Dilatation als Funktion von Zeit und relativer Feuchte bei salzfreiem und salzbelastetem Umm Ishrin-Sandstein.

As observed for NaCl-laden sandstone¹⁰ the amplitudes of dilatation increase with the number of cycles underlining the role of NaCl as a damage factor for porous materials (Fig. 7).

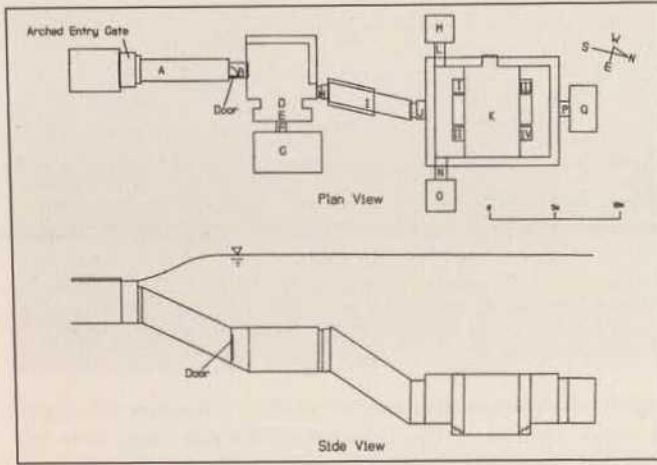
Fig. 8. Valley of the Queens, The Tomb of Queen Nefertari, Floor plan and cross section / Tal der Königinnen, Grab der Königin Nefertari, Grundriss und Längsschnitt.

city of Luxor), Egypt (Fig. 11–12). It is oriented north to south and carved approximately 13 m deep into the limestone bedrock. Figure 8 shows plan and section views of the tomb. A steel entrance door, left opened only during the visiting hours, is attached to a large steel bulkhead on the south wall of the upper chamber. A steep staircase, (A), approximately 4.5 m long, leads to the arched entry gate of the tomb at ground level. The tomb consists of two major chambers: the upper chamber, (C), and the burial chamber, (K). There is a 3.3 m drop between the floors of the two chambers, which are connected by a staircase (I) approximately 7 m long. The estimated total volume of the tomb is approximately 475 m³.

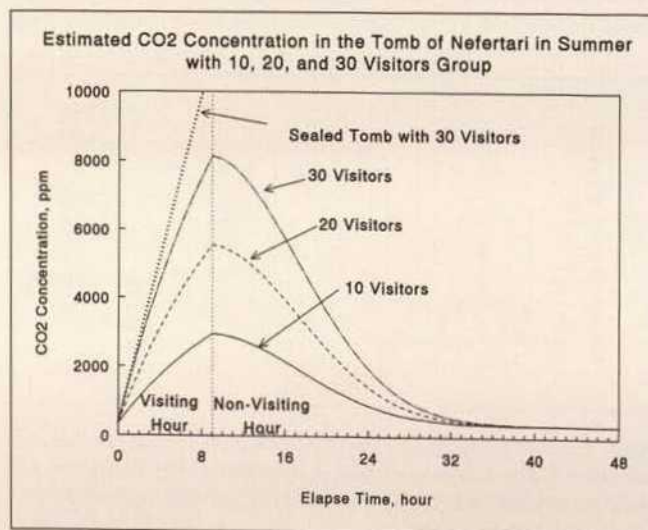
Fig. 9. Calculation of CO₂ concentration for Nefertari tomb as a function of amount of visitors / Berechnung der CO₂-Konzentration für das Nefertari-Grab als Funktion der Besucherzahl.

Based on natural infiltration rates evaluated from the experiments, we estimated a build-up of carbon dioxide in the tomb as well as its residual concentration after 8 hours of continuous visitation by groups of 10, 20, and 30 visitors as shown in Figure 9. Even with only 10 visitors in each group the concentration exceeded 2000 ppm, at which most visitors will feel uncomfortable, in the first 5 hours. And the concentration will not be reduced to the ambient (340 ppm) level by the following morning, indicating a daily build-up of the carbon dioxide.

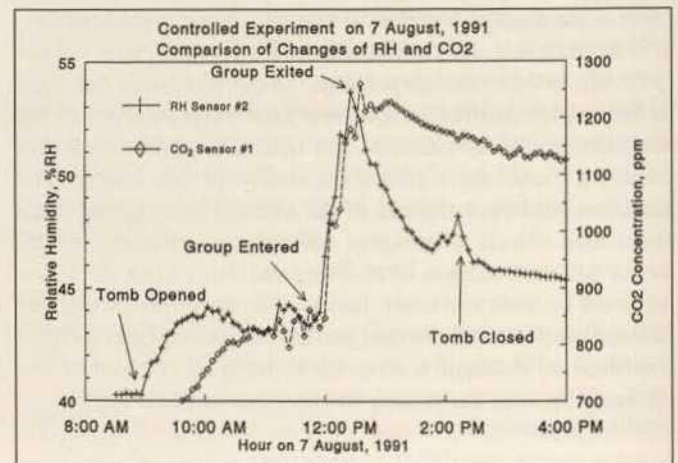
Fig. 10. Relative humidity and CO₂ concentration in the Tomb of Queen Nefertari, recorded before and after the visit of a tourist group / Vergleich von relativer Feuchte und CO₂-Konzentration im Grab der Königin Nefertari vor und nach dem Besuch einer Touristengruppe.

Figure 10 shows changes of the relative humidity and carbon dioxide in the tomb during an experiment conducted with 37 adult Egyptians in the burial chamber in August 1992. Both rates of the moisture and carbon dioxide generations coincided with typical rates that are published by the ASHRAE. The natural infiltration rate of the tomb was evaluated to be 8.9 m³/hr (0.019/hr) from the decay rate of the carbon dioxide. This low rate resulted from the combination of a high outside summer-time temperature (35°C), lower temperature (29°C), and the architectural configuration (the entrance is approximately 13 m above the floor) of the tomb. The warm, therefore, buoyant outside air has no chance of entering the cooler cave located 13 m below the ground. On the contrary, as seen in the same figure, the decay rate of relative humidity was much higher than that of the carbon dioxide. This indicated that a large portion of the moisture released by the visitors was absorbed by surfaces, such

as wall paintings, floor, and ceiling, of the tomb. It took more than 48 hours before the relative humidity returned to the pre-experiment level.

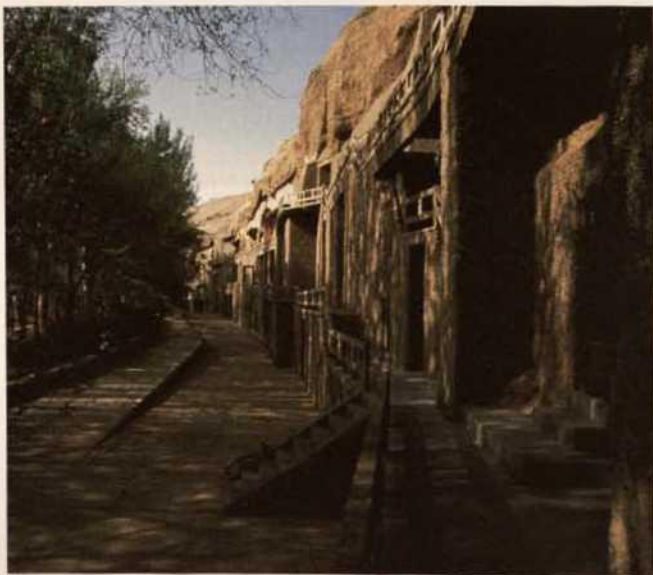
Fig. 15. Mogao Grottoes, cross section of a typical cave / Mogao Grotten, Längsschnitt einer typischen Höhle.

The Mogao Grottoes are located some 1,800 kilometers west of Beijing along the ancient Silk Road, at the eastern edge of the Taklimakan Desert and the south-western edge of the Gobi Desert, beside the oasis town of Dunhuang in north-western China. The site is a Buddhist sanctuary and consists of 492 decorated cave temples situated along 1.6 km of cliff face, dating between the fourth and the fourteenth century A.D. A typical architectural feature of the caves is shown in Figure 15. Figures

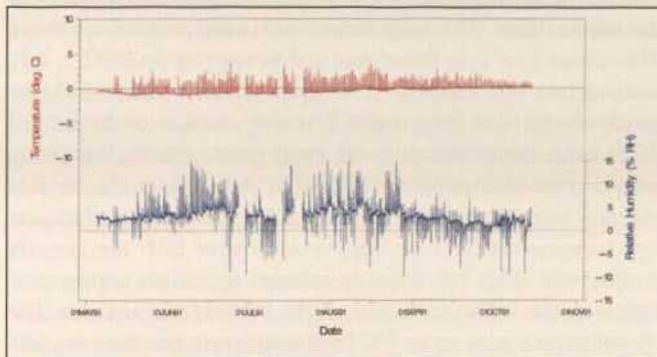
Fig. 17. Mogao Grottoes: Air temperature and relative humidity difference between Cave 323 (visited cave) and Cave 335 (closed cave) / Mogao Grotten: Vergleich von Lufttemperatur und relativer Feuchte zwischen Höhle 323 (Besucherverkehr) und Höhle 335 (geschlossen).

The impact of visitors on the microenvironment was assessed by simply subtracting temperature and relative humidity of the non-visited cave from those of the visited cave (Fig. 17). Both, temperature and relative humidity difference varied throughout the period. However, the open cave had a (1°C) lower baseline of (overnight) temperature during early summer, and the difference decreased by September. The open cave had also a consistently higher (4-6%) baseline for relative humidity throughout the summer. The visitors effect was more apparent through two

daily positive spikes (one in the morning and the other in the afternoon as caves were closed during the lunch hour) of 2 to 4°C during the summer months. The relative humidity also had two daily spikes, however, the spikes varied in both magnitude and sign (positive and negative). Positive spikes were found on hot, therefore, dry days, while negative spikes occurred on humid days. Monthly averages of the absolute humidity of the visited cave were higher than those of the closed cave and very similar to those of the outside air.

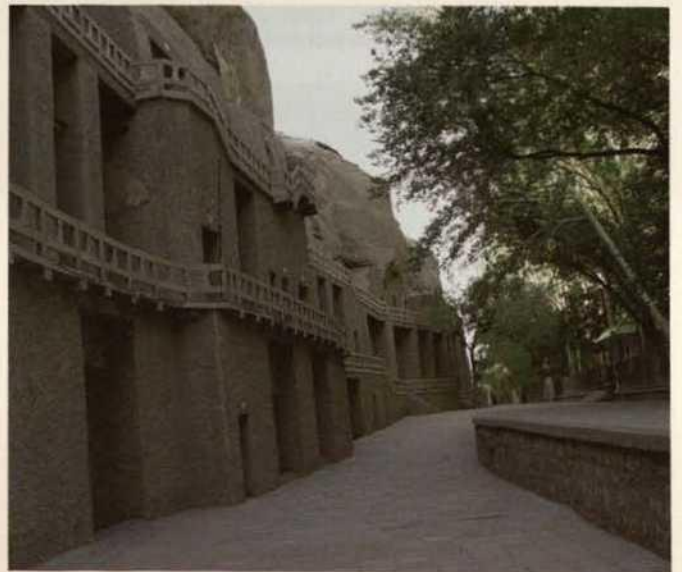
Fig. 18. Mogao Grottoes, Concrete façade and walkways, the north view / Mogao Grotten, Fassaden mit Laufstegen, Nordansicht.

The caves of the Mogao Grottoes were, for centuries, mostly open to the outdoor environment, since their facades have long been decayed or removed as the site was abandoned for centuries. In the 1960's a concrete facade and walkways were built to facilitate access (Fig. 18). All decorated caves were fitted with alumina doors to shelter the caves from the outside climate. The doors are normally closed when the caves are not visited, and opened only during visitation.

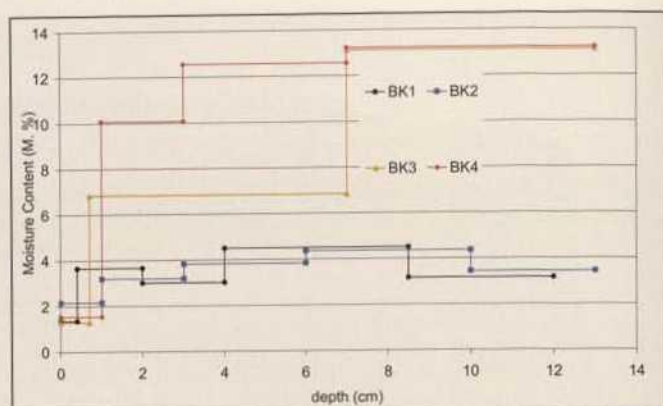
Fig. 21. Saint-Michel d'Aiguilhe: Moisture profile in walls / Feuchte-Tiefenprofil der Wände.

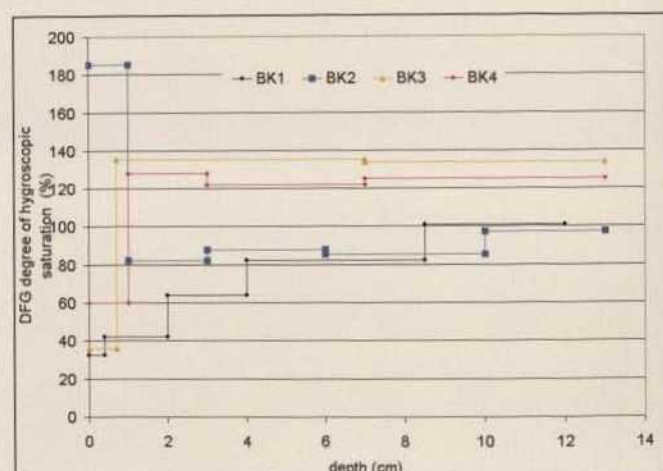
Fig. 22. Saint-Michel d'Aiguilhe: Moisture Degree (DFG) of hygroscopic saturation (%) as a function of depth in the walls / Hygroskopischer Durchfeuchtungsgrad (DFG) als Funktion der Mauertiefe.

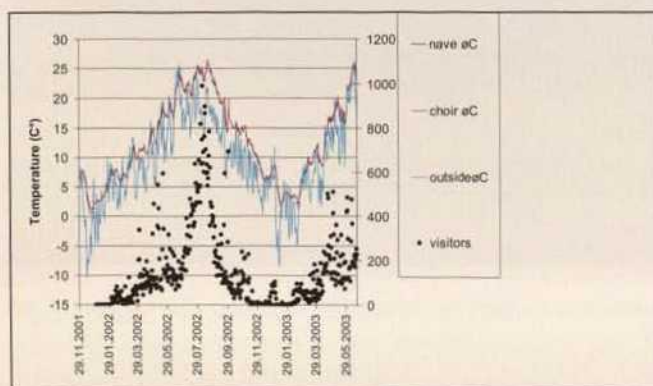
Fig. 19. Saint-Michel d'Aiguilhe: Temperature variation and visitors traffic / Temperaturschwankungen und Besucherverkehr (2001–2003).

absorption of sun irradiation (Fig. 24). Secondly, in case of high tourist activities (up to 1000 visitors a day in August 2002) the visitors could increase the room temperature by their body heat. The peaks of the inner temperature are corresponding with the long term peaks of the outside temperature. It is obvious, that the high amplitudes of the outside temperature are reduced in the inside – especially in winter, when the chapel is closed. But in summer under the influence of the tourist activities, the room has less protection against the outside climatic conditions. As a consequence in summer the amplitudes of the temperature outside are experiencing a faster transfer towards the interior. The daily variations of room temperature and humidity are shown in Figure 20. From the beginning of November until March (when doors remain closed and there are no tourists), the daily variation does not exceed 1 or 2°C. In summer, when the chapel is open to the public, the daily temperature changes in the inside range from 2°C to 6°C. A maximum of 8°C was recorded during a period of rapid cooling in the week of the 22nd of September associated with a high number of visitors (up to 700 visitors a day on September 29).

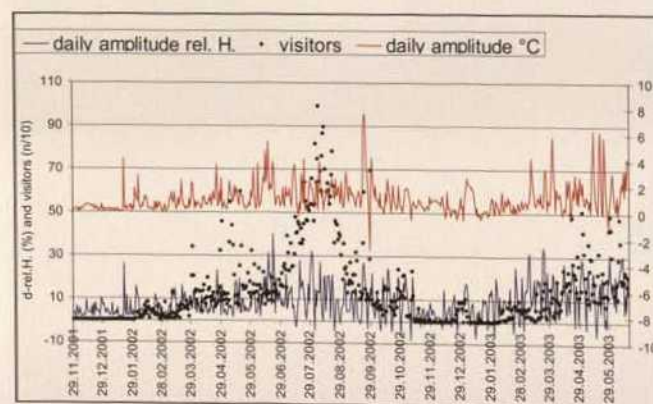
Fig. 20. Saint-Michel d'Aiguilhe: Daily variation of relative humidity and temperature / Tägliche Schwankungsbreiten von relativer Feuchte und Temperatur.

Because of the dramatic temperature increase inside the chapel during the summer months, the relative humidity inside is reduced to a level of 50 to 60%. The value of the relative humidity keeps under the level of the humidity outside, but the absolute humidity is corresponding to the values of the air outside. The low relative humidity inside at that time is caused by the higher temperature-level in the chapel. Due to the open doors and windows in the summer season, the range of the daily change in relative humidity in the chapel is more than twice as high as in winter times (Fig. 20).

The daily amplitude of the relative humidity in the nave (blue) corresponds to the tourist activities. The daily amplitudes are about 5 to 15% in winter and 15–40% in summer (Fig. 20).

During relatively warm days around the new years eve 2002/2003 the chapel was frequently visited (Fig. 20). The visits correlate with an increase of absolute humidity air in the cold church through increased air exchange with the outside environment. Both relative humidity and temperature increase slightly during these periods, due to increased air exchange with the outdoor environment. Because the temperature inside reacts slowly, there are several dangerous approaches to the dew point temperature. On days without visitors (second and ninth day in the diagram) the room climate is not affected by the outer climate. In the case of lower outside temperatures, opening of the chapel could lead to frost effects within the wall. As in the case of Mogao grottoes, the impact of visitors on the moisture balance is recorded as an increased infiltration rate of the outside air. Therefore, the combination of rate of visitation and the outside climate has a large influence on the climatic conditions in St. Michel d'Aiguilhe.

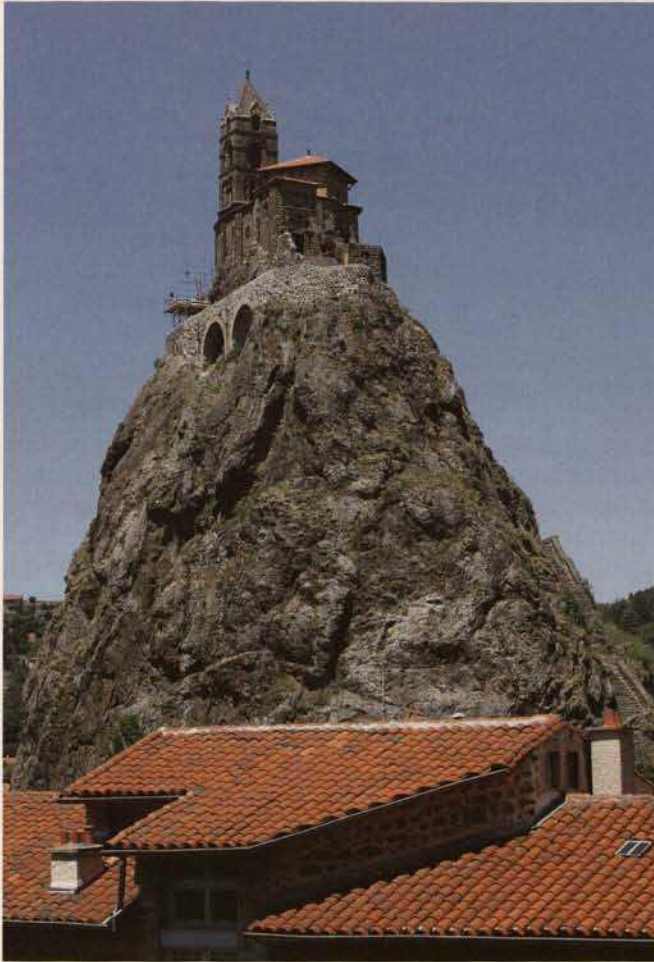
Fig. 23. Saint-Michel d'Aiguilhe (Le Puy), Chapel Saint-Michel / Ansicht der Michaelskapelle.

Due to its location on top of a volcanic cone, the chapel is extremely exposed to the environment (Fig. 23). Everywhere on the outside walls, on exposed stones the deteriorating effects of the weathering, mainly flaking and scaling, but also surface recession, are obvious. The buildings masonry is hardly protected against wind, rain, sun and ice. There is no plaster, nearly no canopy and there is no roof rail. Therefore, particularly on the south-western side the driving rain, which is transported by wind, and additionally the run-off from the roof percolates regularly on the outside of the unprotected porous stone (Fig. 24).

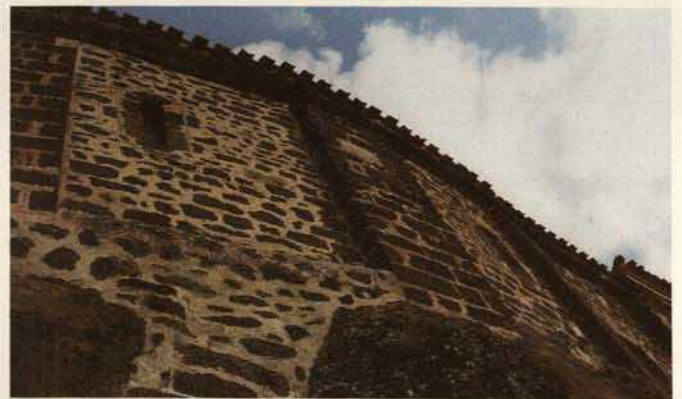
Fig. 24. Saint-Michel d'Aiguilhe, Joint system of the basaltic tuff masonry / Michaelskapelle, Fugensystem des basaltischen Tuffmauerwerks.

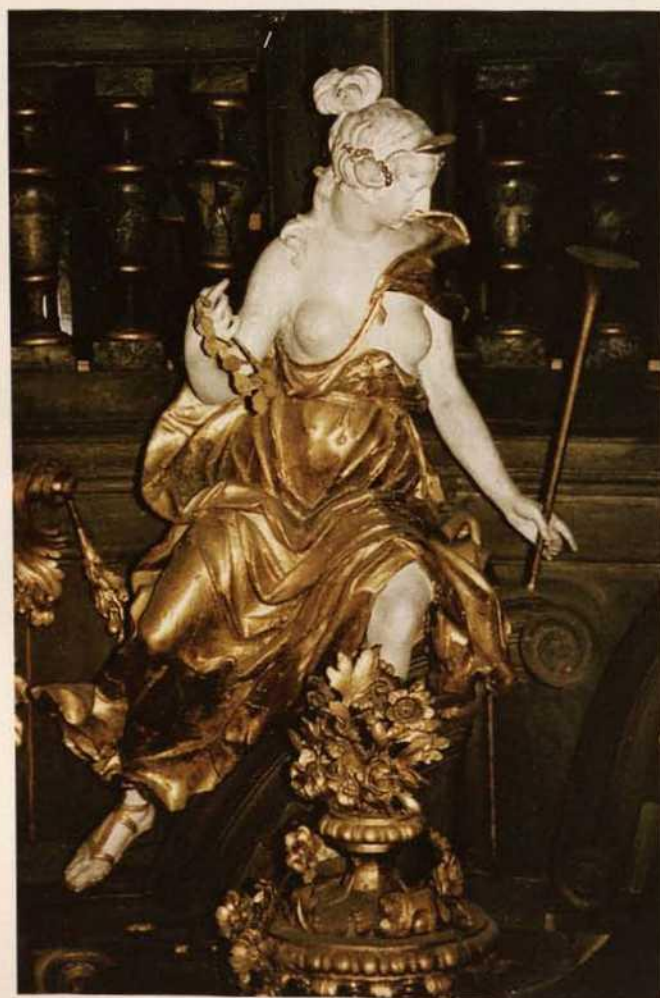
Fig. 25. Bayreuth, The Margrivial Opera House, Interiors, detail: Fame / Markgräfliches Opernhaus, Innenausstattung, Detail: Fama.

The continuous use of the Opera House for theatre plays, concerts and other events was subject to a major discussion since the mid nineties of last century, leading to a long-term and systematic assessment of the climatic conditions. A condition survey on the polychrome and gilded wooden elements (Fig. 25) and the decorative paintings (Fig. 26) revealed an increase of damage with height inside the theatre.¹⁴

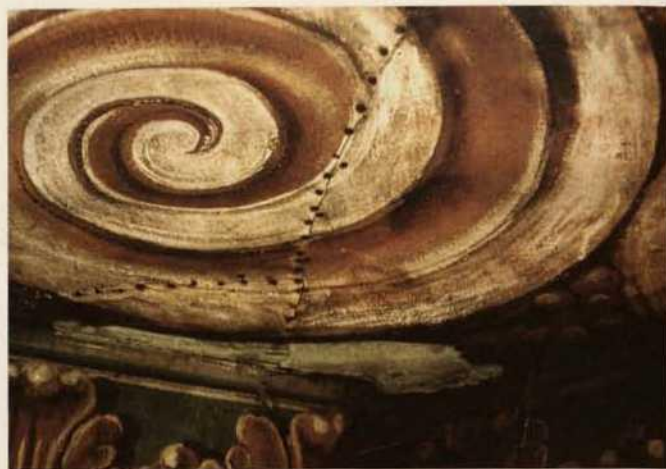
Fig. 26. Bayreuth, The Margrivial Opera House, Ceiling paintings on canvas borders fixed by ancient nails / Markgräfliches Opernhaus, Deckengemälde auf Leinwand mit Randbefestigung durch historische Nagelungen.

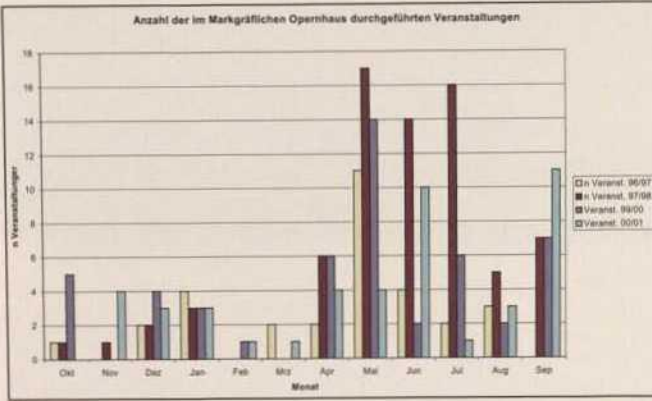
Fig. 28. Bayreuth, The Margravial Opera House: Number of events in the Opera House from 1996–2001 / Markgräfliches Opernhaus: Anzahl der Veranstaltungen zwischen 1996 und 2001.

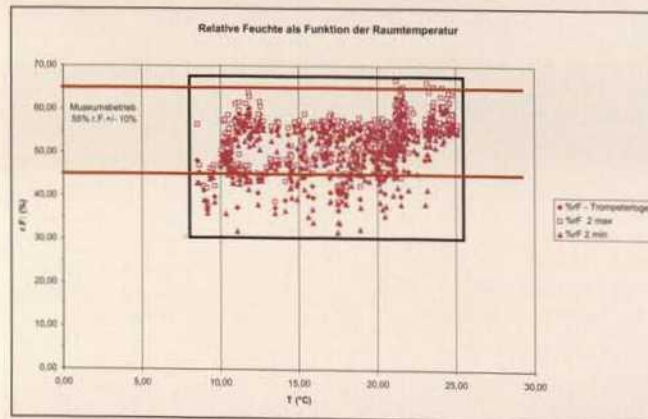
Fig. 29. Bayreuth, The Margravial Opera House: Range of relative humidity as a function of temperature in 1996/97 / Markgräfliches Opernhaus: Relative Feuchte als Funktion der Raumtemperatur während der Saison 1996/97.

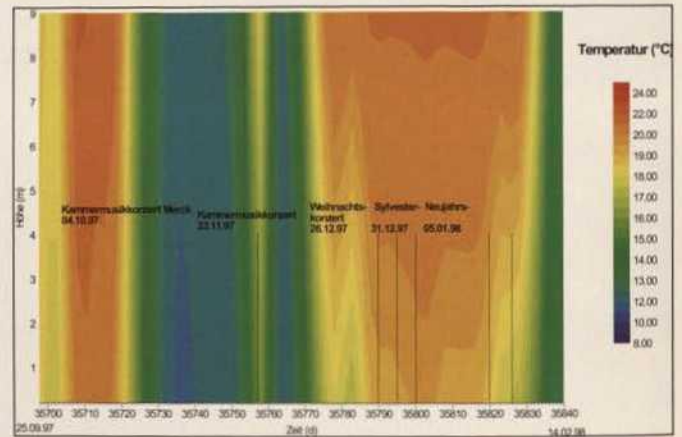
Fig. 30. Bayreuth, The Margravial Opera House: Temperature as a function of height, during winter 1997/98, shown as a function of time with indications for the events / Markgräfliches Opernhaus: Temperaturhöhenprofil während des Winters 1997/98 mit Hinweis auf einzelne Veranstaltungen.

The heating for events during the cold winter season leads to the development of considerable temperature profiles with height as shown in Figure 30. This increase of surface temperatures is accompanied by a dangerous drop of RH below the safety margin of 45% correlating with the observed damage processes.

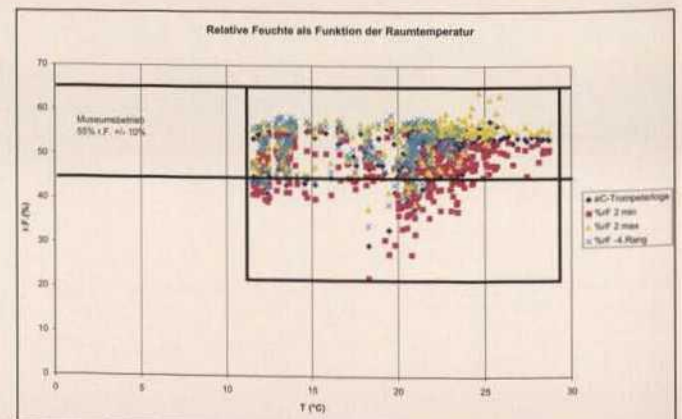
Fig. 31. Bayreuth, The Margravial Opera House: Range of relative humidity as a function of temperature in 1997/98 / Markgräfliches Opernhaus: Relative Feuchte als Funktion der Raumtemperatur während der Saison 1997/98.

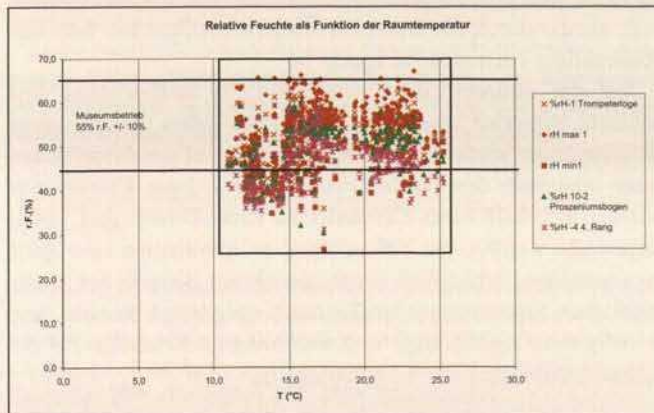
Fig. 32. Bayreuth, The Margravian Opera House: Range of relative humidity as a function of temperature in 1999/2000 / Markgräfliches Opernhaus: Relative Feuchte als Funktion der Raumtemperatur während der Saison 1999/2000.

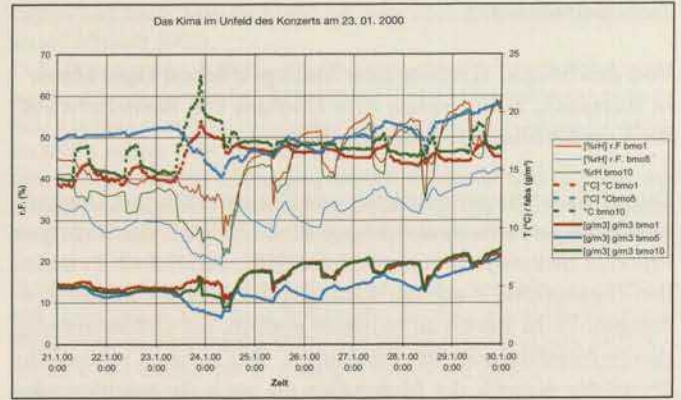
Fig. 33. Bayreuth, The Margravian Opera House: Climatic conditions before and after a concert on January, 23rd, 2000, (hourly recorded values) / Markgräfliches Opernhaus: Klimabedingungen im Umfeld eines Konzerts am 23. Januar 2000 (Stundenwerte).

Until noon of the 23rd the absolute humidity in stage and auditorium is on the same level, with a higher temperature in the stage area. Just before noon temperature and absolute humidity drop in the stage area, probably due to an exchange with the outdoor environment (e.g. transport of instruments). At the same the heating in the auditorium takes place accompanied by a considerable height profile. After the concert, the temperature decreases exponentially. On the morning of the 24th, the thermal context between stage and auditorium is re-established

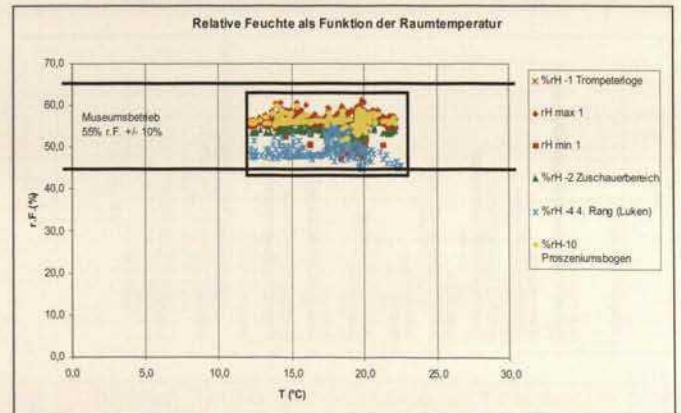
Fig. 34. Bayreuth, The Margravian Opera House: Range of relative humidity as a function of temperature in 2000/01 / Markgräfliches Opernhaus: Relative Feuchte als Funktion der Raumtemperatur während der Saison 2000/01.

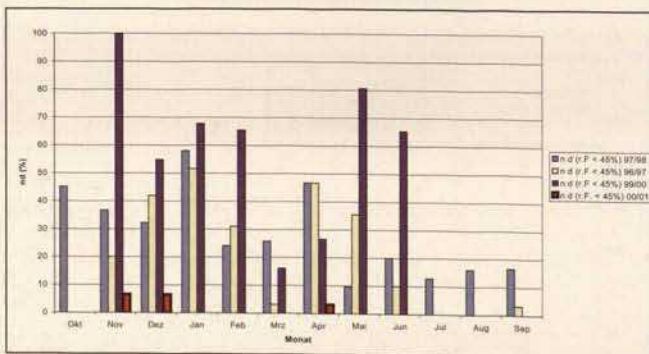
Fig. 35. Bayreuth, The Margravial Opera House: Percentage of days/a on which RH fell below the minimal RH (45%) for the seasons 1996 to 2001 / Markgräfliches Opernhaus: Prozentuale Anzahl von Tagen, an denen eine Unterschreitung der Mindestraumfeuchte von 45% registriert wurde (Saisonvergleich 1996–2001).

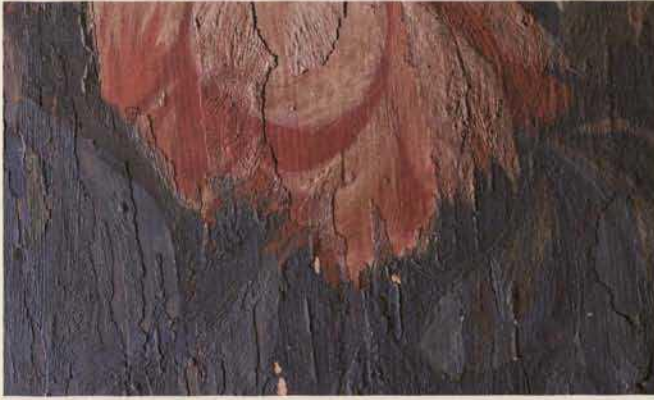
Fig. 36. Bayreuth, The Margravian Opera House: upper loge house, tempera painting on pine wood support, detail: wide loss of paint layers due to significant climatic fluctuations (after retouching) and new damage (still without retouching) / Markgräfliches Opernhaus, "Sichtklappe" des oberen Logenhauses, Temperamalerei auf Nadelholz, Detail: umfangreiche Malschichtverluste infolge der erheblichen Klimaschwankungen (mit Retuschen) und neue Schadstellen (noch ohne Retusche; 2005).

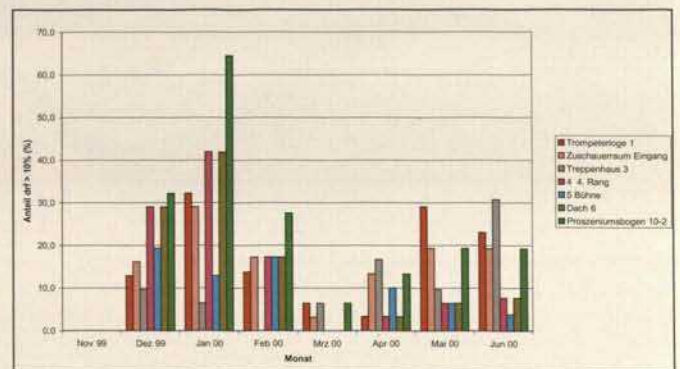
Fig. 37. Bayreuth, The Margravian Opera House: Frequency (% days/month) of humidity variations >10% for different sensor locations within the theatre during the season 1999/2000 / Markgräfliches Opernhaus: Prozentuale Häufigkeit (Tage/Monat) von Schwankungen der relativen Feuchte >10% an verschiedenen Sensorpositionen während der Saison 1999/2000.
