## The Scrovegni Chapel.

### Multidisciplinary Research and Environmental Protection

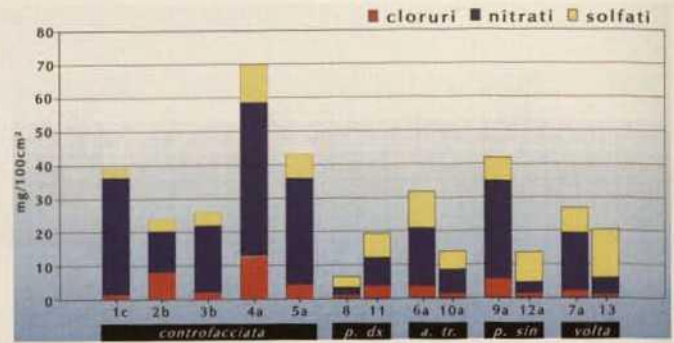
Fig. 3. Padua, Scrovegni-Chapel: Concentration of anion present in the extraction pads of soluble salts applied on the walls.

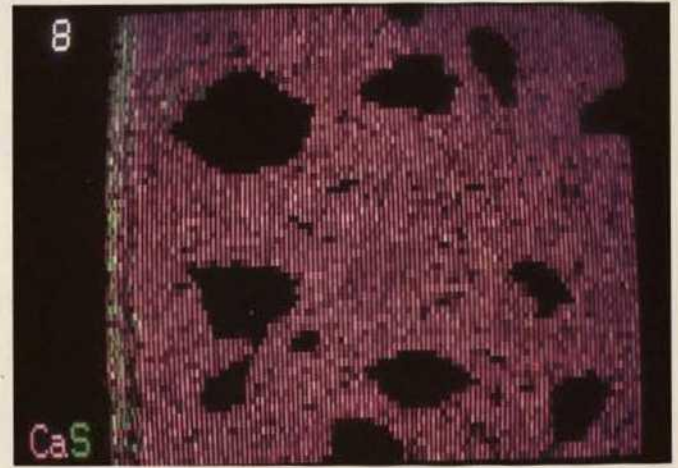
Fig. 4. Padua, Scrovegni-Chapel: X-Ray map at SEM + EDS of calcium (pink) and sulphur (green), 80x.

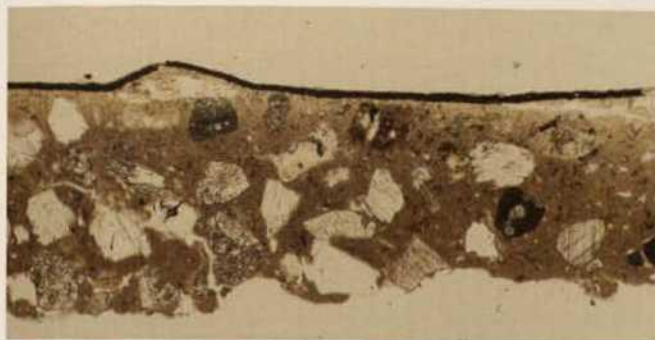
Fig. 5a. Padua, Scrovegni-Chapel: Stratigraphic section observed at transmitted light, parallel nicols, ob. 2,5x. Gypsum crystallization is visible under the pictorial layer.

Particularly, in the case of the Chapel, the causes determining the whitening of the wall of the counterfaçade are indicated in table 2 from 1 to 5 and 7. In fig. 5 it has been documented the damage caused by the crystallization of gypsum beneath the pictorial layer.

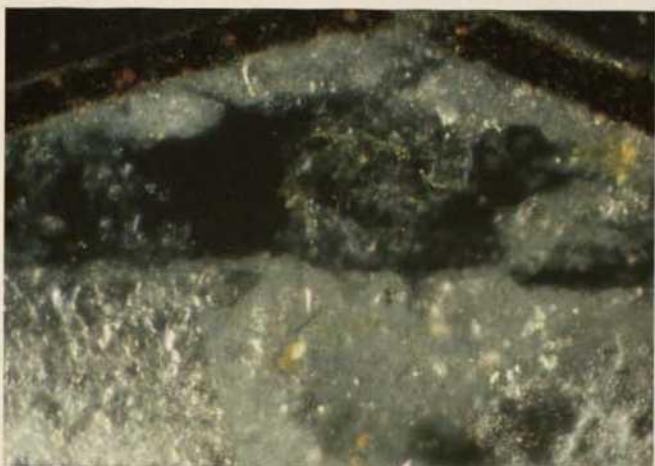
Fig. 5b. Padua, Scrovegni-Chapel: Stratigraphic section observed at transmitted light, crossed nicols, ob. 10x. Gypsum crystallization is visible under the pictorial layer.

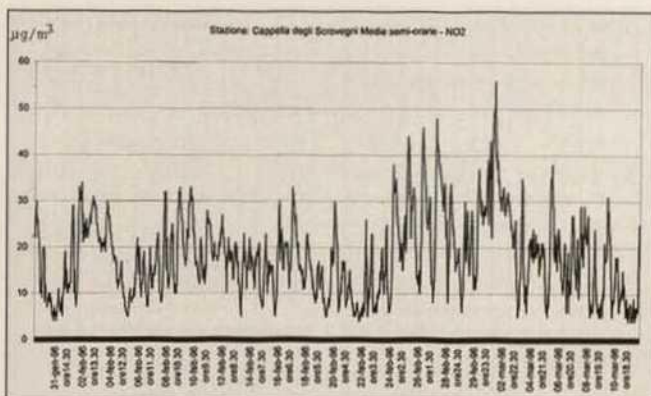
Fig. 6. Padua, Scrovegni-Chapel: Trend of semi-hourly average values of nitrogen dioxide (NO<sub>2</sub>) registered during the period between January 31, 1996 – March 10, 1996.

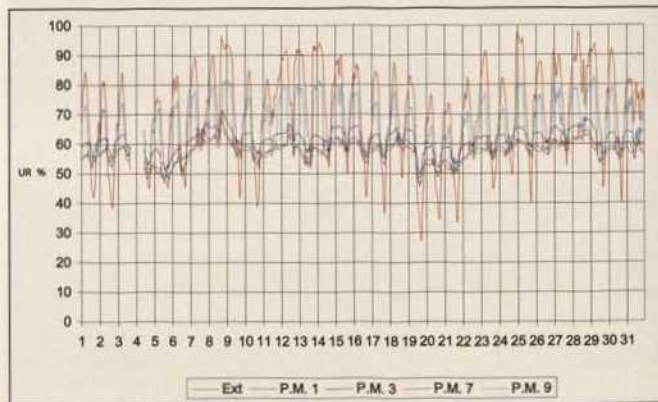
Fig. 10b. Padua, Scrovegni-Chapel: Diagrams of temperature and humidity levels relative to air registered by the monitoring system before the installation - August 1996, left wall.

The relative humidity values measured inside the Chapel before the installation were between 40% and 70% with peaks of 80%. (see fig. 8 and 10).

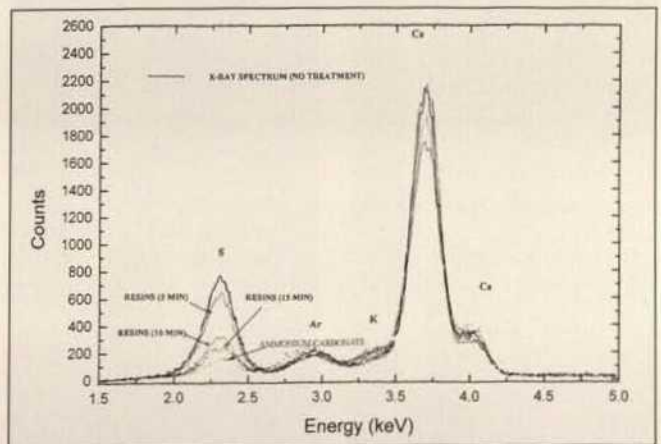
Fig. 13. Padua, Scrovegni-Chapel: XRF Spectra of sulphur relative to different desulphating experiments.

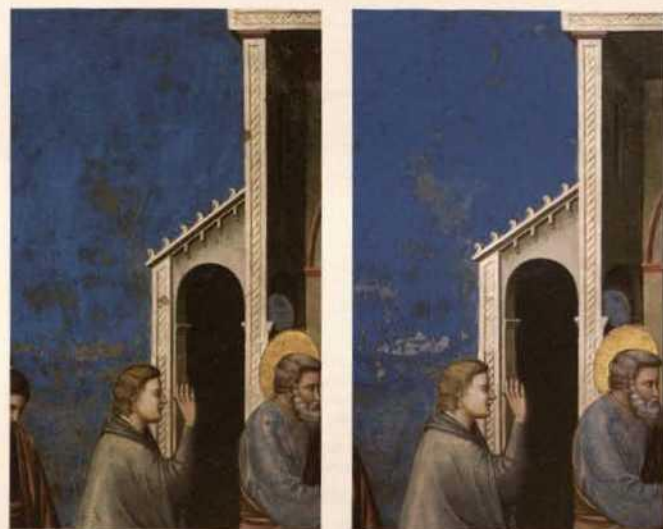
Fig. 14a-b. Padua, Scrovegni-Chapel, The Betrothal of the Virgin, Detail: the light blue background before (a) and after the cleaning (b).

In fig. 14 it is shown a detail of the sky in the painting *The marriage of Mary and Joseph* before and after cleaning and in table 4 the trichromatic values measured on different types of blue are reported. By comparison we could come to the conclusion that this color has gained saturation after cleaning, by taking off a dark layer brushed on and juxtaposed, so increasing the blue component of the reflected light (decrease of *b*).<sup>15</sup> It remains only to be added that the Chapel is still undergoing per-

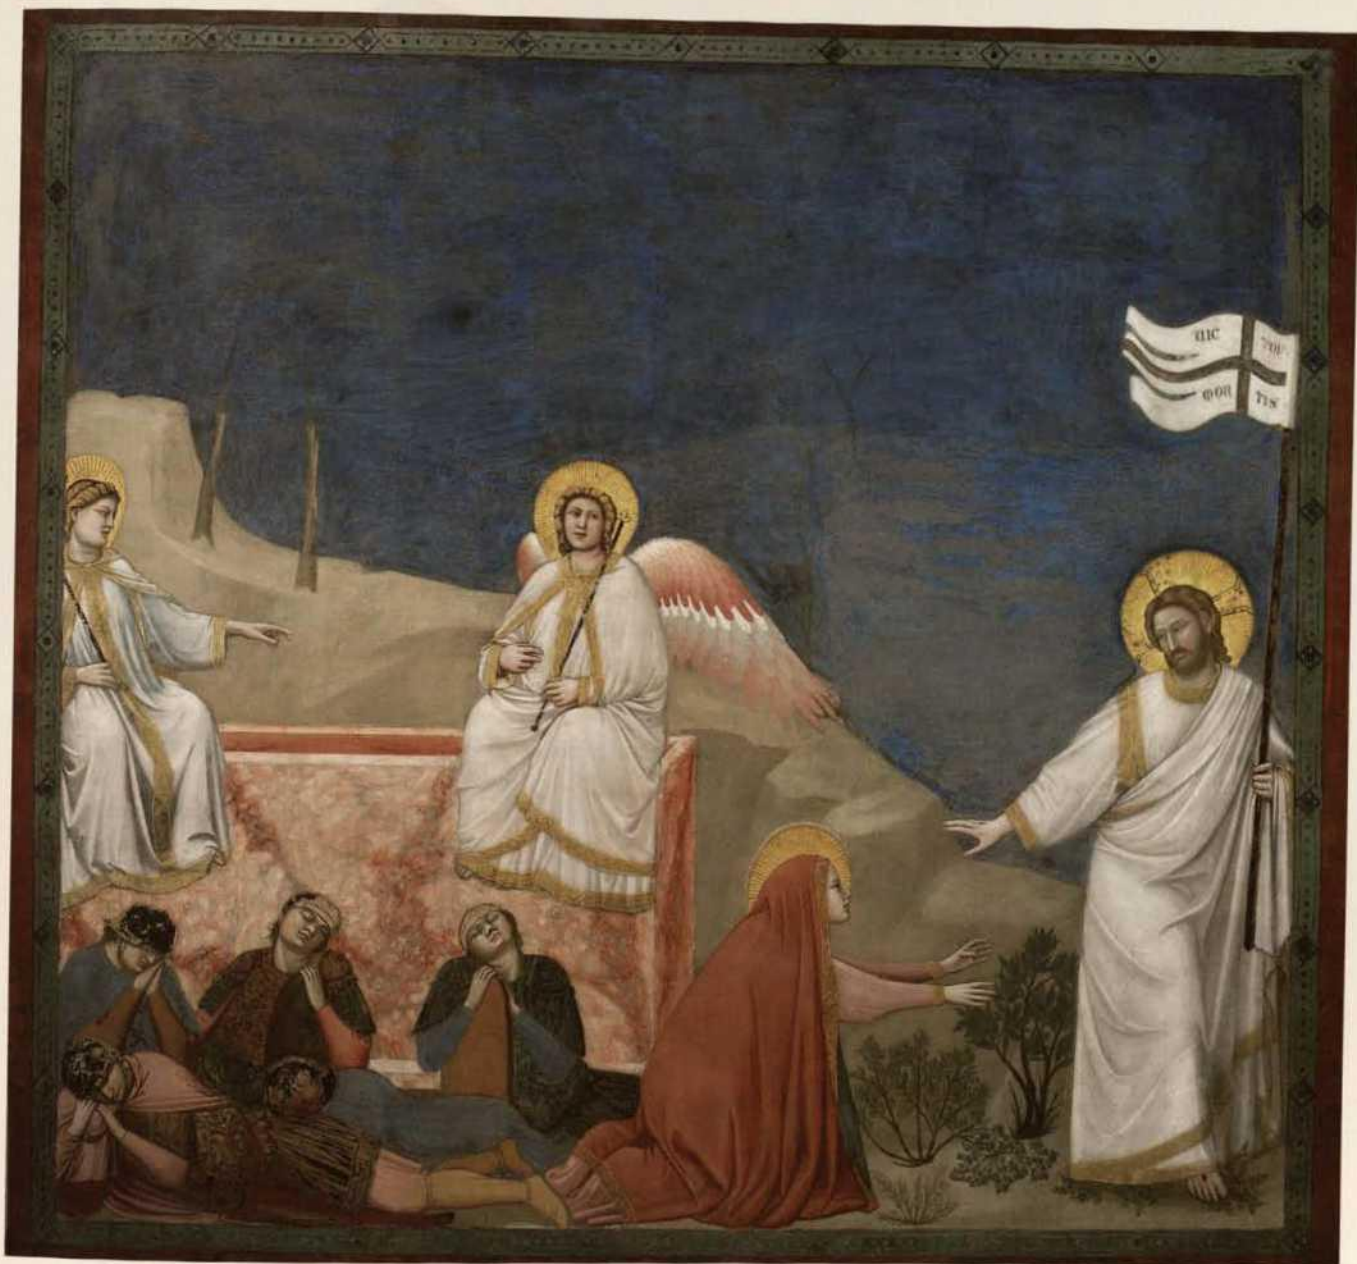
Fig. 15a. Padua, Scrovegni-Chapel, The Angel at the Tomb and the Noli me tangere: after the cleaning.

Fig. 15b. Padua, Scrovegni-Chapel, The Angel at the Tomb and the Noli me tangere: before the cleaning.

Moreover, in the previous years, and most of all at time of restoration of the wall paintings (June 2001 – March 2002), a series of analyses and researches have been promoted bearing in mind two goals: conservation and study of pictorial techniques.

In particular, two XRF portable equipments have been utilized, calibrated to measure sulphur and chlorine on wall paintings: this technique has allowed to map the distribution of the two pollutants on many panels before and after the cleaning.

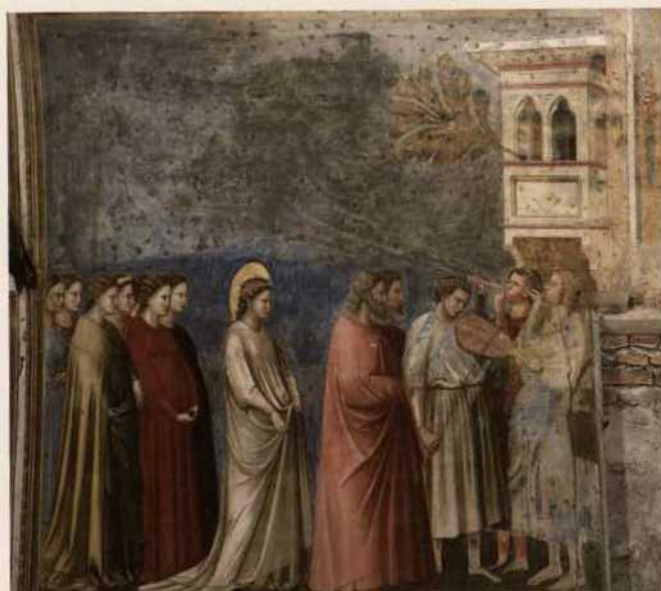
Fig. 20a. Padua, Scrovegni-Chapel, The Virgin's Return Home: before the cleaning.

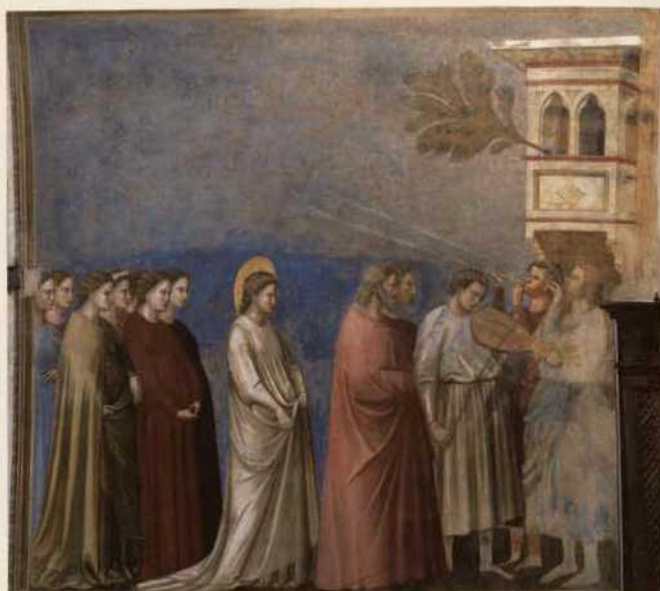
Fig. 20b. Padua, Scrovegni-Chapel, The Virgin's Return Home: after the cleaning.

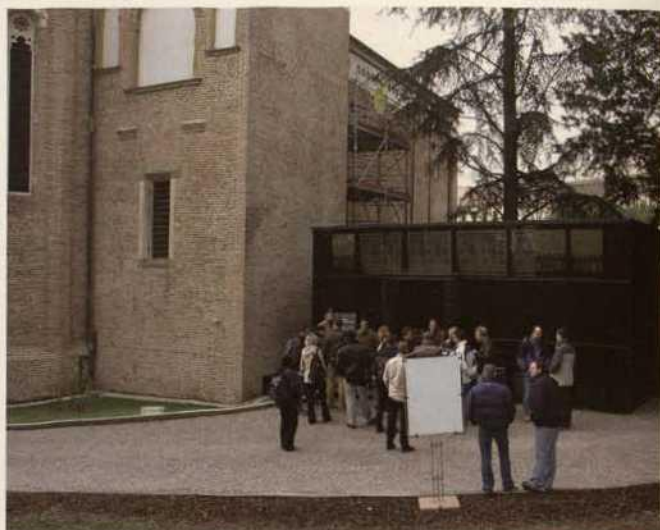
Fig. 21. Padua, entrance to the Scrovegni-Chapel: Corpo Tecnico Attrezzato (2003).

partments, that is into 3 rooms: an entrance area/waiting room, a filter area which consists of the tunnel entrance/exit from the Chapel and an area leading towards the outside, with automatic sliding doors interlocked. The CTA has an air conditioning unit of its own (fig. 7).
