Technological-Architectonic Studies on the Polychromy in the Grand Masters' Palace in Malbork

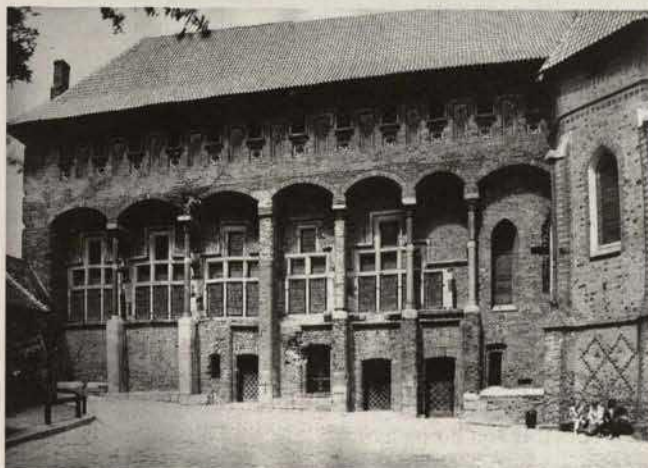
Fig. 1. Facade of the Grand Masters' Palace before restoration in 1998. In the first arcades from the south fragments presented in colour plate VIII, 3 and 4 exist (Photo by A. Skowroński)

century new war damages were observed. The key date is 1782-86 when a textile factory was set up in the castle interior. This is when granite pillars were removed, stone windows deteriorated and spaces between pillars were bricked up. Also the crenels were demolished. The devastation of the Palace continued until 1804 when the Prussian king Frederic Wilhelm III prohibited further damage. In the following 200 years restoration work was carried out. As for the elevation, 1822 was an important date, when re-erections were removed and pillars and windows were reconstructed. Work continued until 1915 when Conrad Steinbrecht took over. World War II also left its trace on the Malbork Castle, including the eastern facade. During the renovation programme in 1947-49 deteriorated pillars were replaced by brick pillars (Fig. 1).
