Kirsten Trampedach

Experiences with Lime-Based Materials used in the Maintenance of Mediaeval Churches

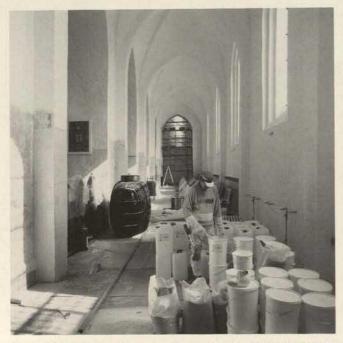
Fig. 2. Lime putty, quartz sand and limewater delivered ready for limewashing the cathedral in Århus.

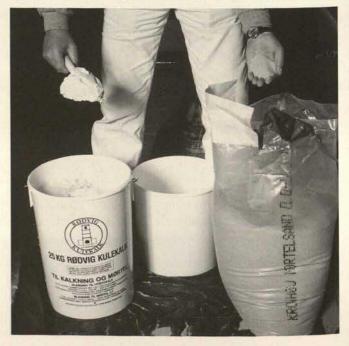
Fig. 3. Lime putty and quartz sand for producing a sandy limewash.

The limewash is often prepared with addition of fine quartz sand to the lime putty. The method is especially convenient in cases where the preservation of old, and to some extent weak, layers is important. There are still quite a number of mediaeval wallpaintings covered by limewash layers in many churches, and attempts are made to avoid uncovering the paintings unless a technical reason demands it. Therefore, we try to work even on weak surfaces, and experience has shown that this is often possible by using a sandy limewash. The layer must be rather thick – resembling a slurry applied with brush. If a normal limewash is applied on a weak surface it often flakes off. Additionally, the sandy limewash creates a good base for further whitewashing with lime without sand. The absorption is good and uniform and the covering power is excellent.

The quartz sand added to the lime putty is of two different types: A rough one with a grain size from 0,2 mm up to 0,5 mm and a finer one from 0,0 to 0,3 mm. Often the use of the finest sand is sufficient, but in some cases it is necessary to apply the rough one as a first layer followed by the fine. Recently we have started experiments using a powder quartz size 200 μ m, but with equal proportions to the above mentioned mixtures: 1 part lime putty to 4 parts aggregates. Water is added until a suitable consistency is achieved. It is important when working with sandy limewash that each treatment is completely dry before further applications. If not, there is a big risk of discoloration.

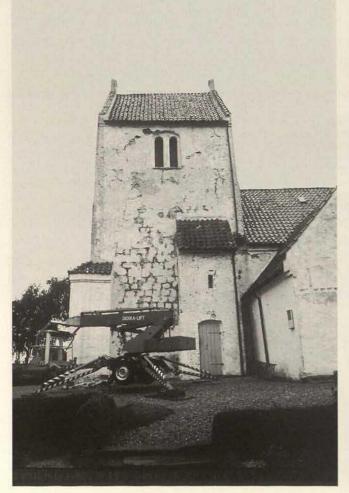
Fig. 5. Vallekilde Church (Zealand). The tower after cleaning in 1991. The lower part is made of granite boulders and the rest partly of hardburnt bricks. In those areas, a cement slurry was preserved.

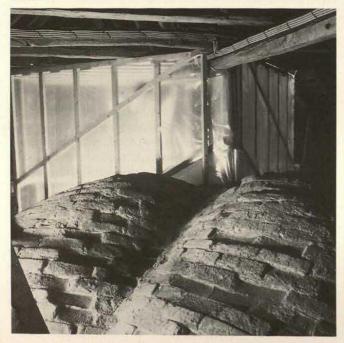
Fig. 8. Kirkerup Church (Zealand). The top side of a 14th century vault, with bricks showing deterioration caused by salts (mostly natrium chlorides).

In recent years much attention has been paid to the condition of the top side of the brick vaults. Most salt problems in wallpaintings are related to the salt contents of the underlying bricks. The deterioration of the brick is often advanced before the problem is visible on the painting beneath. Based on these observations, preventive treatments are now carried out by applying a layer of plaster to the top side of the vault. In fact, this is a repetition of the original treatment, which in most cases was carried out upon finishing the construction of the vault. However, nobody had been aware of the importance of this layer over the following centuries, and when it deteriorated it was not replaced with a new layer. The function of the plaster layer is to absorb and release the humidity and prevent soluble salts from entering the bricks. The plaster is a sacrificial layer where the distintegrating actions of salt crystallizations will take place, instead of in the brick.

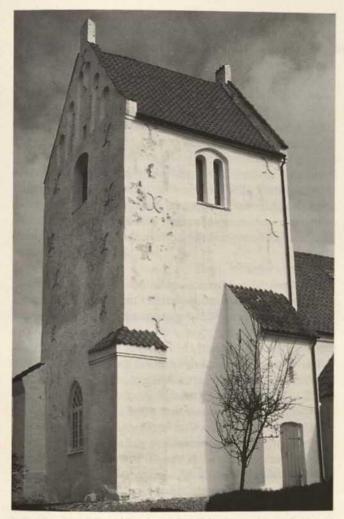
Fig. 7. Vallekilde Church (Zealand) 1996. The rendering has fallen off in the areas with cement and hard-burnt bricks. Repairs have later been executed with hyraulic mortar, which seems to hold.

The use of pure lime mortars is occasionally combined with hydraulic mixtures when treating exteriors. This depends very much on the state of the substrate, and futhermore, exposure to the rough weather in this country must be taken into consideration. At times, exterior repairs have been done with inappropriate materials, such as modern bricks, cement mortars and renderings etc. Very often these materials must be left partly intact, and therefore work is carried out on substrates which are not ideal for lime mortars. The predominant wind in Denmark is from west or southwest, which means that the western and southern facades, especially of the towers, are highly subject to deterioration. Experience shows that a lime mortar/rendering is not sufficient on such areas, unless hydraulic lime is added. On the other hand, experience also shows that in areas where original building materials (e.g. mediaeval bricks, granite boulders) are preserved as base for the treatment, pure lime mortars work satisfactorily.
