The Conservation of the Golden Hall (Konjikido) of Chusonji Temple at Hiraizumi

Abstract

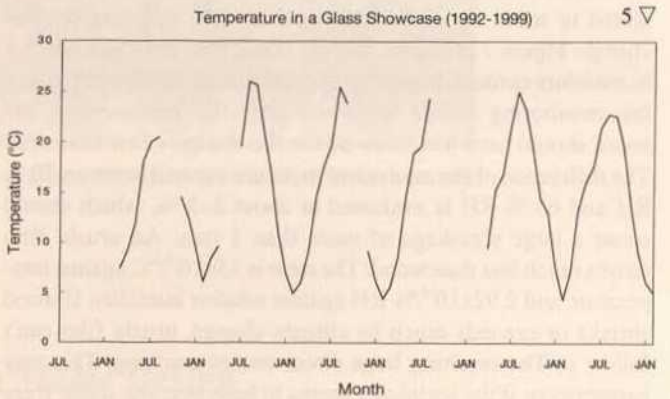
Fig. 5. Temperature inside the glass showcase from July 1992 to January 1999

a. The temperature was measured below the left (south) veranda every hour (24 times/day) by a Pt resistance thermometer since July 1992.

Figures 5–8 show the results indicating evident trends in spite of some missing data. The gap width became larger with seasonal changes of about 0.2 mm (fig. 7). The output of a moisture content meter is shown as the vertical axis of fig. 6, because the relation between the output and the real moisture content of the wooden board was not calibrated. But the manual of the moisture meter says that the output range 0–10 mV usually corresponds to a moisture content of 0–30%. The strain gauge measuring the gap width seemed to be broken because it expanded too much (fig. 8).

The gap width varied seasonally by temperature change. The reason was thought to be as follows. Wood expands perpendicularly to its fibers with the ratio of $35\text{--}60 \times 10^{-6}/^{\circ}\text{C}$ against temperature change. The temperature inside the glass showcase varies about 20°C annually, also raising the seasonal moisture content change of the board (fig. 6). As the width of the board is 310 mm, movement by annual temperature change was estimated to about 0.2–0.4 mm. This figure corresponded approximately to the seasonal variation of fig. 7.
