Restoring 20th Century Skyscrapers in New York: Woolworth Building, Chrysler Building, Lever House

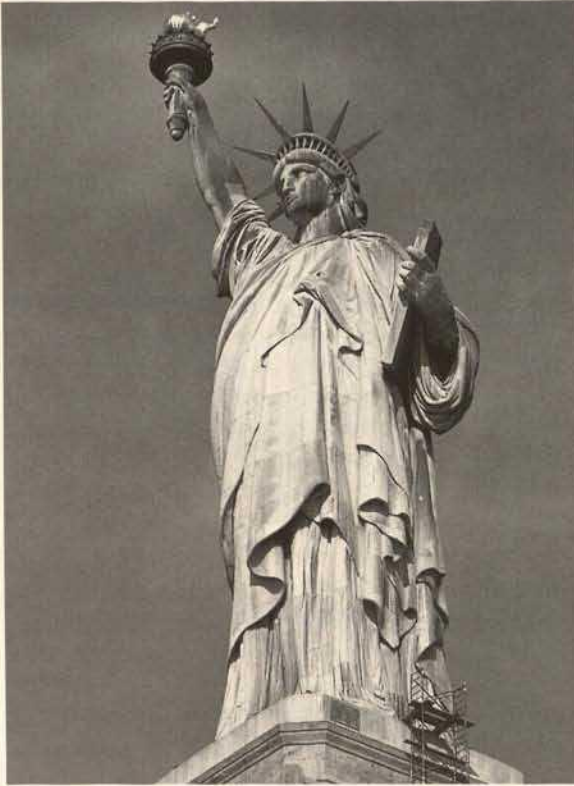
New York, Statue of Liberty: The external copper skin is supported by forged bars, made originally out of carbon steel but now replaced with stainless steel members, that follow the different contours closely. Where originally felt was utilized to separate the dissimilar metals, now Teflon tape is found. The bars are connected to the structural frame and function not unlike the springs on a wagon. The movement is absorbed in the spring allowing the outer skin to move freely without being restraint by the more rigid structural steel frame.

unique structural frame (designed by Gustave Eiffel) using iron bars and straps. The copper skin and the wrought iron straps, separated by felt to prevent galvanic action, absorb the movement caused by either the wind or the temperature fluctuations. This structure which reflects technological innovation and which could be considered an early example of a curtain wall, appears to be traditional on the outside. Many high rises and buildings created subsequently represent this very same dichotomy. A large and diverse number of buildings, which, in a short period of time, went from 4 and 8 stories to 20 and 40 floors. Most downtown areas in the United States, especially New York, show this wide variety and the odd, but interesting, juxtaposition of size, style and shape.

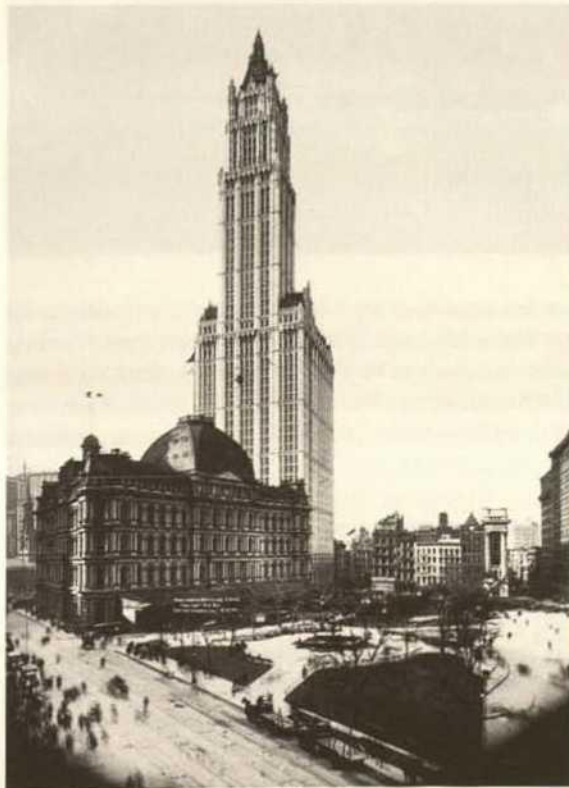
Ill. 3

New York, Woolworth Building, detail of the façade: Substantial sections of the original ornamental masonry were replaced using cast stone units. In some instances the design was simplified while the overall detail and character was maintained. Where the masonry protruded significantly from the wall the overhang was reduced. Because of its height above the ground, the end result was hardly distinguishable from the original design.

In the restoration of the exterior terra cotta substantial sections of broken or stressed terra cotta were removed. The fracturing of the terra cotta did occur not only because of the corrosion of the structural steel anchoring and support systems but also because of excessive compressive stresses in the material. When tested with strain relief gauges, stresses from 1,500 to 4,000 psi were recorded,

well in excess of acceptable safety standards. The volumetric expansion of the terra cotta, which was caused by moisture and re-hydration of the fired clay was tightly restrained by the existing wall construction and caused pressure to build up. This is another example where the combination of technologies led to some unforeseen interface problems. Cutting every other horizontal joint to the full depth of the terra cotta block, some 4 inches, was found to be the best method to bring the pressure down to acceptable levels and minimize damage to the masonry. Where replacement units were necessary, high quality cast stone blocks which simulated the original color and detail closely, were used.

become more frequent in the restoration of a modern building where economic obsolescence of a material is likely to be as critical as its physical condition. Cast stone was selected for economic, technical and logistical reasons. With no large production facility for terra cotta available at the time (thousands of replacement units were required) quality, turnaround and delivery time became critical. While obtaining a replacement unit in terra cotta was expected to take as much as 6 months, a cast stone block could be delivered in two weeks and at a lesser cost.

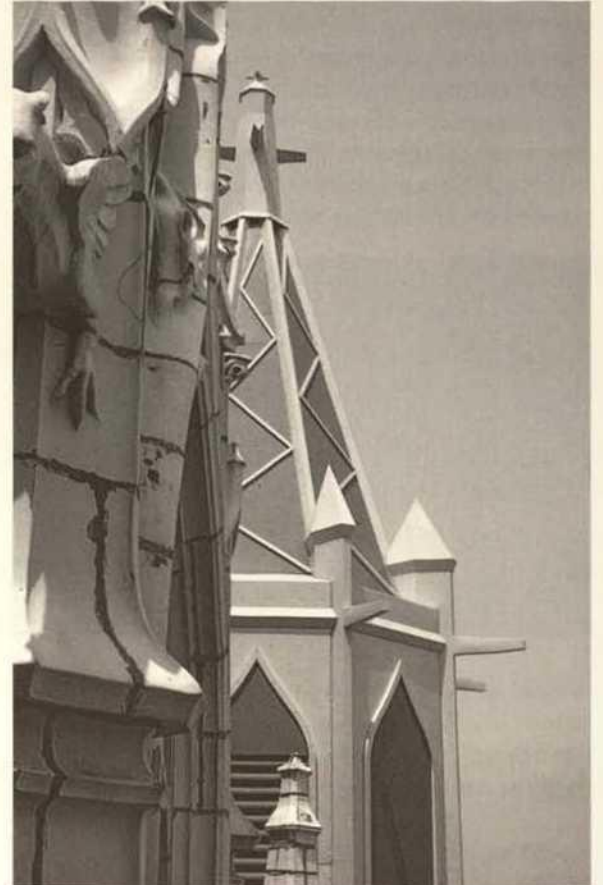
III. 6

New York, Woolworth Building, restored secondary tower: While replacing the tourelles was considered, the complexity, long term durability and the overall cost of such an effort was determined to be prohibitive. However, it was recognized that these tourelles played an important role in the overall appearance of the building. The decision was made to stabilize the original terra cotta where possible and to create a new aluminum cladding that would resemble but not mimic the original detail. When viewed from close, the new detail appears oversimplified. The intent, however, was to maintain the overall appearance when observed from some distance (right side).

After considerable study of various alternatives which ranged from complete elimination to complete rebuilding in-kind, a modified replacement system that evoked the original design was selected. After repairing the structural steel and filling the masonry voids where necessary, a new aluminum panel system was designed to enclose the entire tourelle. Because the metal fabrication process allowed only for bending shapes and applying minimal detail, all original architectural detail had to be simplified and compressed to its visual essentials in such a manner that the overall architectural articulation and appearance

was maintained. Colors for the baked finishes of the aluminum were not just used to match the original detail but, like the original design, enhanced the articulation of design with its profiles and moldings. On close observation the differences between the new and the old is very apparent but when moving further away the distinction becomes less and less obvious. When seen from the ground or when compared with a photograph taken directly after completion of the original construction, the change is hardly noticeable. A concern that the new surfaces would become more noticeable over time because of their smoother finish has proven to be unwarranted. While the uniqueness of the original architectural composition and detail was recognized, it could hardly be observed from the ground, some 54 stories below, or from further away. Once it was determined that the primary sig-

nificance of these tourelles was in the overall silhouette of the building, a solution or a "creative restoration" was found. The simplification of form supported the overall appearance and silhouette or in other words the design intent of the original architecture.

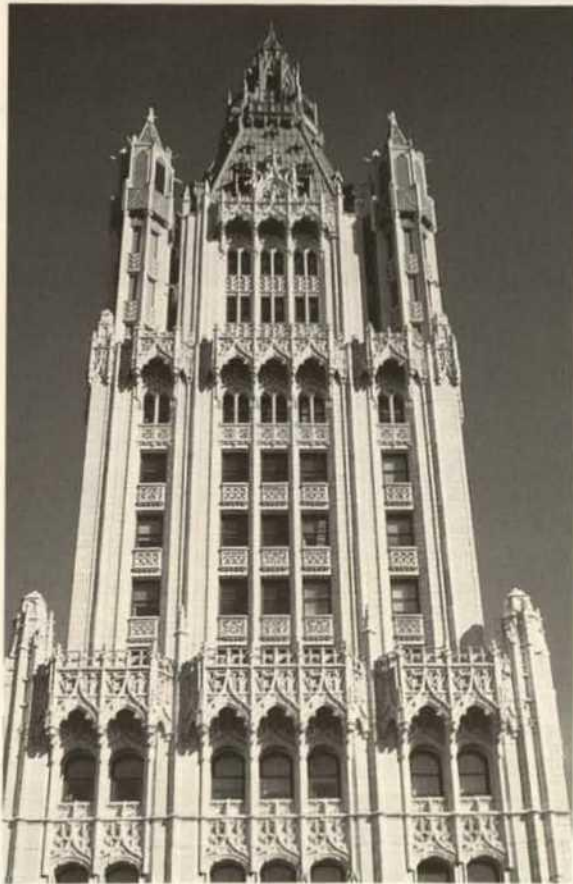
III, 7

New York, Woolworth Building after restoration: When the top of the tower is observed from some distance away, the distinction between the new and the old begins to disappear. The new tourelles with their new aluminum cladding resemble the original design sufficiently to support the overall appearance as intended by the original architect Cass Gilbert without having duplicated his design exactly. The design intent has been maintained.

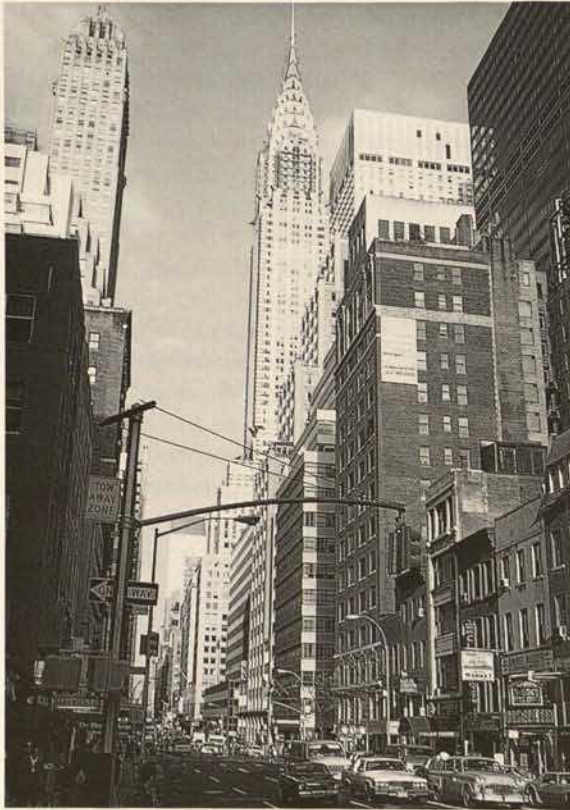
III. 9

New York, Chrysler Building, detail of the façade: The sheet metal ornaments that adorn the different corners. These distinctive ornaments, which recall the automobile past of the first owner, Walter P. Chrysler, were generally in good condition.

With the increase in the size of buildings and the more frequent and wider use of non-traditional materials, the interaction of dissimilar materials and technologies, particularly under severe conditions will cause serious problems. For instance, stainless steel, particularly chrome nickel alloys, became widely used in the 1930's in the USA. The distinctive ornamental sheet metal on the *Chrysler Building* was made from an early German stainless steel alloy marketed in the United States under the name "Nirosta" and is similar to our type 300 series. The metal itself has remained quite unaffected by the aggressive atmospheric conditions but the connections between the metal sheets

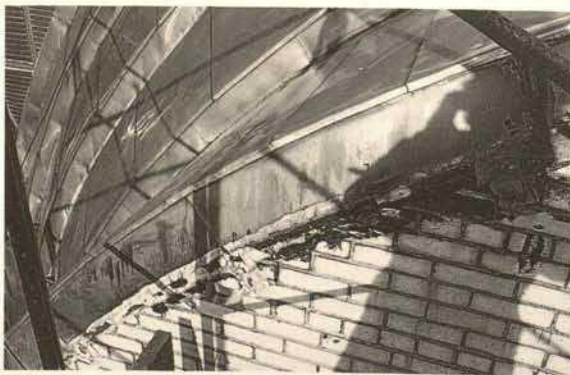
III. 10

New York, Chrysler Building, detail of the roofing: The lack of proper provisions for movement is also found in the interface between the sheet metal and the masonry. Where the stainless steel spire meets the masonry, the differential thermal movement of the dissimilar materials causes havoc. The sheet metal tears at the masonry making this joint difficult to keep watertight.

and with the masonry were clearly affected. Most problematically were the areas of the spire where the metal directly abutted the masonry or the parapet walls. The differentials in expansion and contraction caused the metal to rip the masonry apart resulting in water infiltration. Reinstallation of the metal sections, providing expansion and sliding joints for the metal combined in some instances with a secondary water proofing membrane proved effective. With simply buffing the metal a "shiny" appearance was restored.

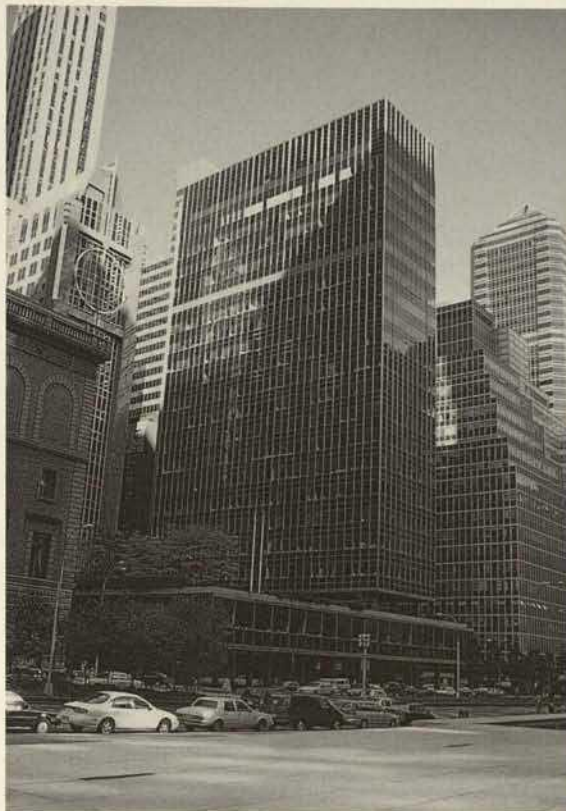
III. 11

New York, Lever House: Designed by Gordon Bursnaff of Skidmore Owings and Merrill at the end of the 1950's and located on Park Avenue, the building with its gleaming glass and stainless steel curtain must have been very striking among the masonry Beaux Arts-style buildings that lined Park Avenue at the time. Now surrounded by glass and metal curtain wall buildings of a later vintage, the significance of the building as a pioneer and icon of modern architecture is much harder to appreciate.

Designed by Gordon Bunshaft of Skidmore Owings and Merrill and built between 1950 and 1952 the building is an example of the corporate architecture of post World War II. The structural steel framing and floor system was separated completely from the glass and metal curtain wall, in essence establishing the concept of core and shell. The separation went as far as moving all structural supports out of the outer wall and eliminating any distinction between primary and secondary mullions. To stiffen the wall vertical structural steel U-channels were attached to the horizontal spandrel beams. Horizontal glazing

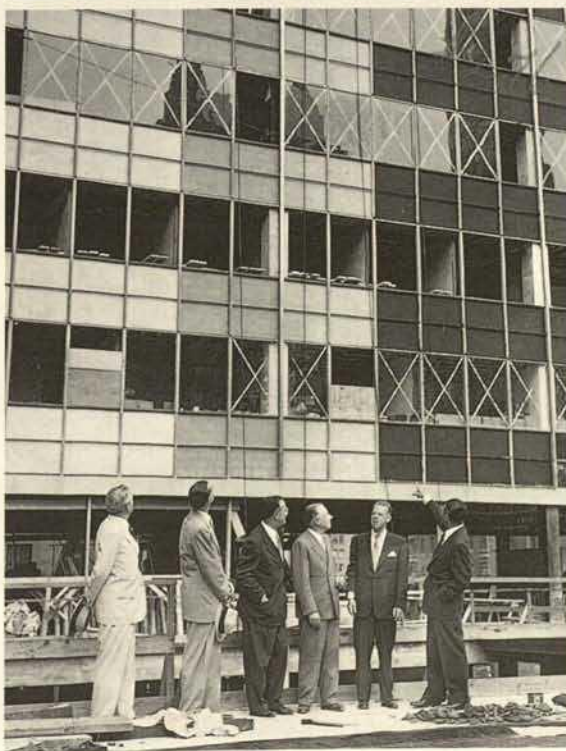
III. 12

New York, Lever House: The curtain wall was installed piece by piece. Because of code requirements at the time the sections of spandrel glass were to be backed with masonry. The back of the masonry was treated as a "shadow box" for the glass, which was vision glass with wire mesh embedded. The overall design and technology of the curtain wall was simple.

angles were attached to the sides of the verticals. The glazing was placed in the rabbits and secured against the horizontals and verticals with carbon steel glazing stops. The assemblies were covered with stainless steel covers. The wall had no operable sections – one of the first of its kind – and was wet glazed. A system of flashing and weep holes allowed water that may have entered to drain out.

At the location of the spandrel a concrete block wall was maintained as a fire stop, as required by the building code at the time. A small section of block was more or less suspended below the slab while the remainder was placed on top of the slab. The front of the block wall was parged and painted and served as a 'shadow box' for the tinted and wired vision glass that was used at the spandrel level.
