Rescuing the Flood-ravaged River Island of Majuli, Assam

Deepika Jauhari

Rettung für die hochwassergefährdete Flussinsel Majuli, Assam

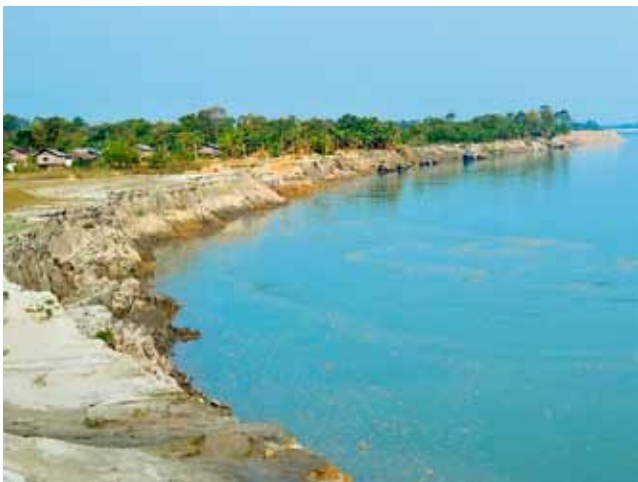
Fig. 2: Continuous erosion of the Majuli Island

as well as biodiversity in Majuli. The flood causes havoc amongst people and their livestock living on the island. The continuous erosion rips off the geographical area gradually (Fig. 2). The river island is receding every year: Of an area of 1345 sq km in 1891, no more than 640 sq km of land was left in 2008 (Fig. 3).¹ Since 1991 out of 244 villages,

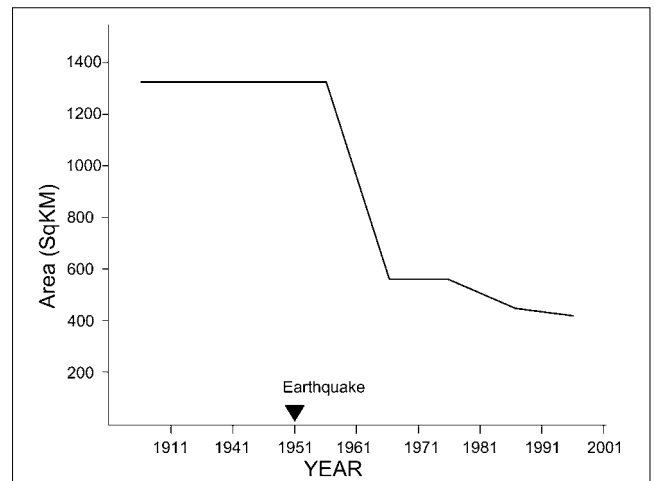
Fig. 3: Shrinking of the Majuli island from 1911–2001

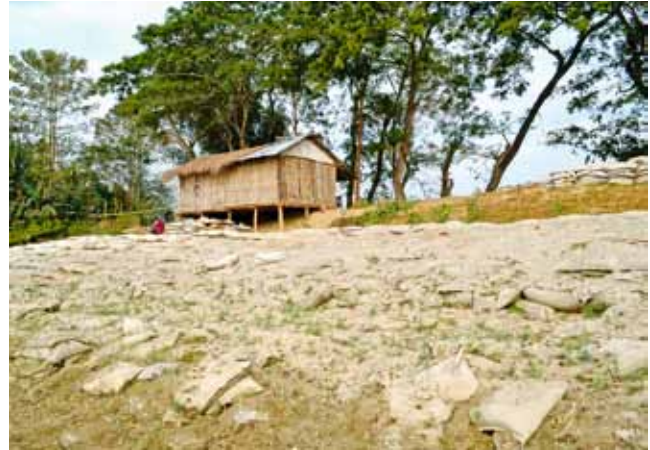
Fig. 4: Ineffective measure, river bank after the floods (2014)

35 have been razed by the river. Studies indicate that if this process goes on, the island will disappear in the next 15–20 years. Uncontrolled and indiscriminate development along with ineffective flood control measures for the island have led to ever-increasing flood damages in spite of the millions of money invested in the flood management sector during

the last decades (Fig. 4). The density of population on the island in 1901 was 24 persons per sq km, which went up to 146 persons in 1991. As per 2001 the density of population is 364 persons per sq km in Majuli. This figure is higher than the 340 persons per sq km in the whole state of Assam. The decreasing total geographical area coupled with increasing population is creating economic instability and ecological imbalance on the historic island. The flooding, which causes loss of lives and damage to property, creates a sense of insecurity in the minds of the people.

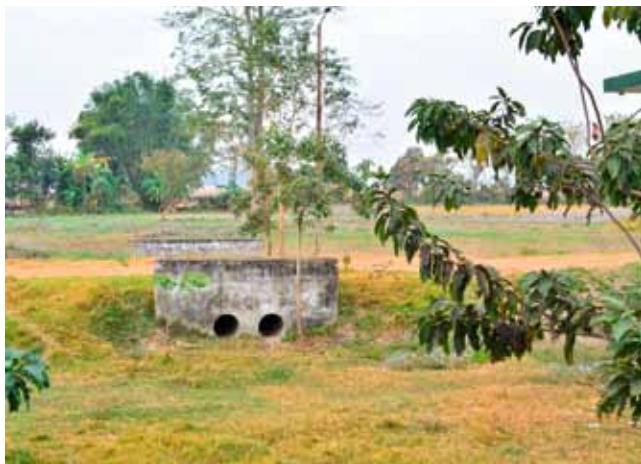
Fig. 5: Road as embankments (2014)

Initially, dykes and embankments were considered immediate interventions to handle the inundation of the island. To contain the floods after the great earthquake of 1950, short term ad hoc-types of flood protection measures were taken as the construction of embankments in the form of roads (Fig. 5) were introduced in 1952–53. Embankments and dykes were constructed on the island with the limited information contained in the hydrological data and the topographical surveys available at that time. These embankments breached on a number of occasions. A total of 155 km of embankments were constructed; however, at present only approximately 90 km of embankments exist.⁵

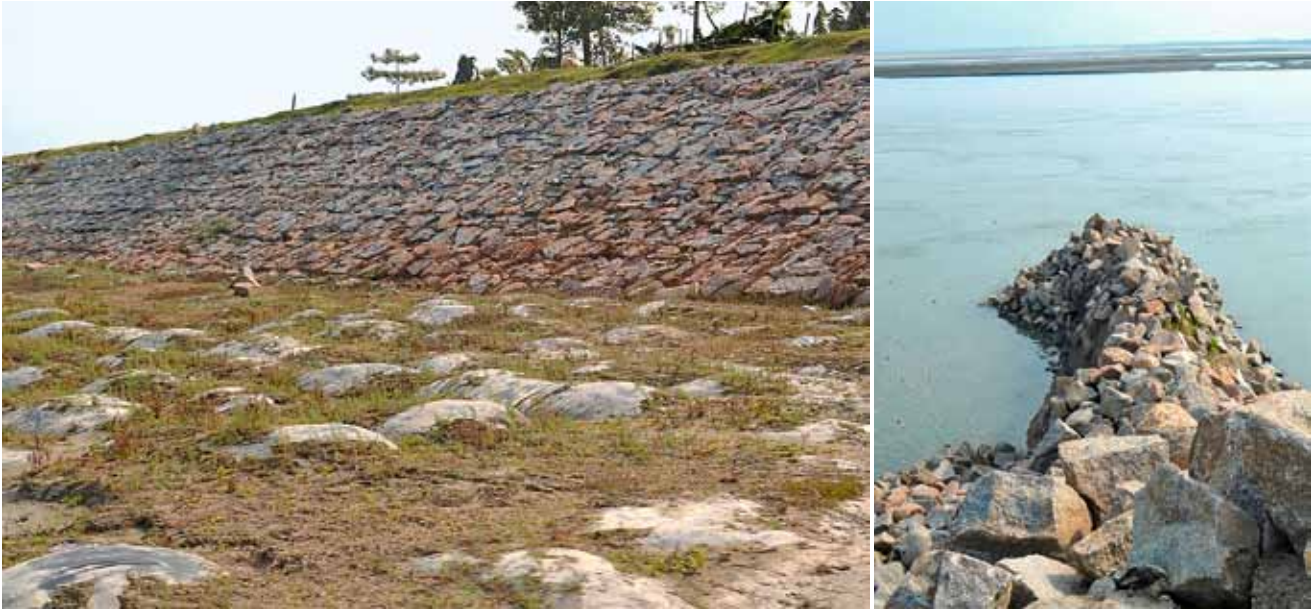
Fig. 6: Stone Spur before & after the floods of 2013

Every year, stone spurs encased in wires are constructed jutting out towards the river. These are constructed in order to curtail the force with which its waters hit the island and also to divert its flow to some extent. But some of the spurs were designed without keeping in mind the detrimental impact they could have. The construction of stone spurs in the Southern mainland side of Majuli at Hatisal, Nimatighat and Kakilamukh diverted the flow of Brahmaputra towards the lower part of Majuli and accelerated devastation in Ahatguri Mouza. The construction of these stone spurs as flood control and anti-erosional measure on the southern bank of the Brahmaputra River near the mainland is responsible for creating a number of chaporis (sand bars) and new river channels in the Brahmaputra River. These stone spurs diverted the strong current of the mighty river Brahmaputra towards lower Majuli, which was the crucial cause for the disappearance of the Ahatguri Mouza, a part of Majuli, by erosion. This example further corroborates the fact that man-made factors accelerated the environmental degradation as well as the flood-induced erosion of Majuli (Fig. 6).

The embankments built around the 1950s by the government agency had a negative impact as they were adopted as an alternative to a long-term holistic solution for the Brahmaputra Valley. The embanked areas were flooded within and this led to further siltation of the river valley. Other engineered solutions of stone boulder spurs have proved to be hazardous for the areas where the river water is diverted to, in turn eroding the land which is in the way of the hastily flowing river.

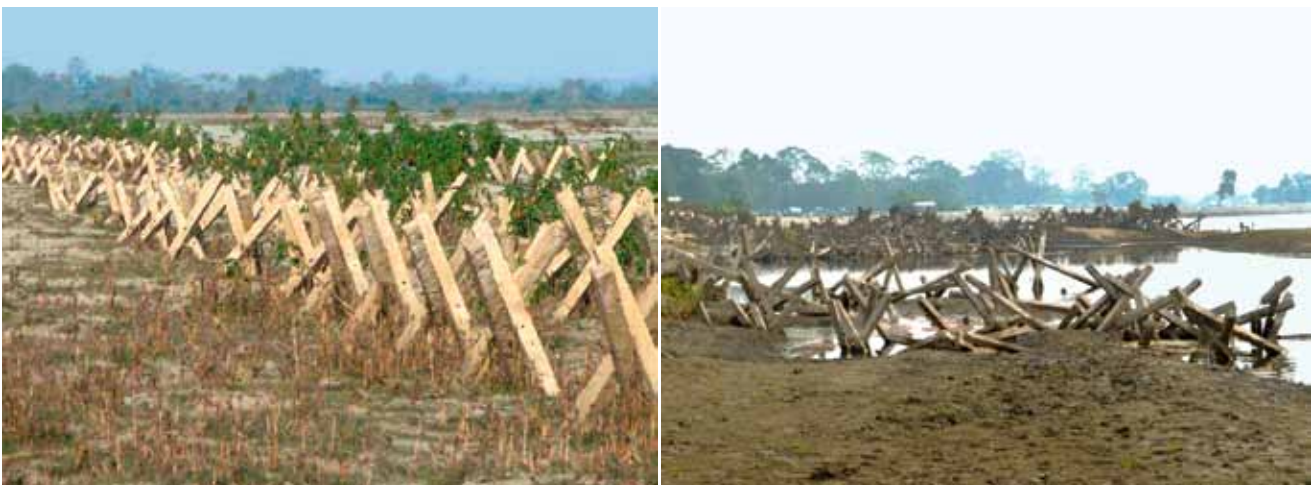
Fig. 7: R.C.C. Porcupines before & after the floods of 2013

These are permeable prismatic structures composed of six members each, made of reinforced concrete (RCC) and joined with iron nuts and bolts. They act as dampers and are a cost-effective alternative to bank protection works for the Brahmaputra River, which carry a considerable amount of silt. Being permeable structures, RCC Porcupines can be used either independently or with the support of impermeable boulder structures or river training and bank protection measures. Depending on the purpose, they can be placed transverse or parallel to the direction of flow.

They are designed for a partial obstruction of about 15 to 20% to the flow of the river. Higher obstruction causes more diversion of flow resulting in undesired scouring around the proposed structures, particularly at the nose portion. Additional protection to the nose and flanks is required to avoid such scour (Fig. 7).

RCC Porcupines have been found quite effective in reducing the intensity of erosion of the river Brahmaputra at Majuli Island by providing protection to the banks, as the Porcupines damp the velocity of flow along the bank. They are cheap in cost (one third the cost of a revetment), easy to construct, sustainable and without significant adverse ef-

fects upstream or downstream or on the opposite bank. In the case of high velocity flows, the implementation of RCC Porcupine works only is not favoured as they then prove to be ineffective. But in general, in areas where partial siltation has taken place, additional Porcupines are placed in the second year to make the silted region firmer.
