## Facing the Inevitable Change – Does Conservation Still Make Sense? The Case of the Helsinki Olympic Stadium

Riitta Salastie

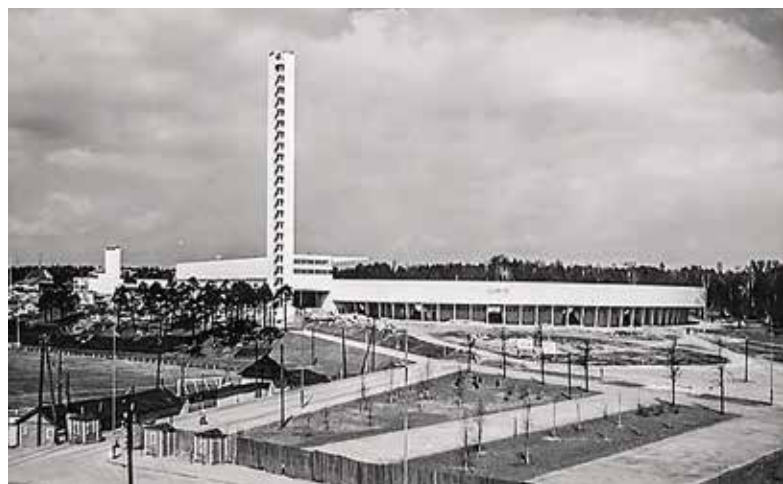
Fig. 1 The Helsinki Olympic Stadium in 1938

Based on an architectural competition, the Helsinki Olympic Stadium was built for the 1940 Olympic Games and inaugurated in 1938 with the main arena, the slender and elegant tower with sportscaster spaces, the museum annex and low curved stands in the Functionalist Style. In this first construction phase the Eastern Stand remained unbuilt (Fig. 1). The Olympic Stadium was built at the southern end of the Central Park, where the minimalistic and stylishly white building landed like a rocket from the cosmos.

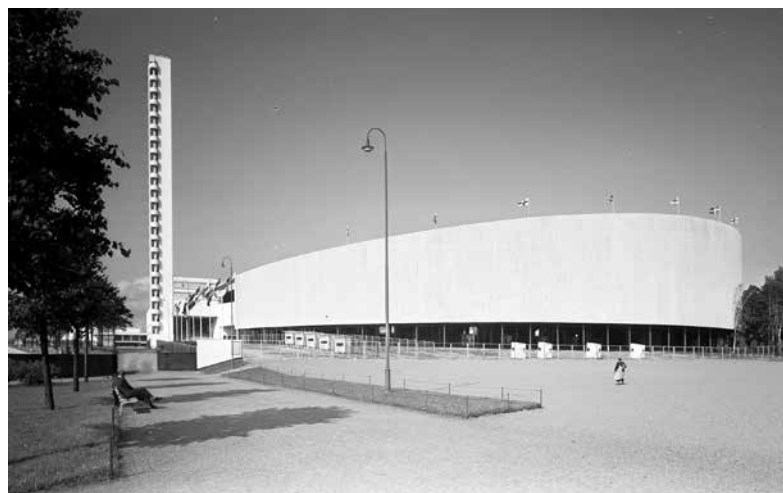
Fig. 2 The Helsinki Olympic Stadium in 1940

had now only two years to prepare for the Games. For this task, the Olympic Stadium was enlarged by a new reinforced concrete east stand and the low stands were extended by temporary wooden stands. Compared to the original 1938 stadium, the extension was quite dramatic: the number of seats was doubled from 23,000 to 46,000. The capacity of the 1940 Olympic Stadium was even 62,000 seats (Fig. 2). Since 1940, wooden panelling became the permanent facade material for the enlarged stands.

The wooden facade of 1940 was innovative and in its circular minimalistic shape very similar to the 1938 stadium's purist and abstract style. Despite the dramatic changes and increase in seats, the 1940 Olympic Stadium continued the avant-garde spirit of the original 1938 stadium. But again, just before the Games were to begin, a military conflict between the Soviet Union (USSR) and Finland broke out and Finland had to cancel the Games because the country was entering the war, the so-called Winter War of 1939–1940.<sup>1</sup>

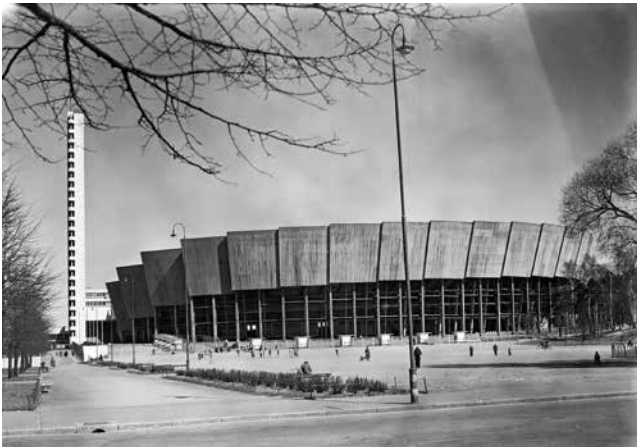
Fig. 3 The Helsinki Olympic Stadium in 1952

The next time a major transformation began was when Helsinki finally was able to host the 1952 Olympic Games after the Second World War. The temporary wooden stand structures of 1940 were demolished in 1948 to be replaced by even larger stands built partly of reinforced concrete and partly as temporary wooden constructions. New reinforced-concrete Olympic stands were completed in 1949. In addition, for the 1952 Games temporary upper stands were built as wooden constructions. During this Olympic phase, the Helsinki Olympic Stadium had as many as 74,000 seats, more than three times as many as the original 1938 Olympic Stadium!

Also, the outer appearance of the Olympic Stadium was radically changed. During the modifications made for the 1952 Games, the facades received their now iconic wooden fan shape, widening outwards. In its spirit, the new Olympic facade was quite different from the pre-war purist style (Fig. 3). The architects were the same, but times had changed in the meantime. After the 1952 Olympic Games, the wooden temporary extensions were demolished and the facade was once more modified – now with lower proportions than the

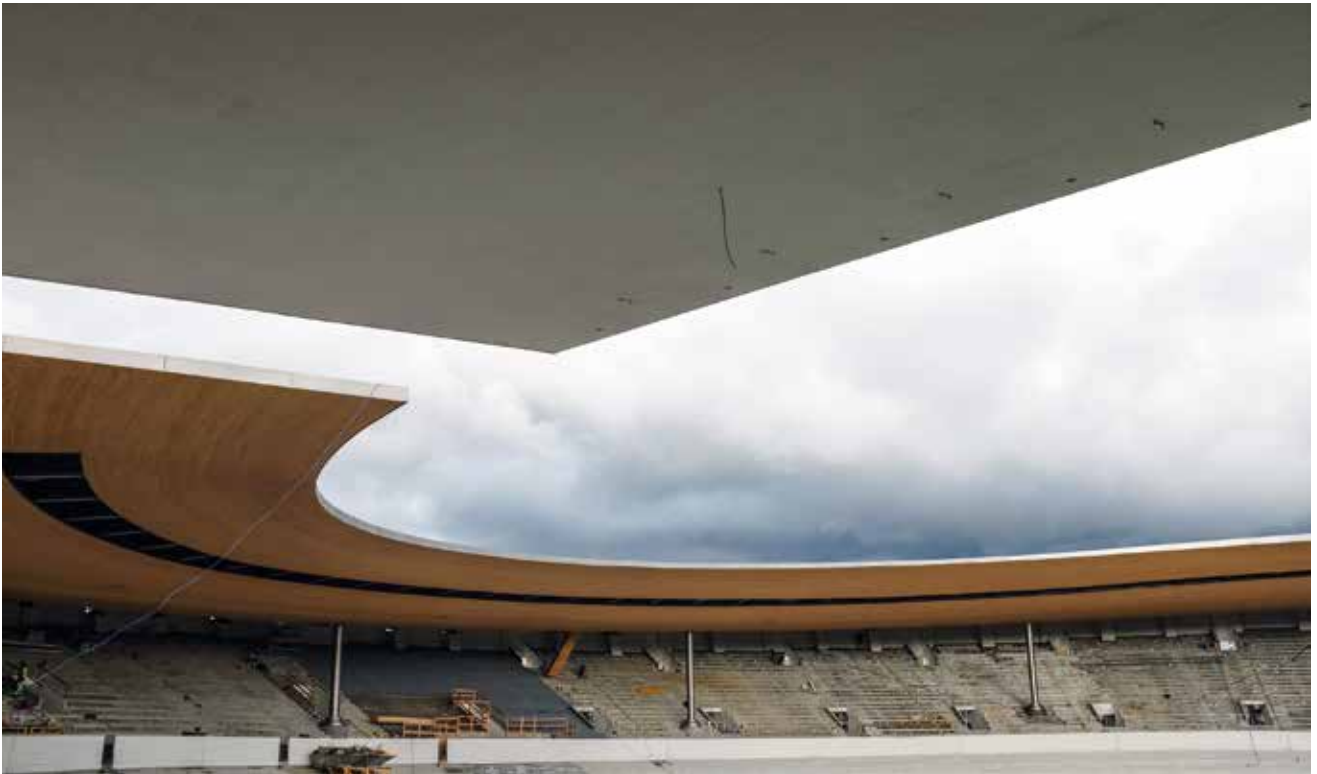
Fig. 5 The new canopy, 2019

derground spaces follow the contours of the terrain and the Central Park and the forest form – as before – an important background for the Olympic Stadium. The most visible and irreversible change in the stadium’s interior is the roofing of the stands. The new canopy is a new layer and a contemporary addition in the history of the building. Unlike the rather small-scale 2006 eastern stand canopy, it is a radical change and a radically new element that transforms the traditional views and the experience of the open sky from the bowl of the stadium.

On the other hand, the addition has been made with great care and developed to work in harmony with the existing interior. Now that the canopy can already be seen there, in spite of the three million kilos of steel, the mass of 400 elephants, necessary for this structure, the new canopy looks surprisingly light – as if floating in the air. With its wooden surface and rather thin profile it is clearly discernible as a new element, but developed to work in harmony with the existing building, not “competing but complementing it”, as for instance the Madrid Document advises (Fig. 5).

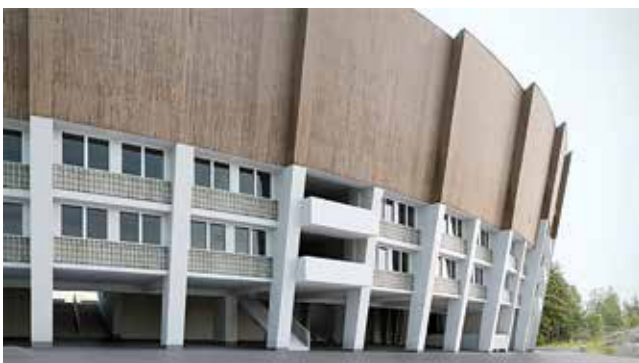
*Fig. 6 The Olympic facade after its conversion, 2019; the new exit staircase 3rd bay*

Due to the intervention, the dimensions of the pillars grew 15 cm on both sides and caused a re-adjustment of all window rows. The coating had to be carried out largely without machines as manual work. The window rows that were part of the protected facades were adjusted to the new dimensions by moving them nearer to each other or by cutting from window sashes and frames – a real *tour de force!* Furthermore, the iconic wooden fan-shaped facade had to be raised two and half metres to hide the new canopy from outside. Due to this operation, the proportions of the renovated facade have actually come close to the appearance of the 1952 Olympic Stadium with its conspicuously higher wooden part. The raising also compensates for the more compact proportions caused by the stabilisation of the bearing pillars (Fig. 6). Another change in the facade is the new exit staircases that were added during the conversion. In an emergency situation the building can now be emptied in eight minutes instead of the previous 13 minutes.

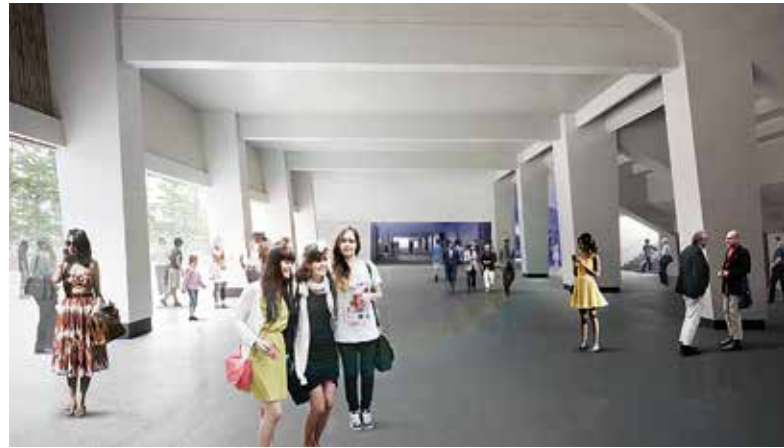
Fig. 8 The new gallery space under the stands

been lost in earlier changes and transformations. One of the most important examples of this is the new gallery space under the stands, thanks to which the whole building can now be circumambulated on the first floor (Fig. 8). The 1938 elegant entrance aula of the western stand is one of the historically valuable and significant building elements that has received new life through conservation (Fig. 9). Even the original 1938 circular wall can still be found there, inside the later additions (Fig. 10).

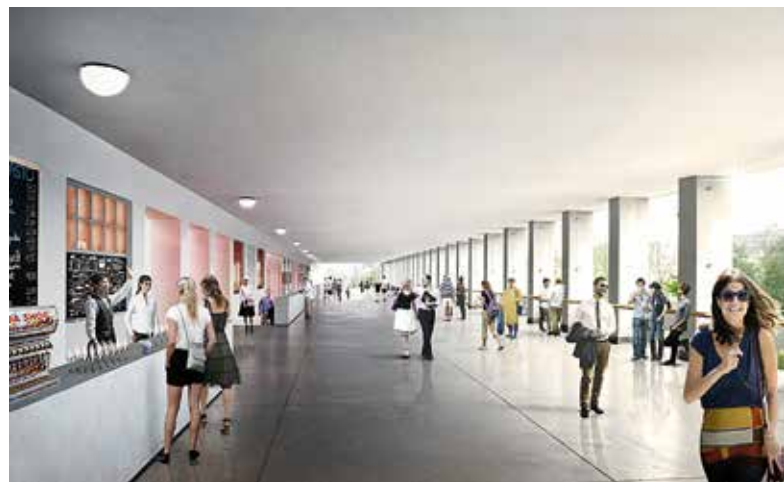
Fig. 9 The conserved aula of the grandstand

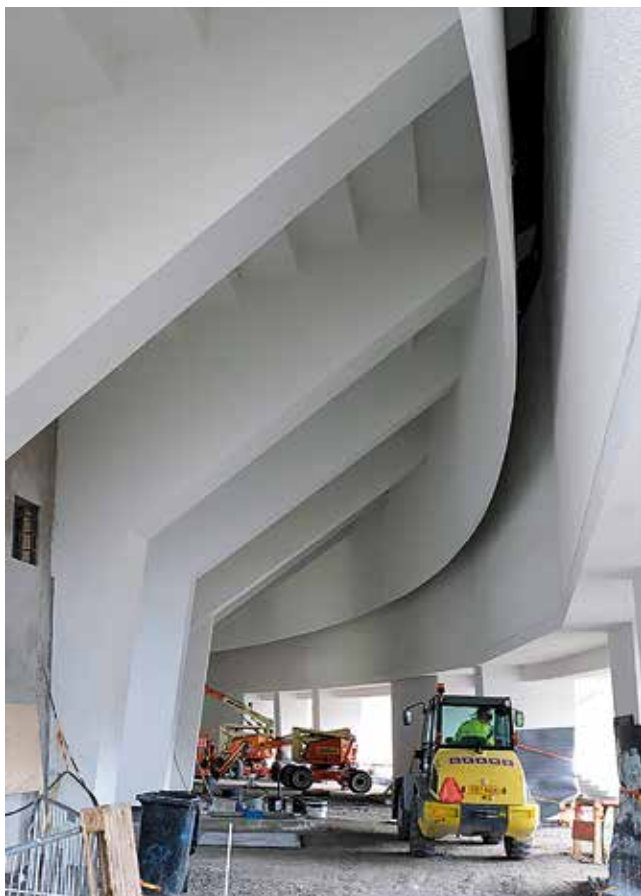
Fig. 10 The original 1938 circular wall inside the stadium building
