ARTUR OBLUSKI

GHAZALI SITE PRESENTATION PROJECT 2012 – 2014 PRELIMINARY RESULTS

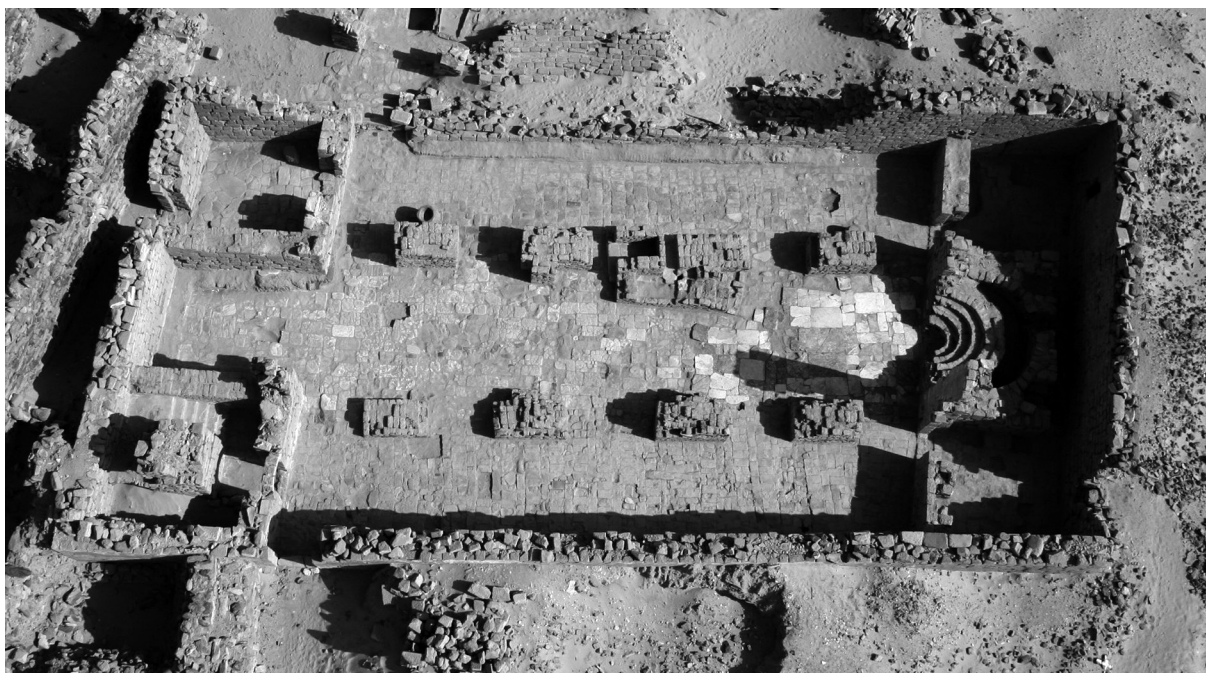
Fig. 2: Kite aerial photograph of the North Church

The North Church of the Ghazali monastery is a basilica with walls built of sandstone in the lower part and of fired brick in the upper part (fig. 2 & cover picture). The church was oriented toward the sunrise. An interesting discovery was made thanks to the kite aerial photographs and detailed documentation, which revealed a fact that had escaped the notice of all the people who have published plans of the church so far.⁸ The church is not rectangular in plan but has the shape of a rhombus with the north wall shifted slightly further to the east than the south one.

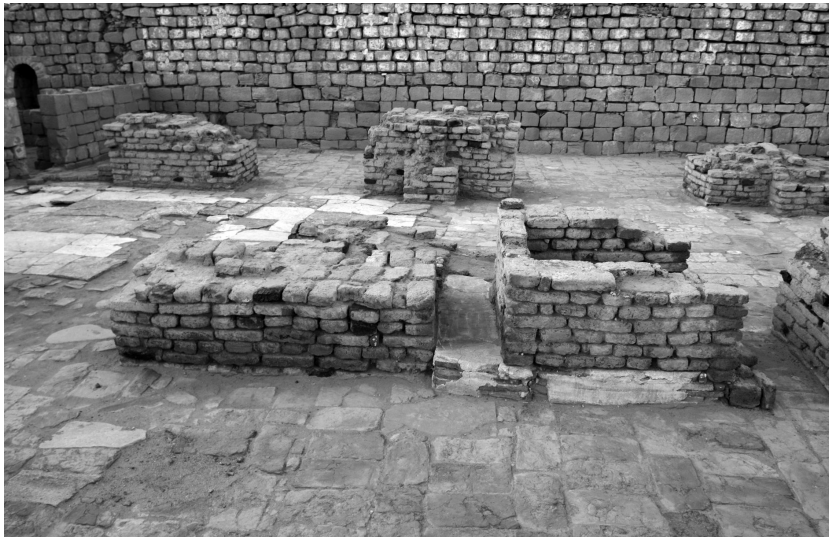
Fig. 3: Remnants of the ambo, North Church

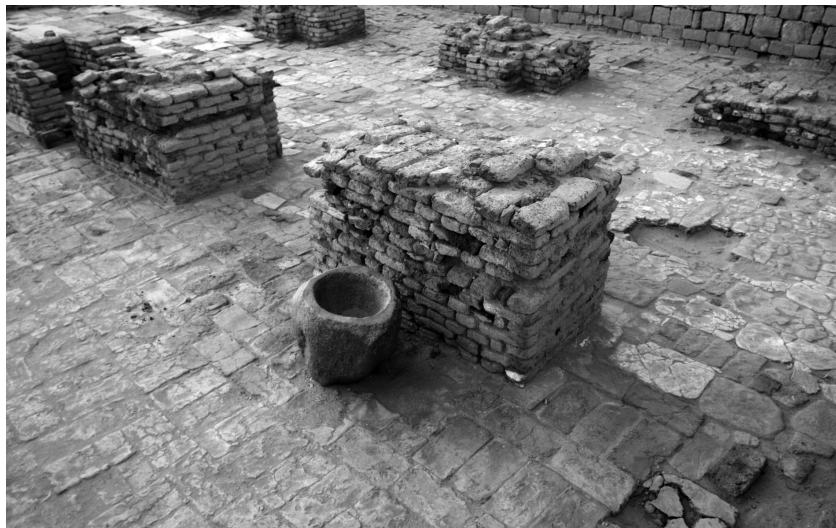
Fig. 4: Aspersion in the northern aisle

arches, which, in turn bore the weight of the dome. The part of the nave from the space between the second pair of pillars towards the east was paved with marble and granite. At a distance of 4 m from the entrance to the apse there were four pots sunken into the floor in a line spanning the width of the nave. They were used as supports for beams constituting the framework of a wooden templon. The ambo was located against the southern and western faces of pillar N-2. It incorporated an earlier bench-like structure (fig. 3). A bench made of sundried brick ran along the wall of the northern aisle. Found next to pillar N-4 was an aspersion in the form of a shallow depression hewn in a granite stone (fig. 4).

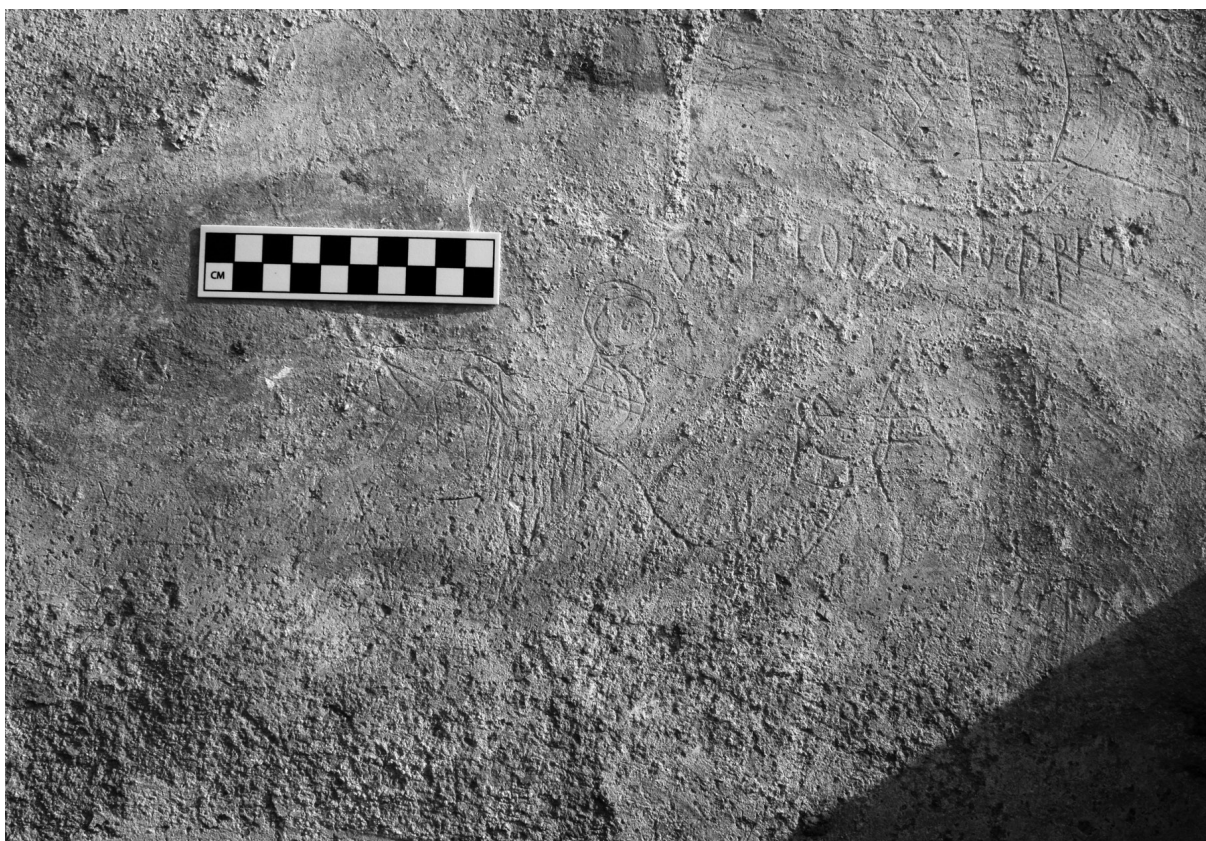
Fig. 5: St. Onophrius inscription. South wall of the North Church, before conservation

preserved, forming the ending of the first three lines of the epitaph. These remnants are enough to state that we are dealing here with a Greek epitaph containing the prayer to “God of the spirits and of all flesh”, very popular in funerary epigraphy throughout Nubia. Thus far, the epigraphic discoveries at Ghazali known to date consist of 136 funerary stelae (mostly in fragments) and a sepulchral stone cross. They constitute the second largest assemblage of epitaphs in Nubia after the cemetery of Sakinya (Toshka West) with its 314 tombstones. The textual finds from Ghazali also include 116 inscriptions on pots (two in ink, the rest scratched) and 102 graffiti on the walls of the North Church. The most interesting graffiti are “St. Onophrius” and the prayer: “The Lamb of God, you take away the sins of the world...” in Greek (fig. 5).

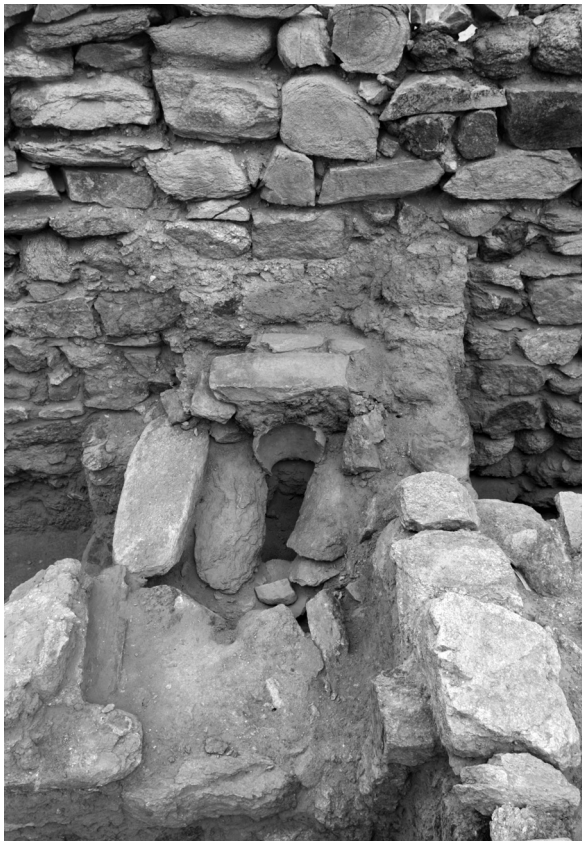
Fig. 8: A toilet of Group 3

Excavations in the area along the eastern wall of the monastery brought to light a row of twelve latrines and a dump corridor located behind them, between the toilets and the enclosure wall (fig. 7). Two groups of latrines (Group 1 and Group 2) located in the area adjacent to the central part of the eastern wall predate the group (Group 3) situated to the east of the church. The earlier latrines formed clusters, which consisted of three units and were separated from one another by a corridor. A single toilet had the form of an elongated rectangular room. At the eastern end of the room there was an elevated space with what might have been a ceramic seat but may well be just a relic of a larger structure. The drainage pipe led to the corridor in the east, where organic remains were found. The toilets of Group 3 were built directly over the dump corridor (fig. 8).

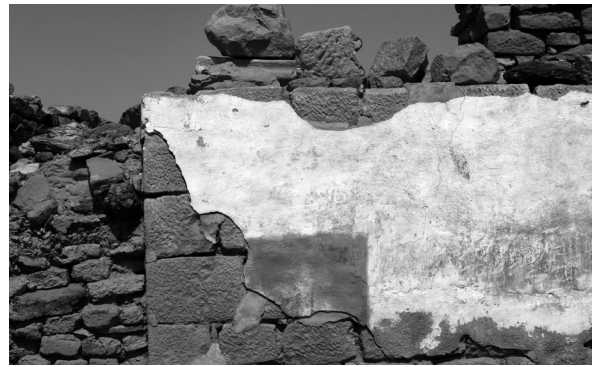
Fig. 9: Southern wall of the North Church during cleaning

the project in 2014.¹³ The conservation treatment was extensive and focused on the consolidation of the fragile plaster of the walls of the North Church in order to preserve numerous graffiti, scratched pictures of holy figures, animals and boats, as well as traces of wall paintings. During the 2014 season, over 200 square meters of plaster were cleaned and re-attached to the walls (fig. 9). Edges of the preserved plaster were reinforced with protective bands. All of

- Documentation. Tracing of the graffiti; photographic documentation was made of the state of preservation and the work in progress.
- Cleaning. Mud and dust were removed using clean water, soft sponges and brushes. To target persistent accretions, 2% Contrad 2000 was applied to regular dirt and a 20% solution of ammonium carbonate in water was used for salt or gypsum recrystallization. A 30% solution of ethanol or pure ethanol and acetone were also used.
- Consolidation of the plaster. This was done in three different ways depending on the state of degradation. After cleaning, the first step in the case of highly eroded surfaces was impregnation with limewater. The edges of plaster and mortar were soaked with a 30% solution of ethanol in water to facilitate the penetration of the resin. Then the plaster

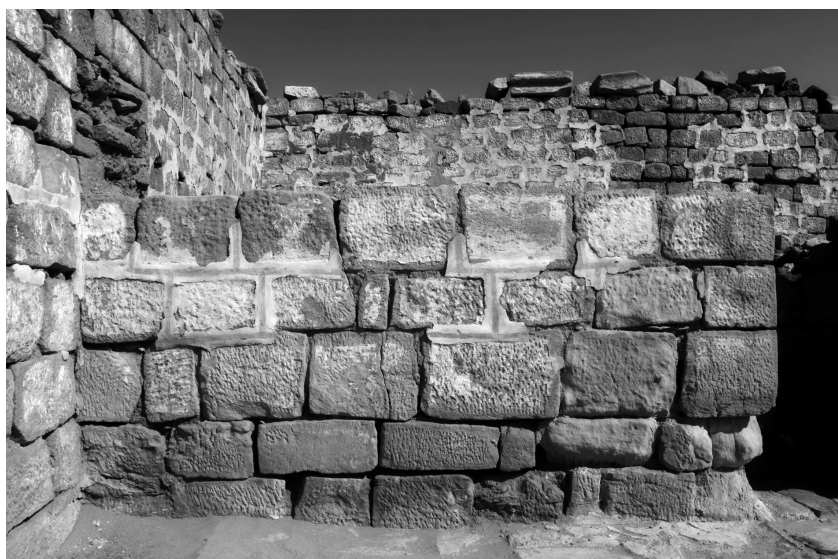
Fig. 10: Western wall of the north-east room of the North Church

the inscriptions and drawings were traced on transparent film before and after conservation. As a result of the treatment, some previously unknown parts of decoration of the North Church were exposed (fig. 10). Measures were taken to protect the monument: some pathways were blocked with stone walls to redirect tourist traffic and limit further damage to the building. Other fragile areas were covered with clean sand. Tops of the pillars and walls of the church were cleared of stone rubble, which had posed a danger to visitors. Thousands of stones stacked in the monastery by Peter Shinnie were also moved outside and prepared for construction and reconstruction works during the stage of the project devoted to site presentation.
