CORNELIA KLEINITZ

# THE 2016/17 FIELD SEASON AT MUSAWWARAT ES-SUFRA (SUDAN): FROM CONSERVATION PLANNING, APPLIED CONSERVATION AND PROTECTION MEASURES TO ARCHAEOLOGICAL AND SOCIAL ANTHROPOLOGICAL RESEARCH

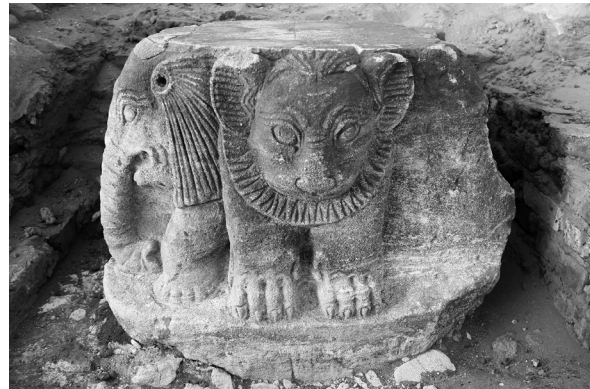
Fig. 1: Early Meroitic column base from room 108 of the Great Enclosure after consolidation (photo: Cornelia Kleinitz).

ments the current state of preservation of the monuments at Musawwarat and outlines short, medium and long term conservation-restoration approaches, strategies and priorities. Applied conservation work and 3D-scanning was dedicated to the Early Meroitic decorated columns on the Central Terrace of the Great Enclosure, with the aim of eventually making these unique pieces accessible again for research and public presentation (Fig. 1, Cover picture).

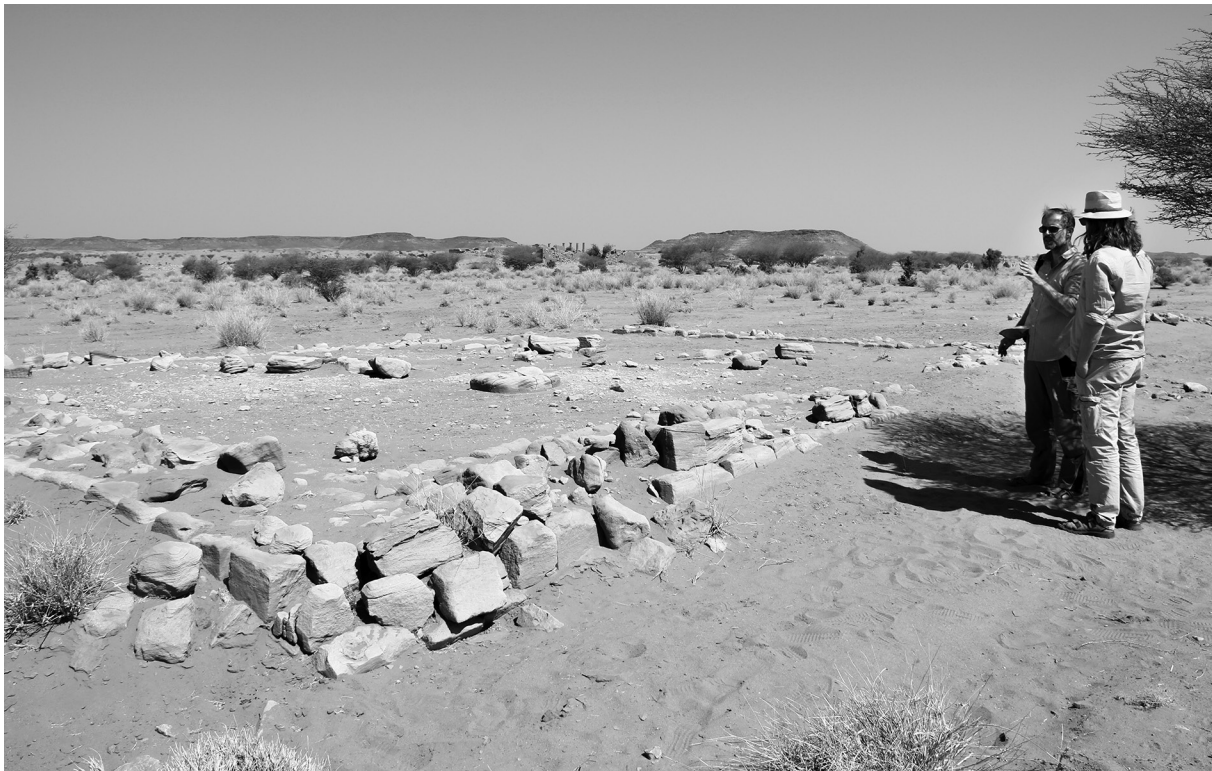
Fig. 2: Conservation survey team during their inspection of Temple ID to the southeast of the Great Enclosure (photo: Cornelia Kleinitz).

in early 2014 in preparation for site management planning.<sup>26</sup> Thirdly, new data was collected during a detailed conservation survey that was undertaken by a team of archaeologists, conservators and conservation planners during the early 2017 field season. The latter involved the documentation of the current state of preservation of all archaeological monuments in the valley of Musawwarat es-Sufra at a general level (Fig. 2).<sup>27</sup>

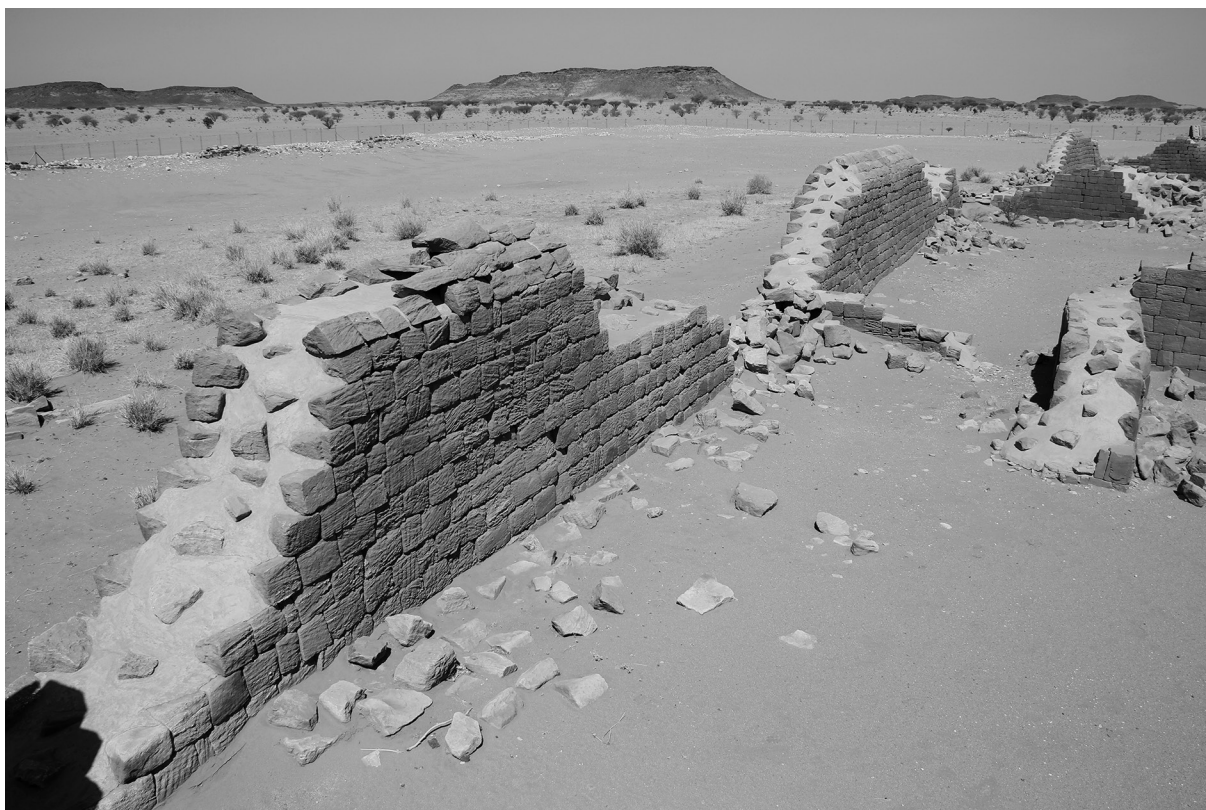
Fig. 3: Wall tops in Complex 500 with their smooth earth and lime mortar covers (photo: Cornelia Kleinitz).

In addition to evaluating which conservation measures would need to accompany the development of a visitor guidance system, recent and ongoing conservation approaches in the Great Enclosure were monitored and re-evaluated. One example are measures of protecting the walls of the Great Enclosure, most of which have lost their original capping and are exposed to water seepage during the rainy season. The established conservation approach, applied since the 1990s, consists of protecting the wall tops with a cover of earth and lime mortar. This redirects rain water along the sides of the walls and prevents water seepage into their interior. During the conservation survey it was recognized, however, that some of the most recently treated wall tops in complexes 200, 300 and 500 already showed signs of damage, such as cracks and holes. The recently applied mortar seems to be much less durable than that applied during the 1990s and early 2000s, which is still in good condition. Consequently, the mixture of the mortar will need to be re-evaluated and adjusted, and the effectiveness of the measures closely monitored before more walls of the Great Enclosure undergo treatment.

A second issue arose, which concerned the appearance of the wall tops. Over the years, the treated wall tops had been prepared with increasingly large and smooth lime mortar surfaces, which were becoming

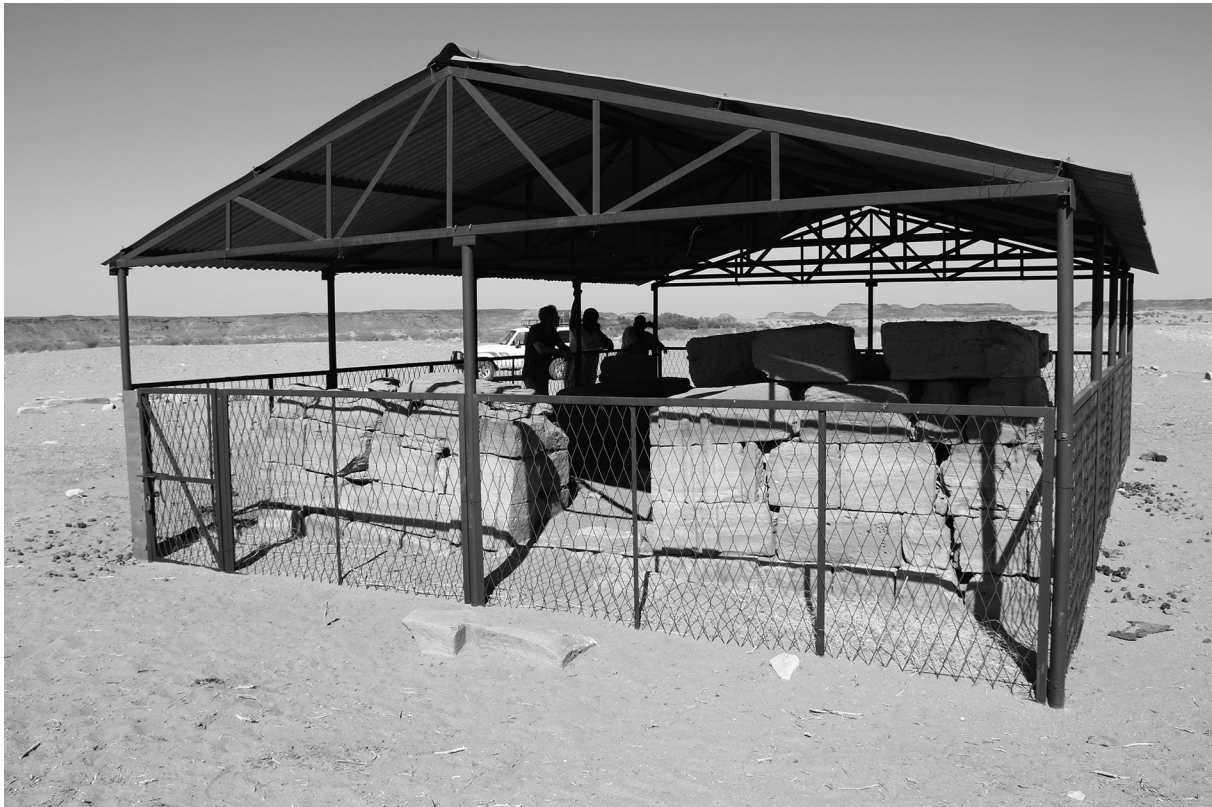
In the central part of the site of Musawwarat, Temple IIA, the Apedemak Temple (IIC) and the Great Hafir (IIH) received special attention. In respect to Temple IIA, it was noted that its protective roof, installed in 1996,<sup>33</sup> only partially served its intended function of protecting this small structure from the impact of rain water. The metal fence surrounding the temple and the support beams for the protective metal roof were set too close to the walls of the building and in consequence, the roof is not ample enough (Fig.4). The temple had filled with airborne sand over time and small sand dunes had accumulated along the outer walls of the building. Rain water reached these sand accumulations, which stored the water and created a moist environment for the sandstone blocks of the temple's walls. Rapid deterioration of the sandstone resulted. Reed mats, which had been attached to the temple's metal fence for many years

Fig. 4: Temple IIA with its protective roof and fence (photo: Cornelia Kleinitz).

and sheltered its interior to some extent, may have added to the creation of a moist environment within the roofed area. In order to preserve Temple IIA in the longer term it will need to be cleaned from sand as much as necessary – a measure that in the future should be part of regular site upkeep – and the roof will need to be extended, or the temple should be buried in a protective shell.<sup>34</sup>

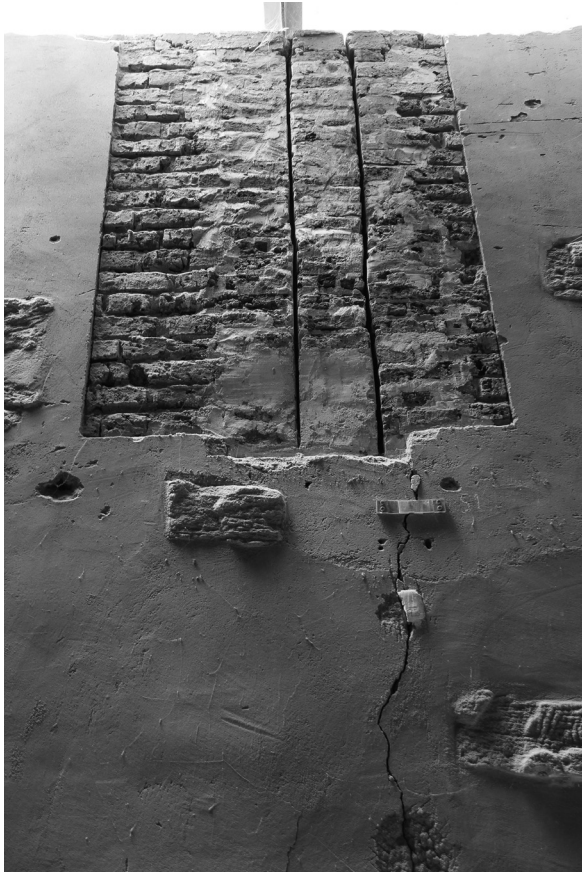
Fig. 5: Section of missing plaster on the inner south wall of the Apedemak Temple (photo: Cornelia Kleinitz).

In regard to the Apedemak Temple, several short-term conservation measures were listed. In the interior of the temple, large sections of the plaster had been removed from the side walls during the repairs of the temple's roof during the 2014/15 season, exposing the bricks that form the upper parts of the restored walls (Fig. 5).<sup>35</sup> The plaster will need to be re-applied and the exposed areas closed. Repairs of plaster are also necessary in smaller sections of the northern and in larger sections of the western outer walls of the temple due to the deterioration of the plaster over time (Fig. 6, Colour fig. 5).

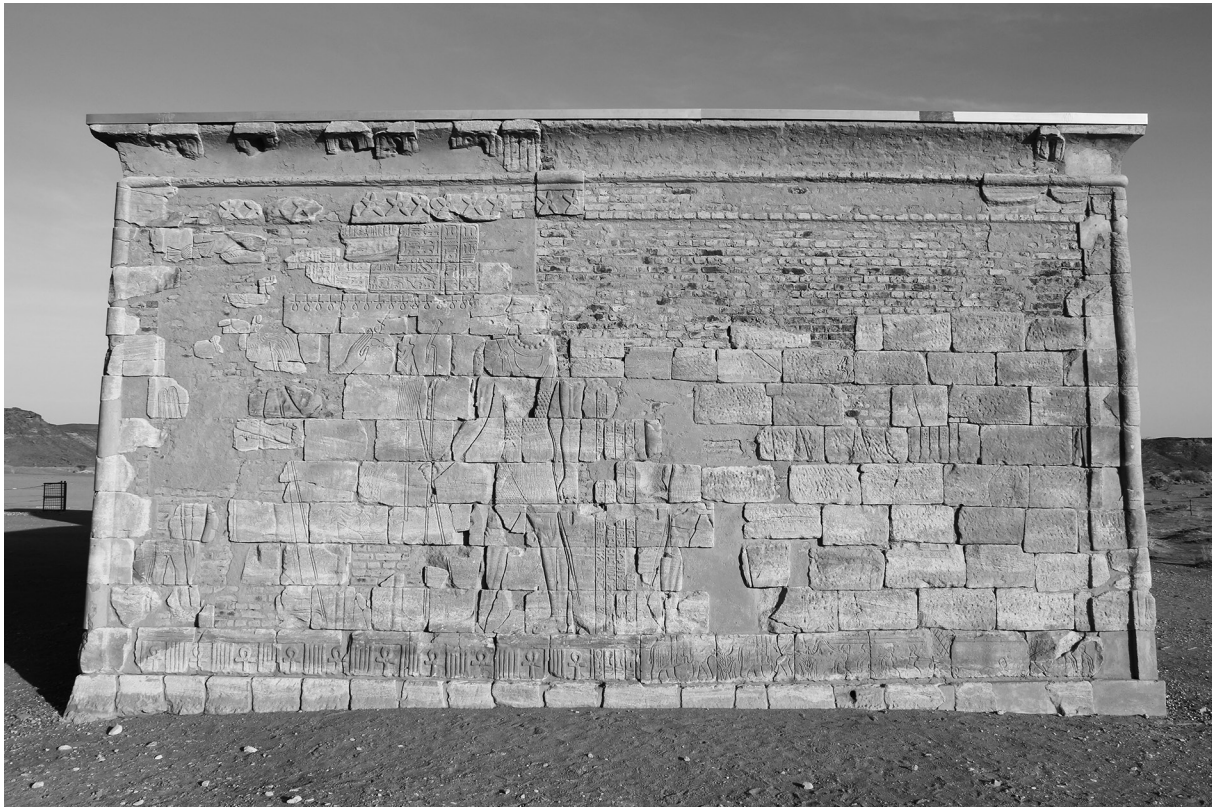
Fig. 6: Section of missing plaster on the outer west wall of the Apedemak Temple (photo: Cornelia Kleinitz).

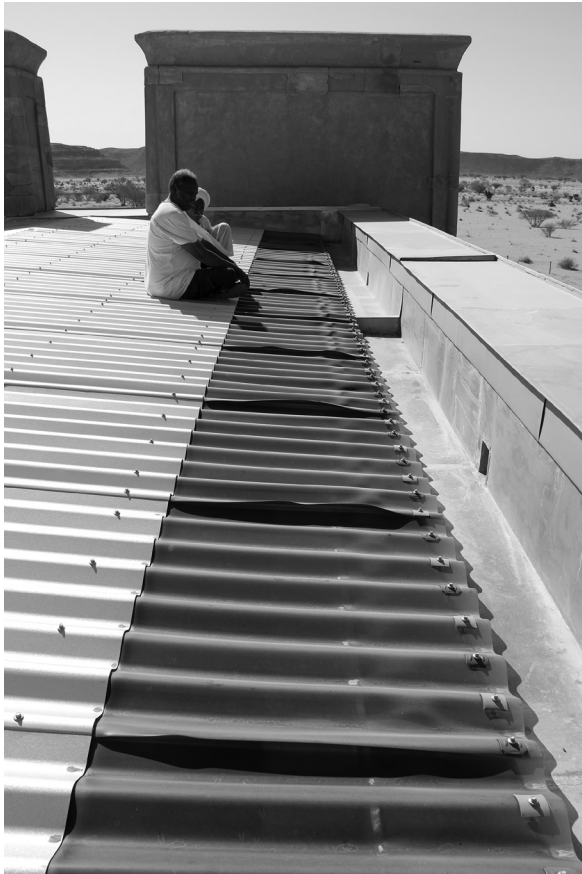
Fig. 7: Deformed PVC sheets from the light slits along the sides of the Apedemak Temple's roof (photo: Cornelia Kleinitz).

to the monument in the near future. Damage concerned especially the transparent polyvinylchloride (PVC) sheets, which had been employed as roofing sheets along both side walls of the temple, allowing light to enter its interior. As they were not able to withstand the high temperatures that develop on the roof of the temple, the PVC-sheets had deformed and gaps had formed between the sheets, permitting the wind to catch and allowing water to enter the interior of the temple (Figs. 7 and 8). The PVC-sheets had also lost much of their translucency and taken on a dark brown colour, which negatively impacted their function as light sources for the temple's inte-

a stable connection and had detached on both pylon towers (Fig. 11). Altogether, the damage to the roof as just described necessitates the replacement of the PVC-sheets with a more durable translucent material as well as repairs to other parts of the roof in a manner that can withstand the local conditions.

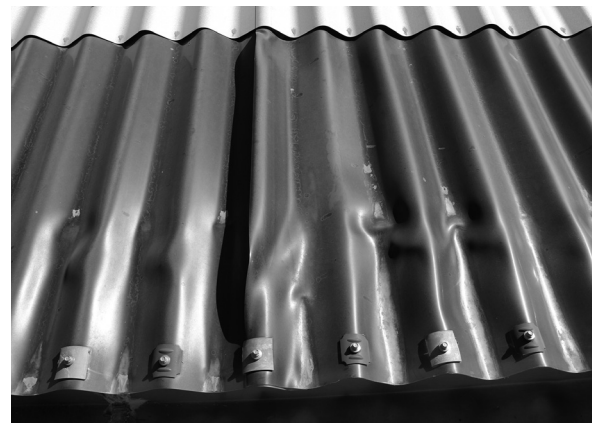
Fig. 8: Deformed PVC sheets on the Apedemak Temple's roof (photo: Cornelia Kleinitz).

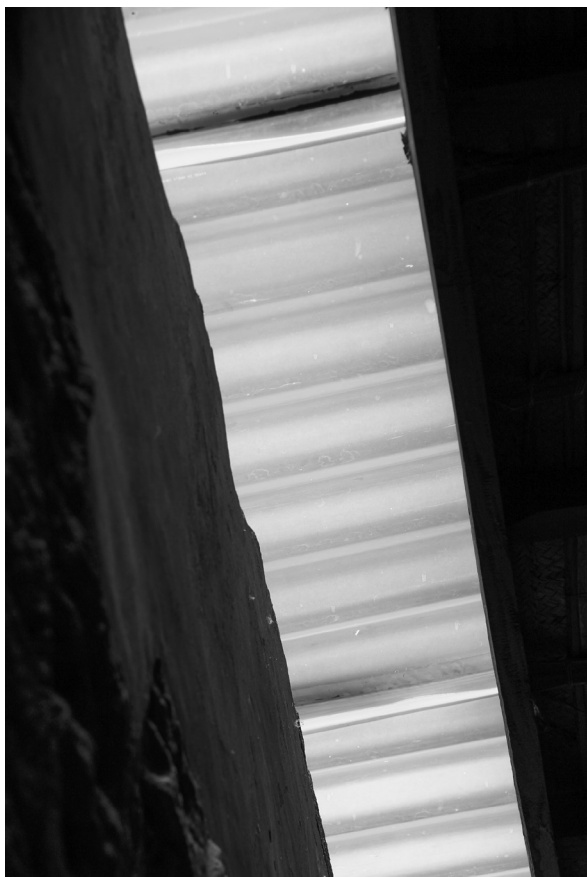
Fig. 9: Loss of translucency in the PVC sheets from the light slits of the Apedemak Temple's roof (photo: Cornelia Kleinitz).

rior (Fig. 9). A second problem concerned the cold welded seams that connect the new zinc sheets on the parapet of the roof, some of which had begun to open (Fig. 10). In view of strong mechanical tear due to severe changes in temperature and strong winds, it would have been preferable to first fold and interlink the sheets to give the connections more stability. A third problem concerned the attachment of the zinc sheets of the roof lining to the pylon, which lacked

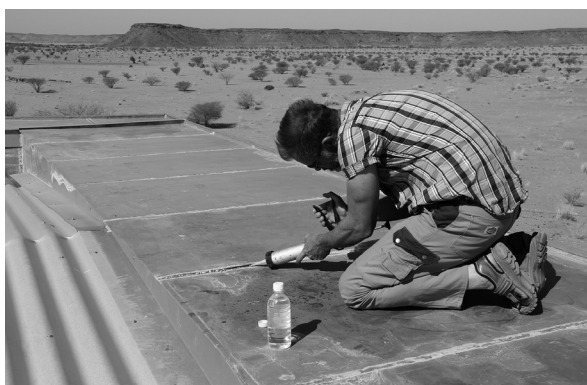
Fig. 10: Provisional repairs to the seams between the zinc sheets of the parapet of the Apedemak Temple's roof (photo: Cornelia Kleinitz).

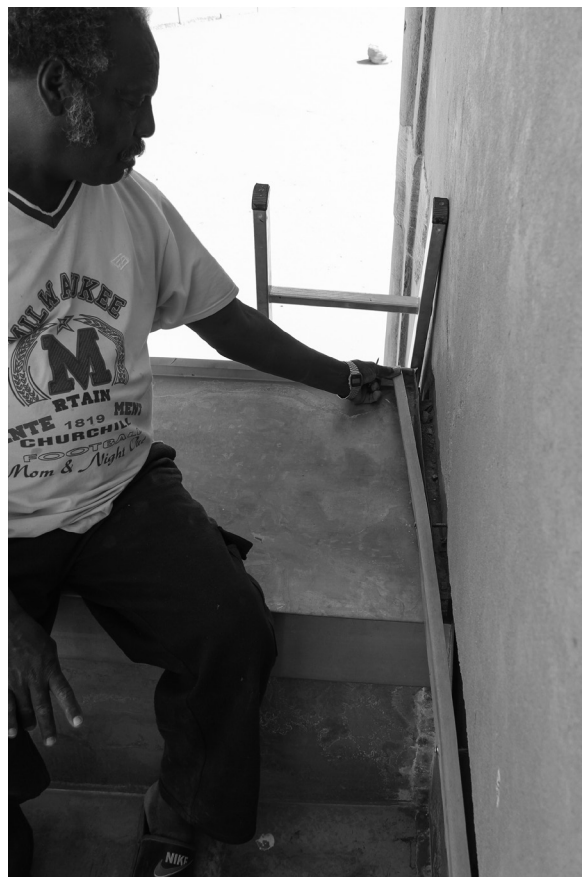
Fig. 11: Loose connection between zinc sheets of the roof and pylon of the Apedemak Temple (photo: Cornelia Kleinitz).

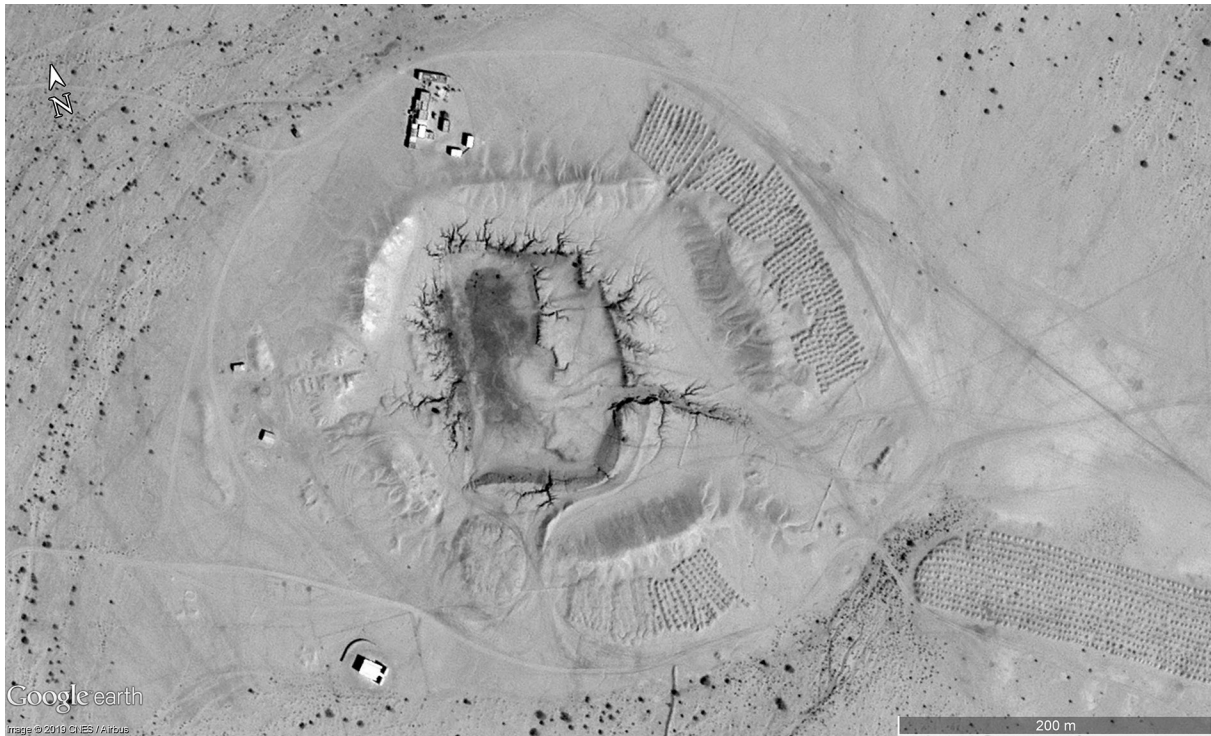
While the previously mentioned issues of conservation can be addressed with sufficient time and funding, the rapidly deteriorating condition of the Great Hafir was noted with great worry and its preservation deemed a possibly insoluble challenge. The erosion gullies that had formed along the edges of the area excavated illicitly by the Sudan Civilization Institute (SCI) between 2003 and 2006<sup>37</sup> have grown in length, width and depth to an extent that the original *hafir* lining – and no longer ‘only’ the sediment that had collected in the reservoir over the past two millennia – was going to be impacted during the next strong rains (Figs. 12 and 13). Having already lost the climate archive preserved in the sediments of the Great Hafir, the loss of the *hafir*'s built structure would spell the end to this largest of the ancient Sudanese water reservoirs.

Fig. 12: Deep erosion gullies along the excavated interior of the Great Hafir in 2016 (image: Google Earth).

Ideas for the prevention of the collapse of the Great Hafir's structure included the construction of channels and barriers along the slopes of the reservoir's walls, but it is clear that this would address only parts of the problem. The preservation of the Great Hafir is a challenge that would need to involve structural engineers and environmental specialists in addition to conservators, and the scale of this preservation project exceeds the capacities of the Musawwarat Project. Whatever approach is eventually taken, it must involve local consultation.

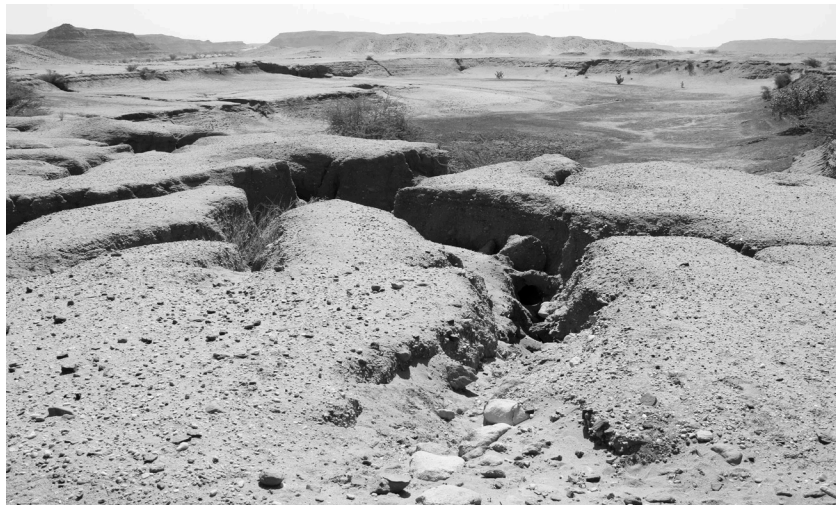
Fig. 13: Deep erosion gullies in its northwestern section of the Great Hafir (photo: Cornelia Kleinitz).

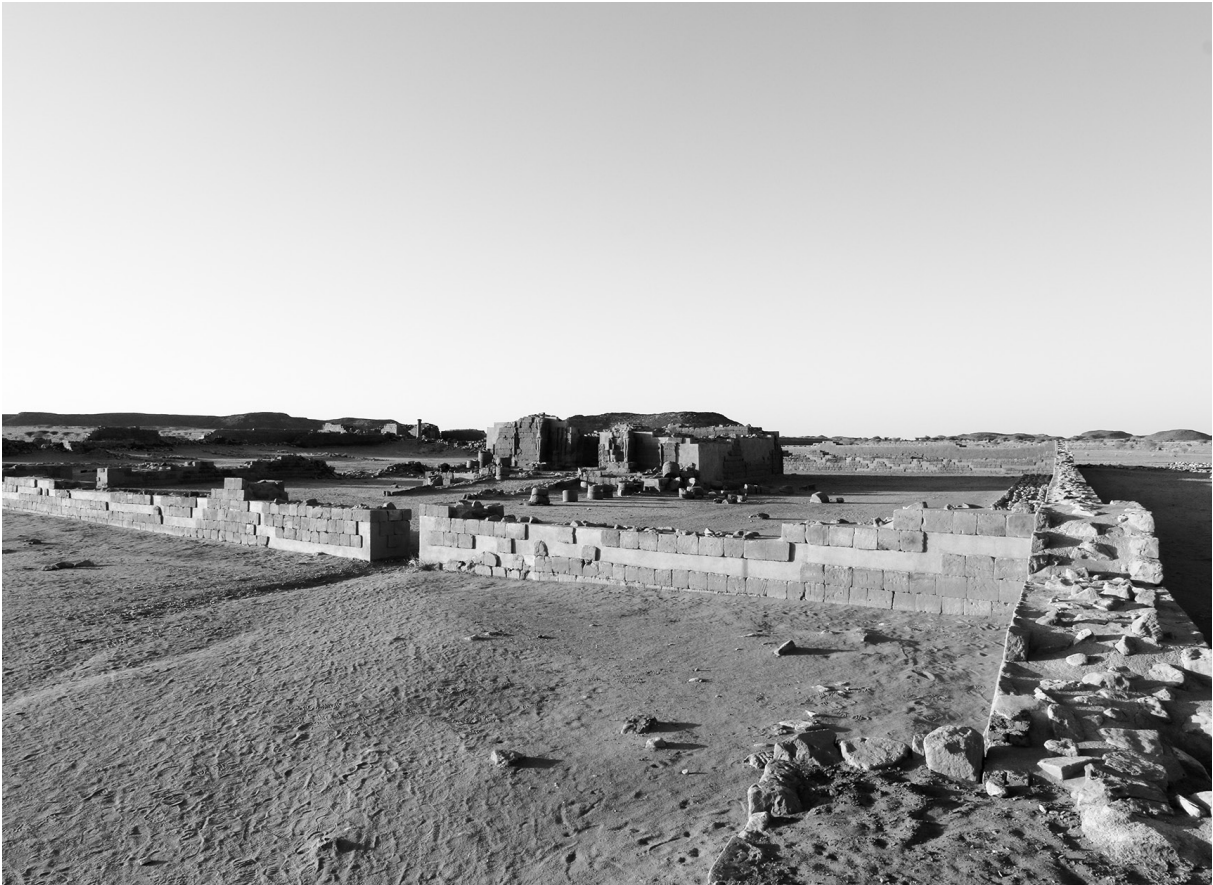
Fig. 15: Restored sections of Complex 300 with Temple 300 (photo: Thomas Scheibner).

yards<sup>38</sup> – are followed (Fig. 15). A central aspect of the Conservation Master Plan was dedicated to outlining short-term conservation work that would need to accompany the development of a basic tourist infrastructure and a visitor guidance system for Musawwarat. On the basis of previous work as described above, a visitor path was outlined, with the plans to be adjusted and implemented during the 2017/18 and 2018/19 field seasons.<sup>39</sup>

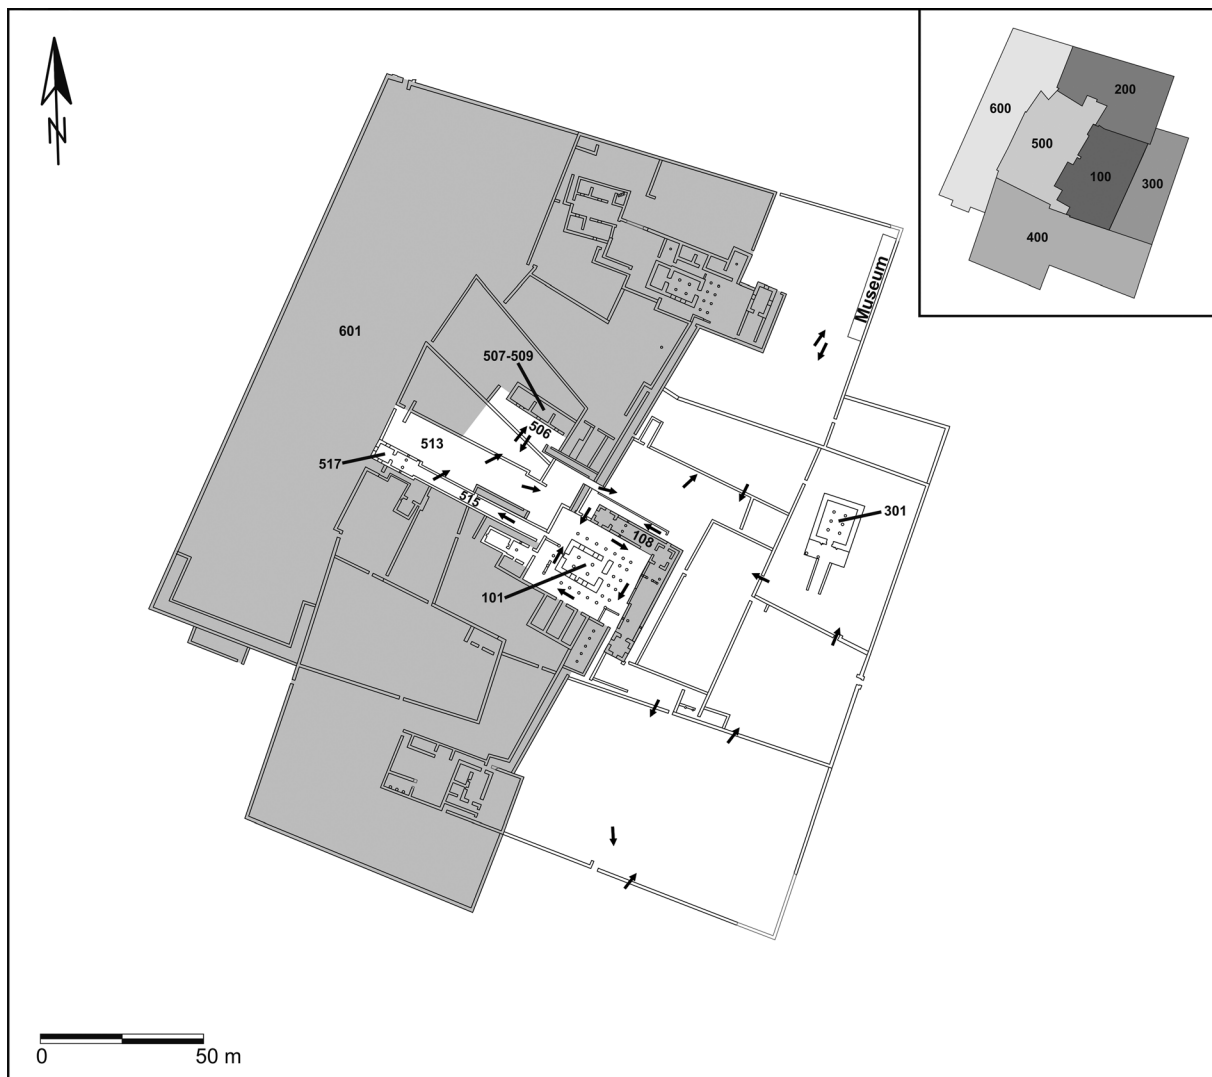
Fig. 16: Planned accessibility of the Great Enclosure (white: accessible, grey: inaccessible) and directions of visitor movement (graphics: Jorge de Torres Rodriguez).

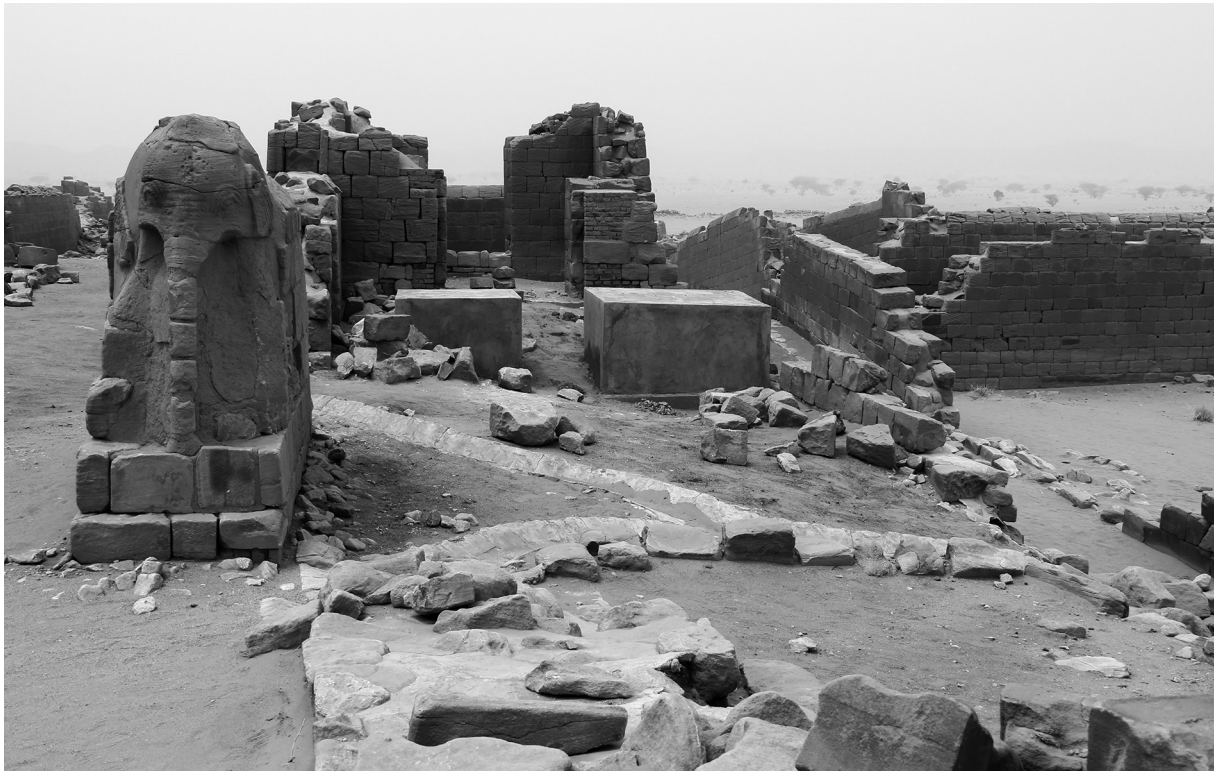
Fig. 17: Modern water drainage channels in the northeastern part of the Central Terrace behind the elephant wall end in room 108 as well as brick enclosures for decorated column bases (photo: Cornelia Kleinitz).

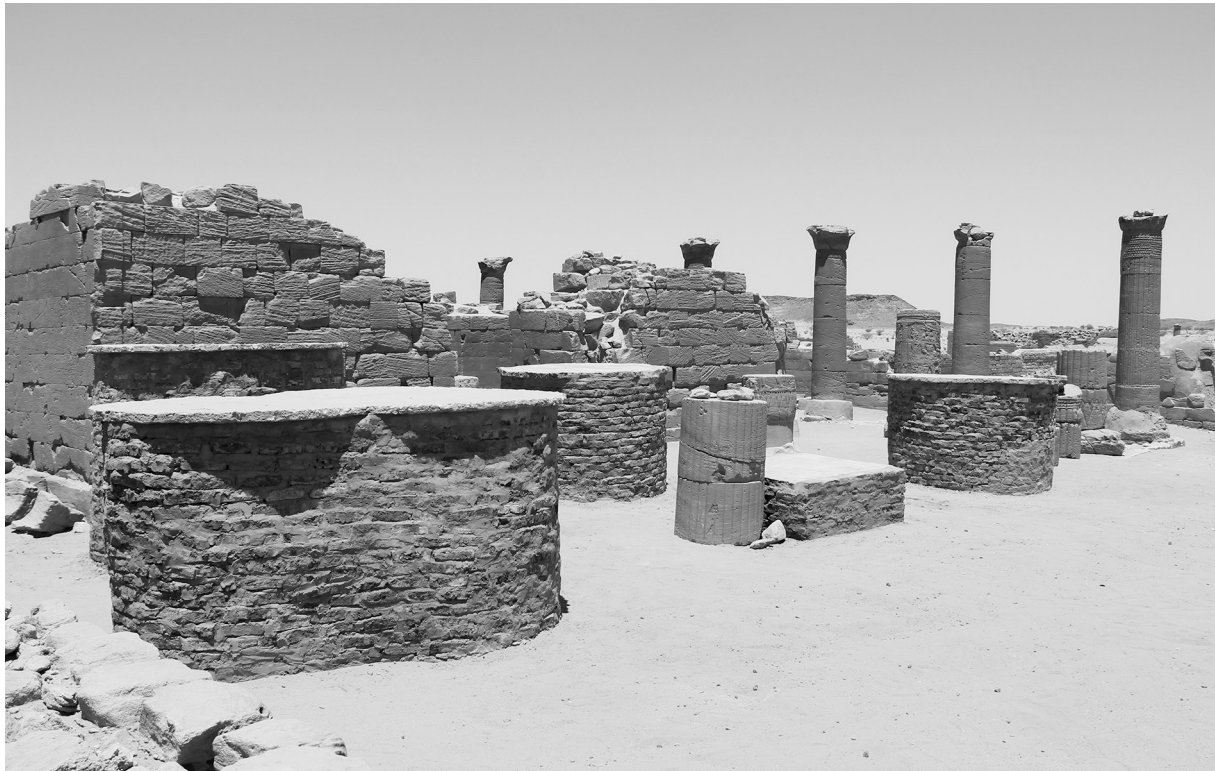
Fig. 18: Brick enclosures protecting the decorated Early Meroitic columns in room 102 in front of the Central Temple of the Great Enclosure (photo: Cornelia Kleinitz).

architectural elements with unique relief decoration from the Early Meroitic period had been covered with protective brick enclosures since the mid-1990s as a temporary measure because of the fragility of the local sandstone that was used as building material (see Fig. 18).<sup>41</sup> In an attempt to preserve these extraordinary pieces while also including them into the visitor experience, the columns had in recent years begun to receive attention in form of 3D-scanning tests,<sup>42</sup> as well as the testing of conservation approaches and treatments.<sup>43</sup> A full conservation assessment and plan was drafted in early 2015.<sup>44</sup>

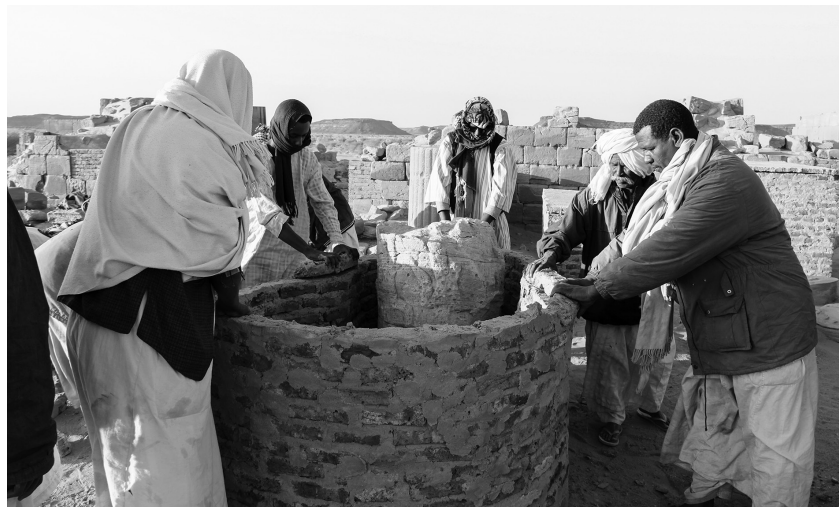
Fig. 19: Demolition of brick enclosure protecting parts of column 5 (photo: Cornelia Kleinitz).

Supported kindly by Karl-Heinz Priebe, the systematic treatment of the column drums and bases was begun in the 2016/17 season, with the aim of eventually rehabilitating the heavily visited area in front of the Central Temple and the northeastern part of the Central Terrace.<sup>45</sup> The brick enclosures of several column drums and bases were demolished and the columns cleaned (Figs. 19 to 21). As part of

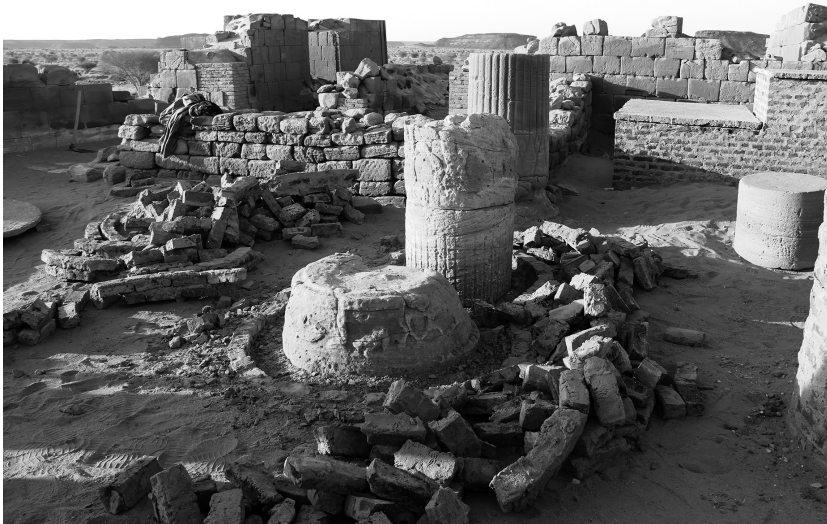
Fig. 20: Drums and base of column 5 with demolished brick enclosure (photo: Cornelia Kleinitz).

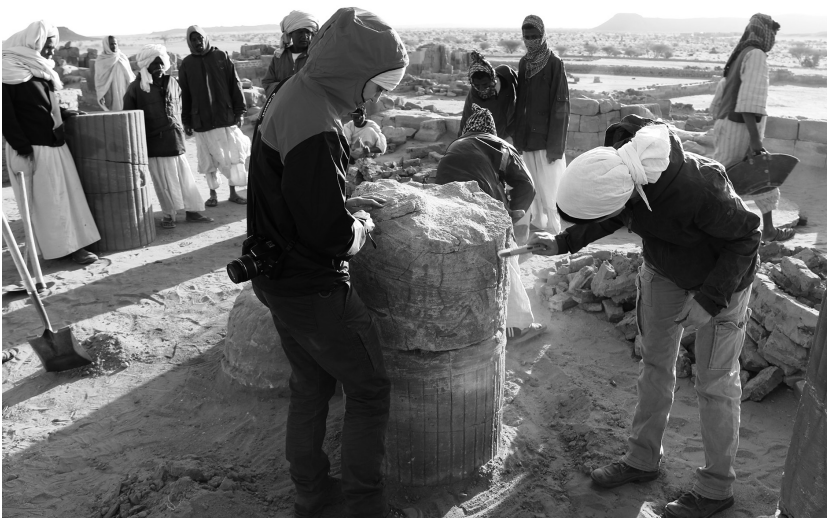
Fig. 21: Cleaning of column 5 by the conservation team (photo: Cornelia Kleinitz).

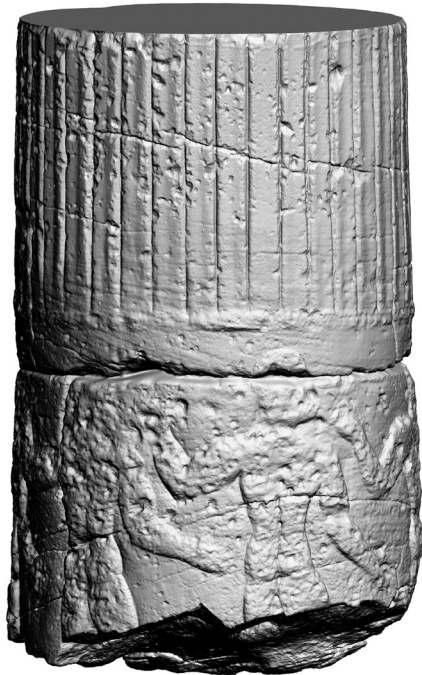
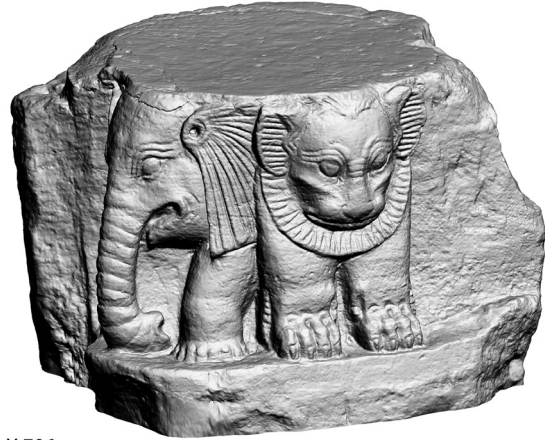
102 Säule5 Trommel1-2

X 671 mm  
Y 662 mm  
Z 1072 mm

Volumen: 0.32 m<sup>3</sup>  
Oberfläche: 2.53 m<sup>2</sup>

X 706 mm  
Y 622 mm  
Z 478 mm

Volumen: 0.14 m<sup>3</sup>  
Oberfläche: 1.42 m<sup>2</sup>

Fig. 22: 3D-model of two drums of column 5 with its frieze of 'dancing young men' (image: Thomas Bauer, TrigonArt).

the 3D-documentation of the columns structured light scanning was applied. 3D-modelling was subsequently completed for several drums and bases from columns 3, 4, 5, 7, 8, 9 and 10 in room 102 (Fig. 22) as well for two column bases from room 108 (Fig. 23). Since they were in a very poor state of preservation due to the sandstone having lost much of its integrity, two column drums from column 5 and the two bases in room 108 were consolidated using a colloidal silica solution (Remmers KSE 300) (Fig. 24 and see Figs. 1, 22 and 23).<sup>46</sup> The consolidation with

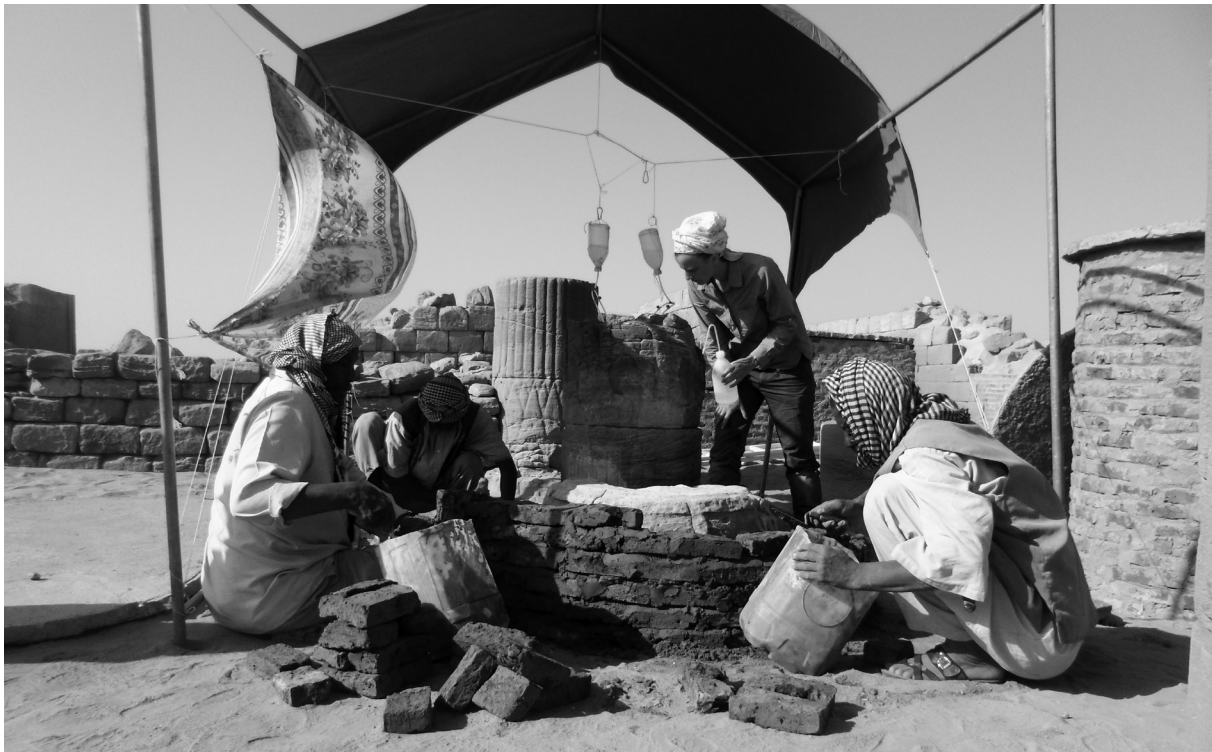
Fig. 24: Conservation of column 5 in progress: Infusion and flooding of column drums with colloidal silica solution (photo: Alfatih Mohamed Ali Saeed).

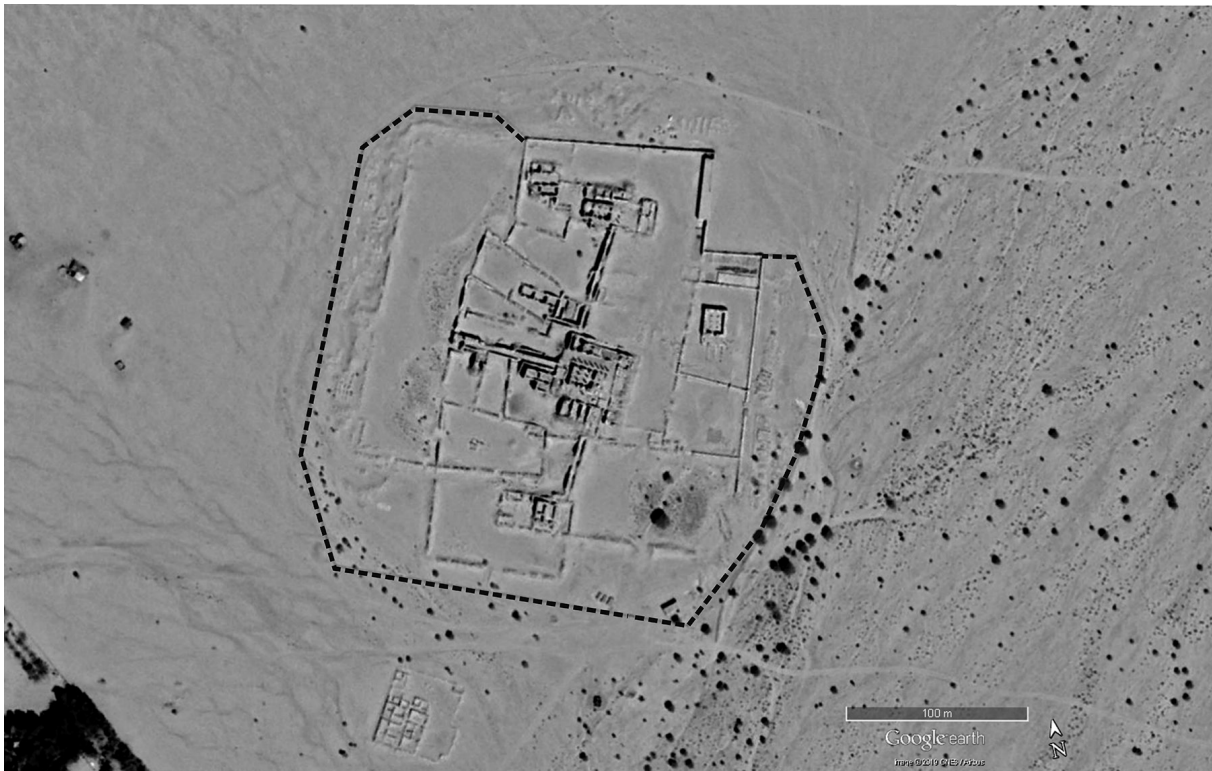
Fig. 25: Google Earth image of the Great Enclosure with the outline of the fence marked (image: modified from Google Earth).

The path of the fence was finalised to extend 12.50 m to the north and south of the northern and southern outer walls of the Great Enclosure, respectively, and 25.00 m to the west of the western outer wall of the Great Enclosure. On the eastern side of the Great Enclosure the fence follows the outline of an artificial platform that was created in past years to protect the monument from the waters of the Wadi es-Sufra (Fig. 25).

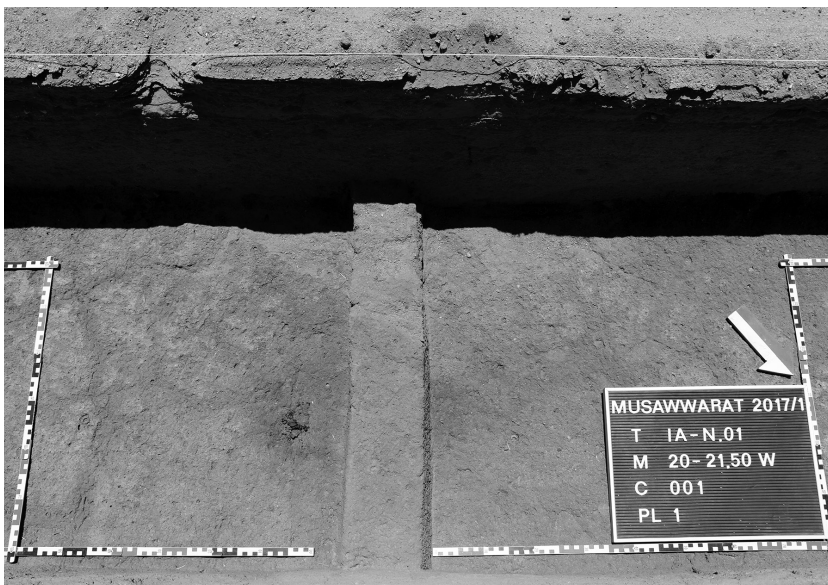
Fig. 26: Fire pit in survey trench IA-N.01 to the north of the Great Enclosure (photo: Thomas Scheibner).

In preparation for the setting of the fence, several block deposits to the west of the Great Enclosure were shifted minimally to clear its path. To the northwest of the Great Enclosure a survey trench (IA-N.01) with a length of 40.00 m and a width of 1.00 m was dug down to the natural soil. Finds and findings involved a) one small fire pit, filled with greyish, ashy sandy-silty material, containing larger amounts of charcoal (Fig. 26), and b) two fragments

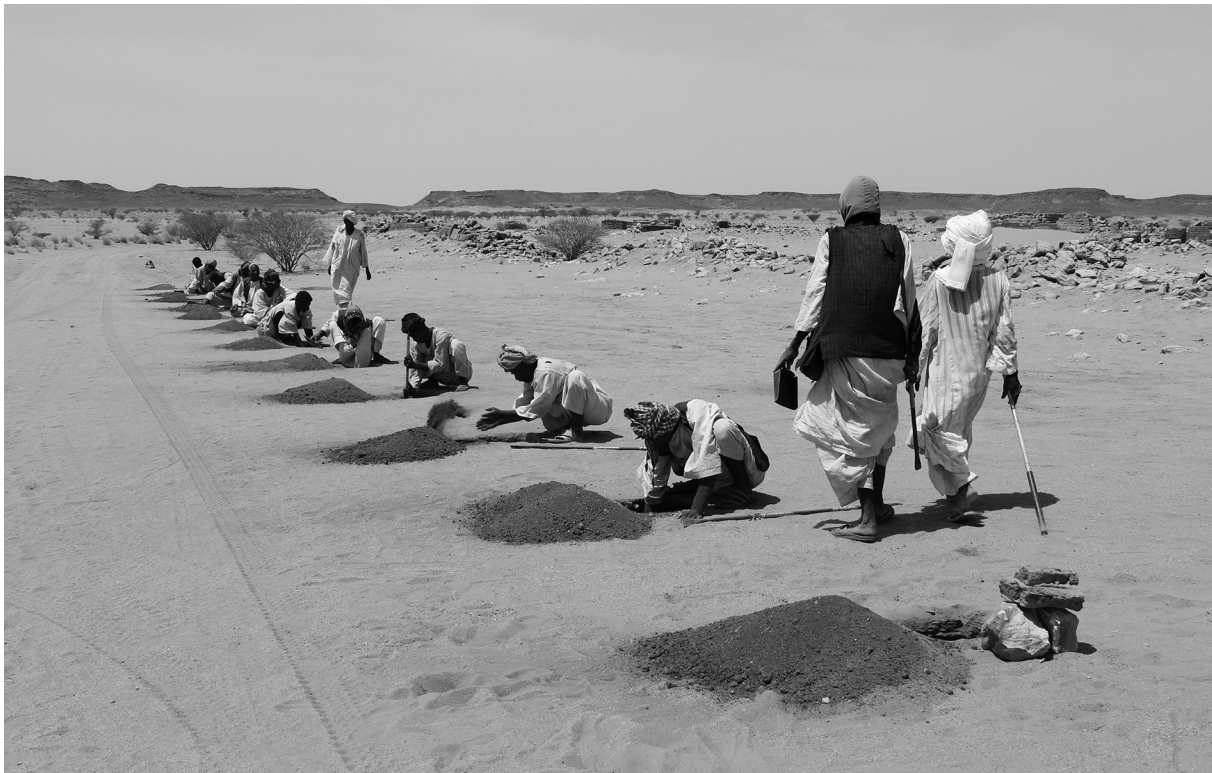
Subsequently, 346 foundation pits with a dimension of 35 x 35 cm and depth of 40 cm were dug for the poles of the fence as well as the support poles for the gates, corners and other

Fig. 27: Digging the foundation pits for the poles of the fence to the south of the Great Enclosure (photo: Cornelia Kleinitz).

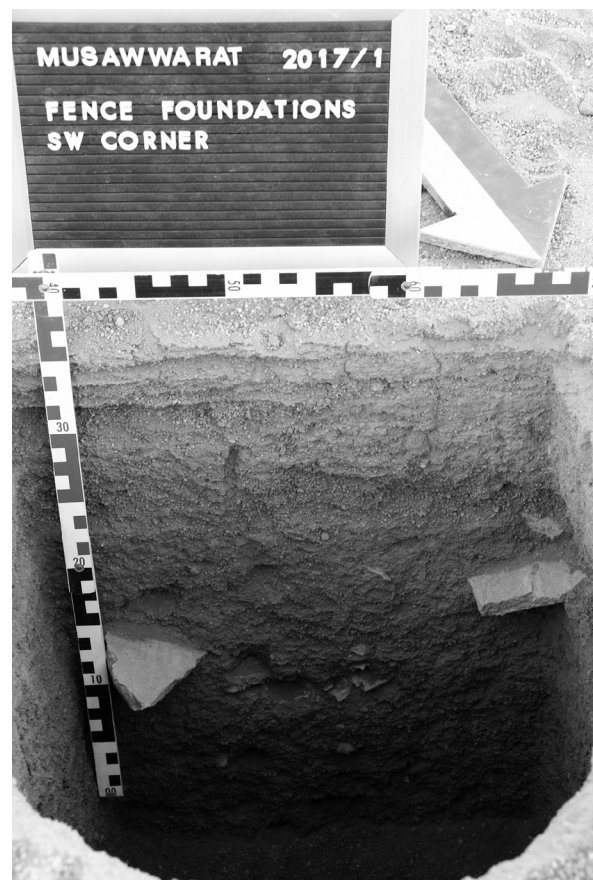
Fig. 28: Pit with ash and potsherds in the foundation hole of the corner pole of the fence to the southwest of the Great Enclosure (photo: Thomas Scheibner).

reinforcements (Fig. 27). They were archaeologically investigated as far as possible. Due to the careful planning of the fence's outline – no fence poles were set in immediate proximity to the walls of the Great Enclosure, except where excavations had already taken place in the past – very few archaeological features were encountered. Finds and findings include a pit with ashy fill and numerous wheel-thrown Meroitic potsherds in the foundation hole of the southwest corner pole of the perimeter fence, starting 15 cm below the present surface and extending down to a depth of 40 cm (Fig. 28). The dimensions of this pit were not entirely revealed since it stretched beyond the limits of the foundation pit and the excavation area could not be extended due to a lack of time. The area in which the pit was found is located between the Great and Small Enclosures and known from previous excavations for its settlement remains.<sup>48</sup>

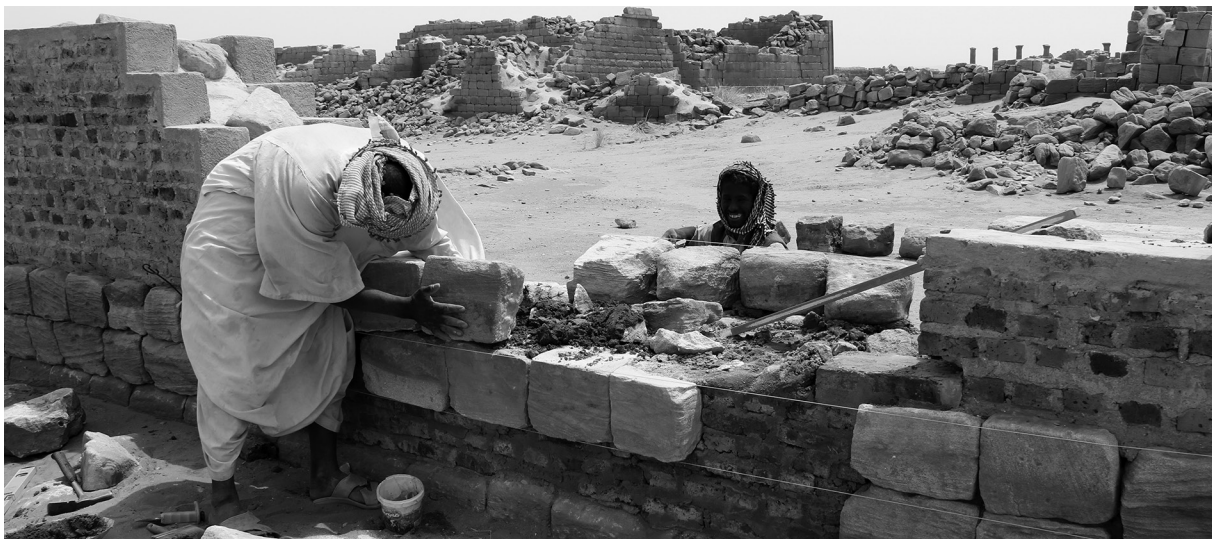
The mesh wire fence measures 770.40 m in length and encloses the entire Great Enclosure, except where the enclosure walls are of sufficient height to prevent unchecked entry, such as in its northern part. One section of the restored northern wall of the Great Enclosure, which did not have the height required, was closed with a plastered brick wall and sandstone building blocks (Fig. 29).

Fig. 29: Increasing the height of a section of the northern enclosure wall of the Great Enclosure (photo: Cornelia Kleinitz).
