CORNELIA KLEINITZ

# THE 2016/17 FIELD SEASON AT MUSAWWARAT ES-SUFRA (SUDAN): FROM CONSERVATION PLANNING, APPLIED CONSERVATION AND PROTECTION MEASURES TO ARCHAEOLOGICAL AND SOCIAL ANTHROPOLOGICAL RESEARCH

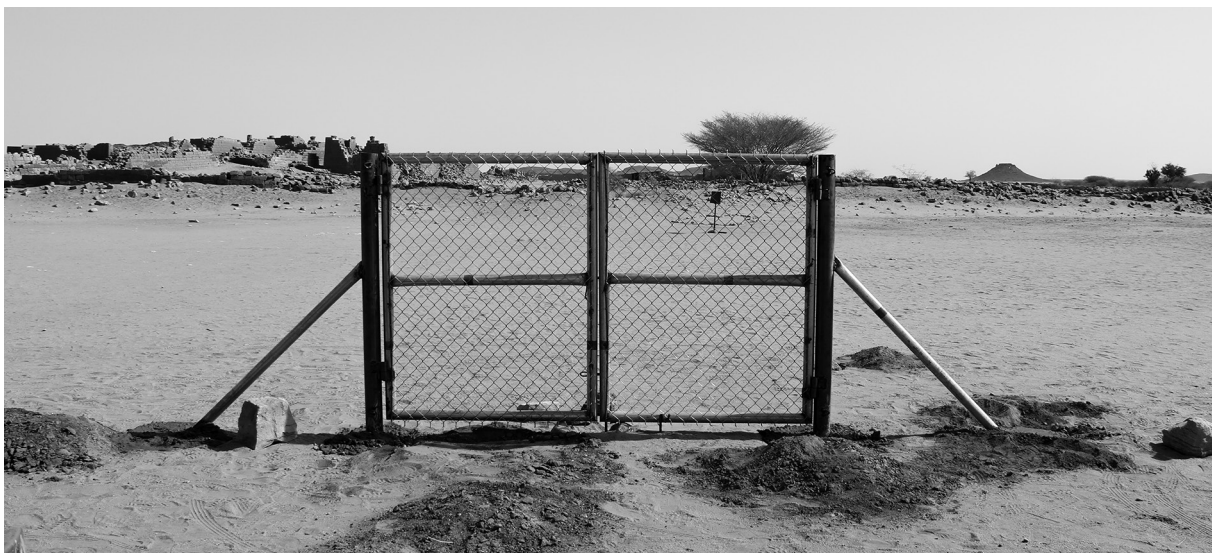
Fig. 30: Main (visitor) gate of the fence for the Great Enclosure immediately after installation (photo: Cornelia Kleinitz).

mesh; or the construction of more adequately sized foundations with a more durable concrete mixture. However, as the fence could only be installed by a contractor at the very end of the field season, adjustments were not possible.

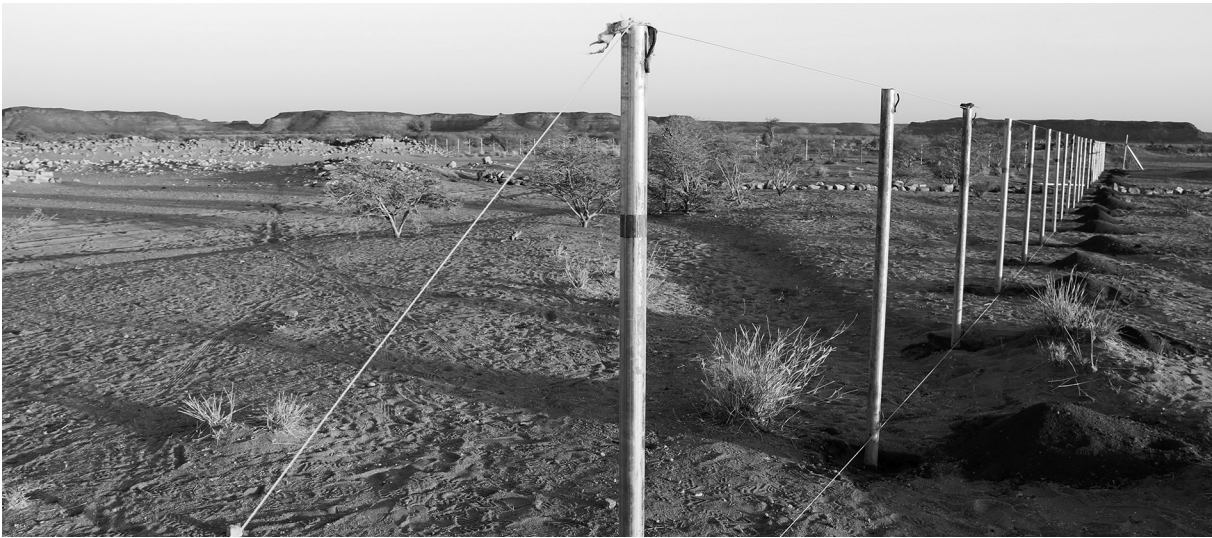
Fig. 31: Metal poles on the western side of the Great Enclosure during the construction of the perimeter fence (photo: Cornelia Kleinitz).

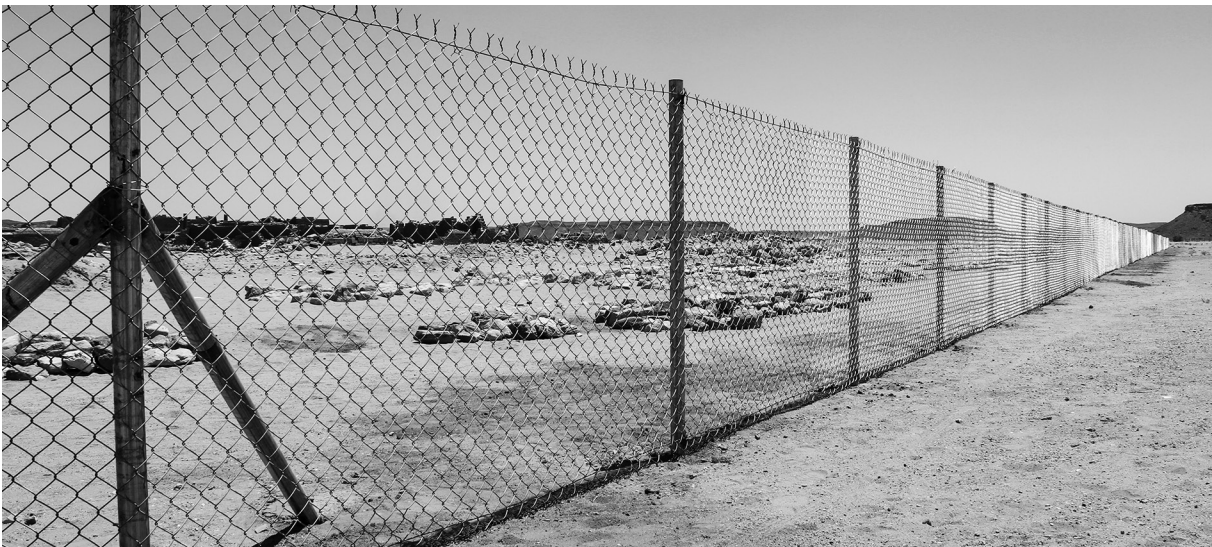
Fig. 32: Western side of the fence of the Great Enclosure after the completion of work (photo: Cornelia Kleinitz).

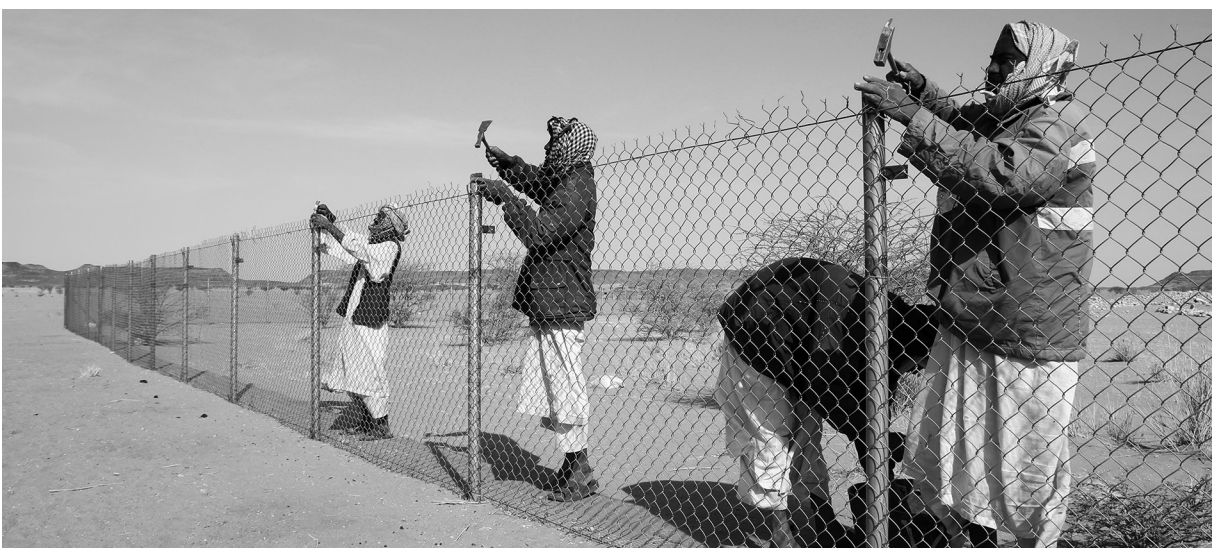
Fig. 33: Closing of the tops of the metal fence poles during the 2017/18 season (photo: Cornelia Kleinitz).

At the next opportunity, i.e. early in the 2017/18 field season,<sup>49</sup> the upper openings of the metal poles were closed with concrete caps to prevent rainwater from collecting inside the poles and corroding the metal, and the mesh was fastened to the upper and lower horizontal wires in multiple instances to increase the stability of the fence (Fig. 33). At that point it had become already apparent that the fence was functioning as hoped for and that its installation indeed helps to protect the Great Enclosure.

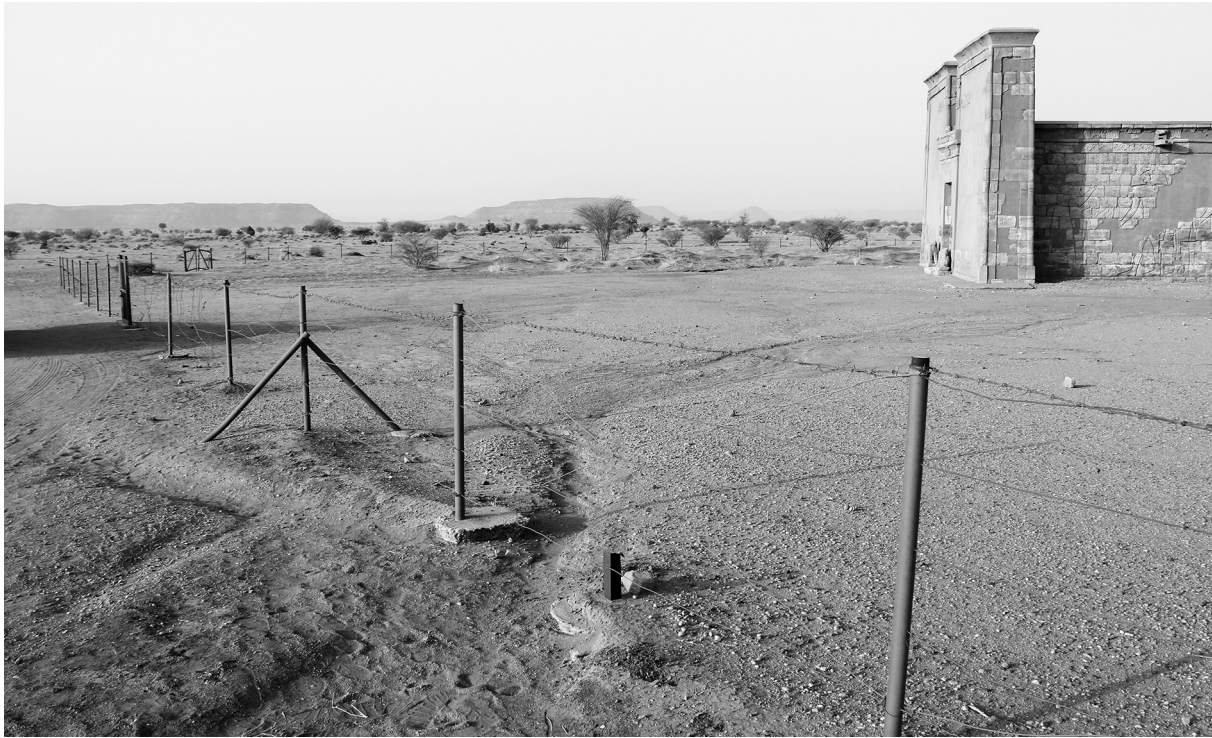
Fig. 34: Erosion gullies in the vicinity of the Apedemak Temple (photo: Cornelia Kleinitz).

After the 2015/16 field season had to be cancelled due to an interruption of funding, which resulted also in the interruption of regular basic maintenance activities at Musawwarat, the 2016/17 field season put significant effort into the upkeep of the site. At the Apedemak Temple, the severe rain of the 2016 rainy season had washed out some of the foundations of its perimeter fence and erosion gullies had formed in the immediate vicinity of the temple (Fig. 34). The fence's foundations were subsequently covered again and the gullies blocked with gravel (Fig. 35).

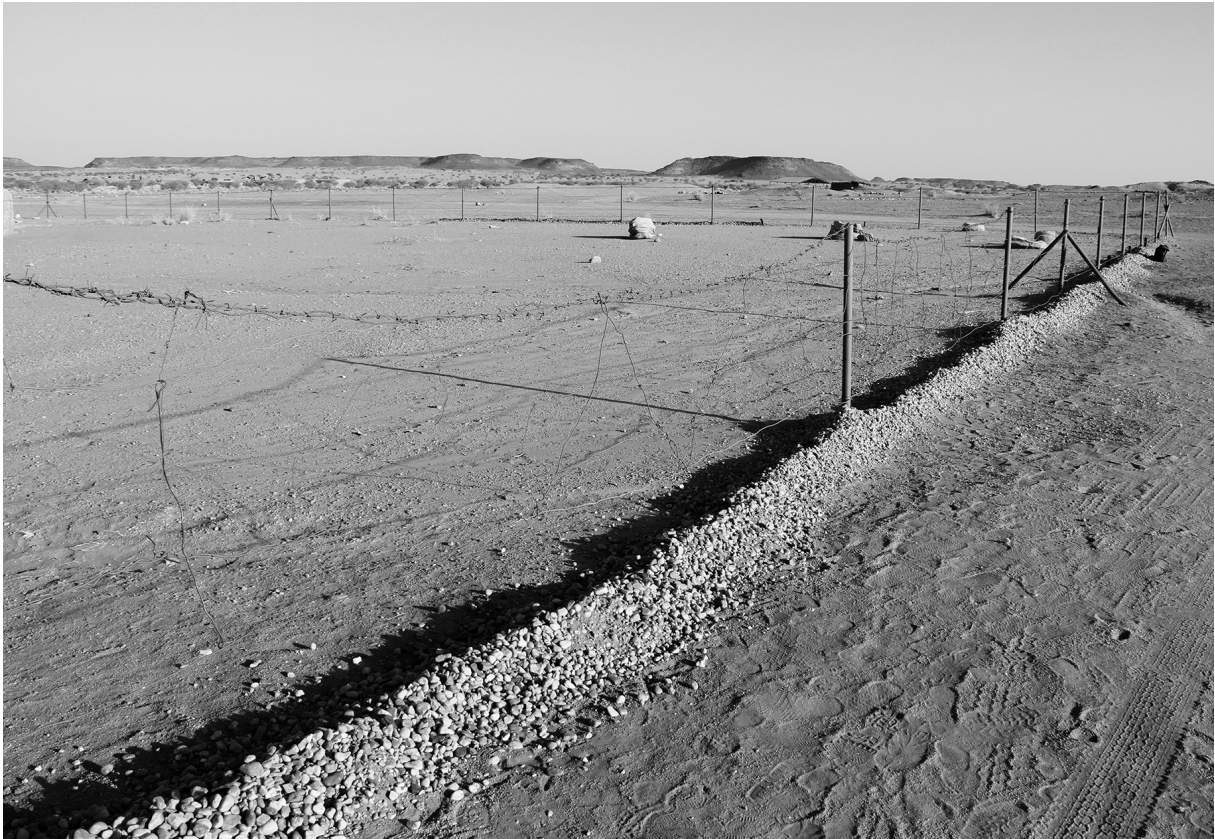
Fig. 35: Fence of the Apedemak Temple after the filling of erosion gullies (photo: Cornelia Kleinitz).

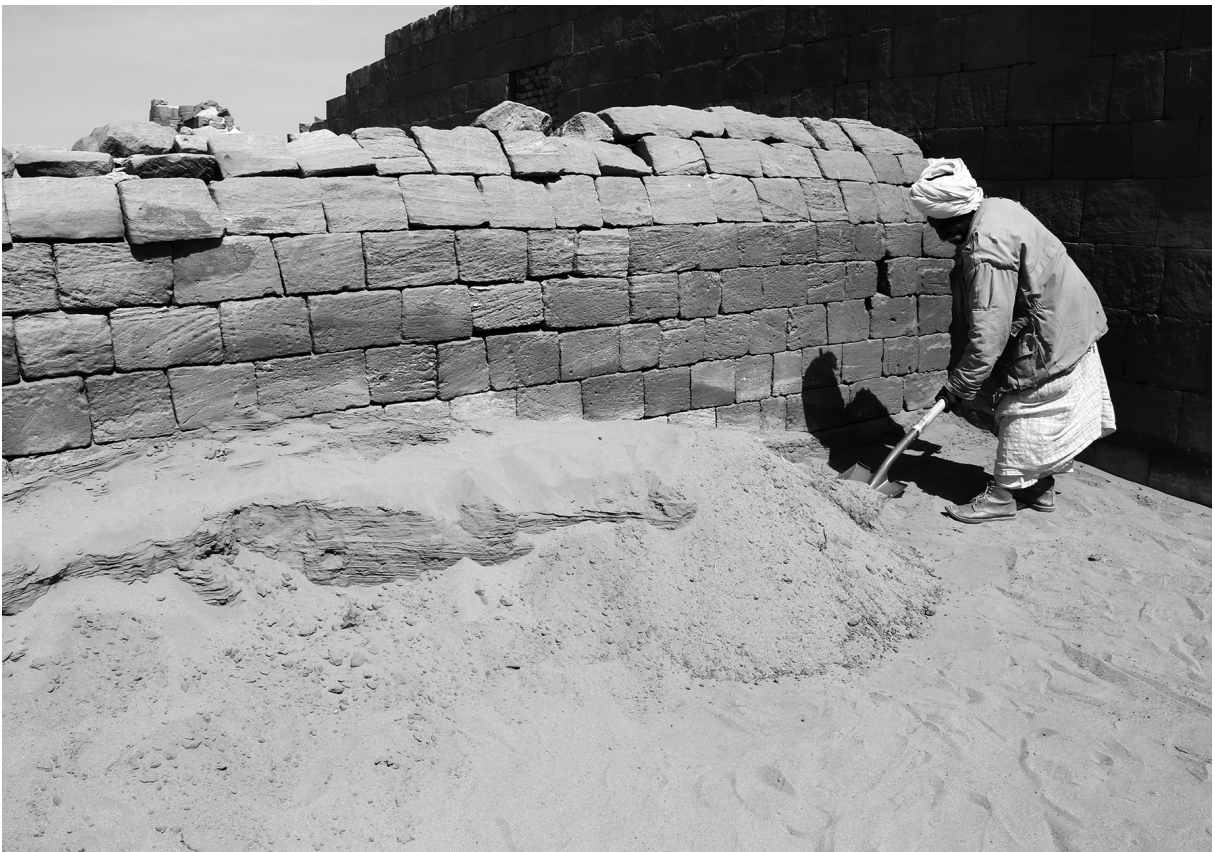
Fig. 36: Removing windblown sand in room 529 of the Great Enclosure (photo: Cornelia Kleinitz).

Several substantial sand accumulations had formed in the Great Enclosure, which were threatening to destabilise and/or otherwise damage some of its walls. Several of these large sand accumulations were removed from rooms 407, 501, 513, 528, 529 and along the northern wall of the Great Enclosure (Fig. 36). Basic maintenance work at the Great Enclosure also involved the cleaning of the Musawwarat Site Museum and of the objects on display. In preparation for the re-development of the museum in the 2017/18 and 2018/19 field seasons,<sup>50</sup> the building and its exhibits were photographically documented, providing the foundation for the development of a new exhibition approach.

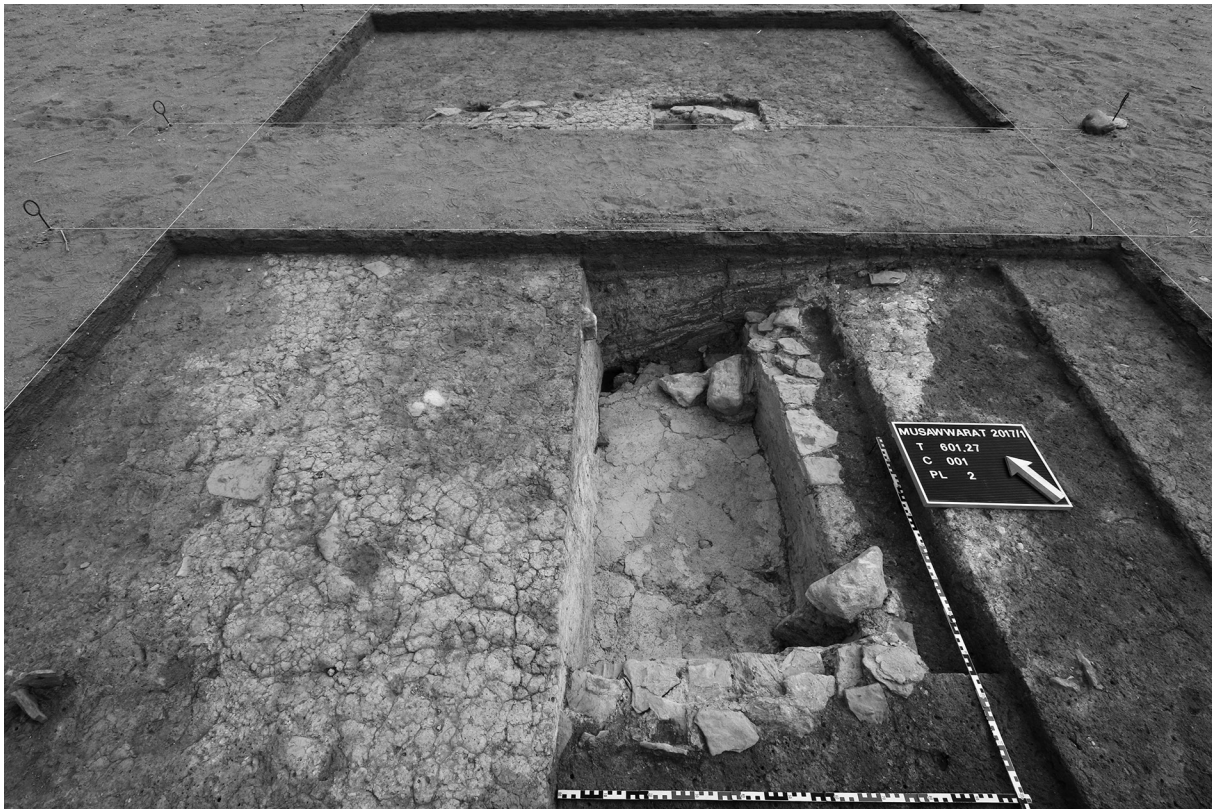
Fig. 37: Basin with whitish-grey fill in trenches 601.27 and 601.28 (photo: Thomas Scheibner, see also Scheibner 2017, Fig. 2).

The neighbouring trenches 601.27+28 had shown a strong magnetic anomaly (dipole) in the geophysical survey. The excavations of the 2016/17 field season revealed that this anomaly was caused by a basin, which was used either for mixing of lime mortar or for clay material preparation, possibly pottery production. The basin was cut into the ancient natural soil and its walls consist of ferricrete sandstone slabs, partially also of (re-used) sandstone blocks in the upper parts of its side walls (Figs. 37 and 38).

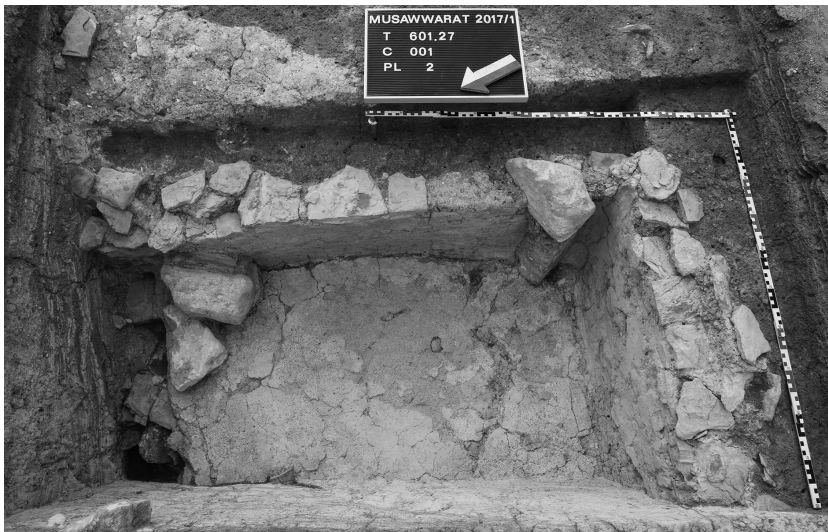
Fig. 38: Detail of southeastern corner of the basin in trenches 601.27+28 (photo: Thomas Scheibner).

The inner faces of the side walls and the bottom of the basin are lined with lime plaster of high quality. The basin is trapezoidal in plan, with an obtuse-angled northwestern corner due to a shorter wall on its western side. It is preserved to a depth of up to 40 cm. The inner dimensions of the basin are c. 3.10 m in length on its eastern side and c. 2.80 m on its western side, and 1.60 m in width. The ferricrete walls measure about 20 cm in width, which brings the outer dimensions of the basin to c. 3.50 m (only 3.20 m in the west) by c. 2.00 m. The whitish-grey fill
