THE CHIOSTRO DELLO SCALZO*

by John Shearman

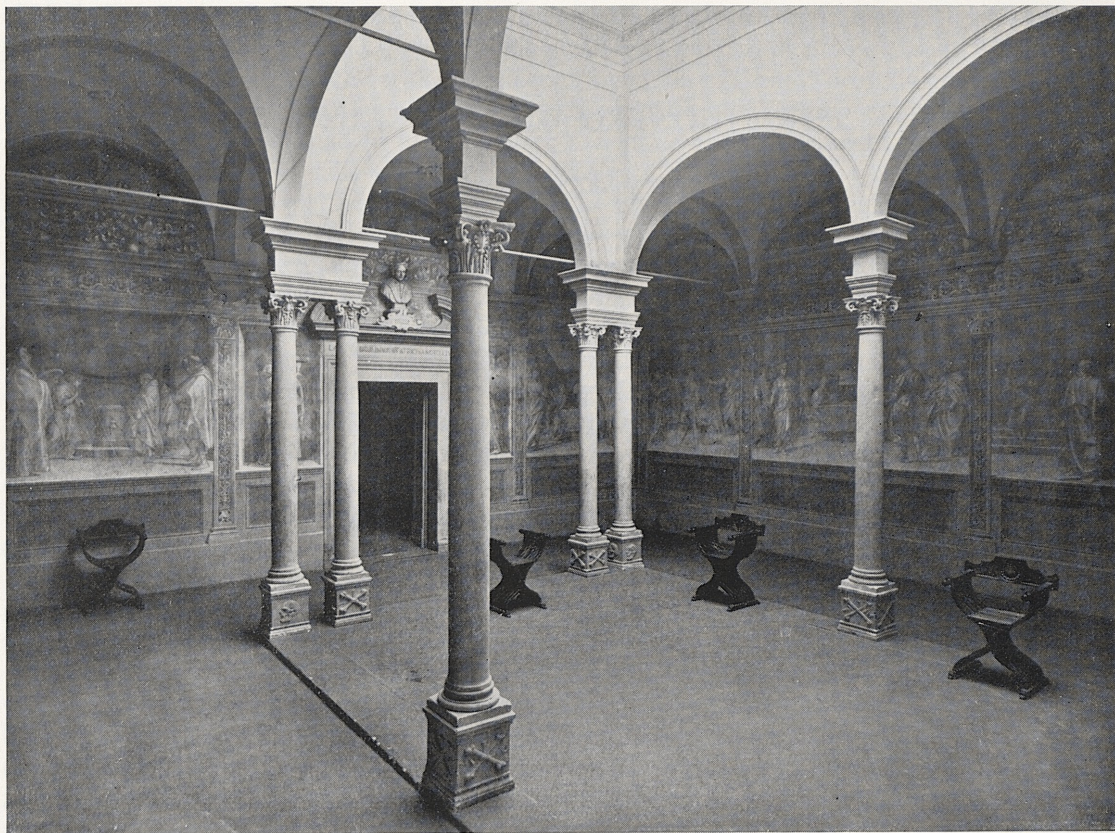
1 Chiostro dello Scalzo, present state.

The first problem is set by the style of the architecture itself (fig. 1). The latest possible date for the erection of the atrium of the Compagnia, within which Andrea del Sarto's frescoes were to be painted, is given by the approximate date for the first of these frescoes; at the latest, 1513 or 1514.³ In the early Cinquecento, no parallel can be found for the motif of the coupled columns in the corners of the colonnade; the device is rare, even in later centuries. From a different line of reasoning, the quality of the cutting itself, Paatz was led to conclude that the

further observation, that four of the columns, capitals and bases, do not belong to the original set, is also completely convincing when they are seen within the cloister; they are very close copies of the originals, but this cannot disguise their inferior quality. In the bases the crossed bones are fatter, softer, less tightly drawn, and in the capitals the acanthus and volutes are flabbier and cut with less precision. But, what happens if we follow up the conclusion that these were also added early in the eighteenth century? First, the double-dosseret coupling these four to the original corner-columns must also go⁵, and then everything that rests upon it; this will include the double arch which springs across from this point (figs. 1, 4) to the extended bracket on the shorter walls, above the *Virtues*. It is just conceivable that the outer arch of each pair might be original, and supported on the original corner-columns and a smaller bracket; but the unavoidable conclusion is that if the four inner columns are not original, then the whole of the cross-vault over each doorway (that is, the middle one of each shorter side) and the short barrel-vault supported on the dosserets, between the arches, are not original either (fig. 4). This argument may be taken further when we have examined the painted decoration, but at this stage it is also clear that the wall supported on the columns, at least on these shorter sides, must either have been very different or non-existent (fig. 1).

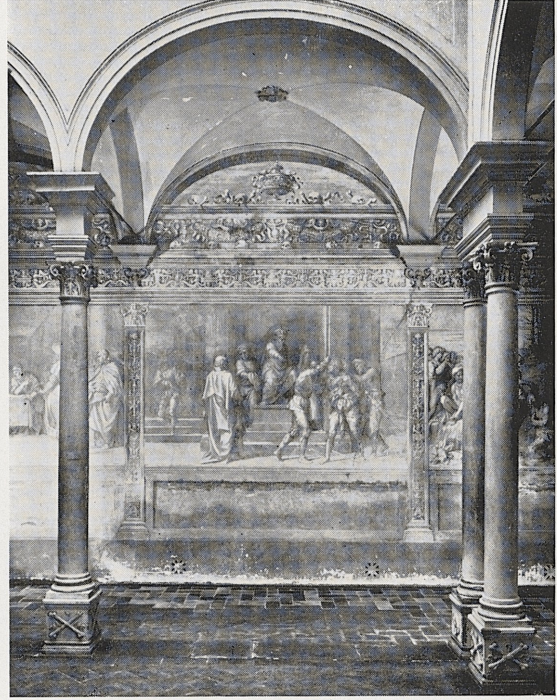
3 Chiostro dello Scalzo, centre bay of left wall.

the verticals of the columns. It seems that not only his decorative, but also his narrative frescoes were harmonized most carefully with this setting; the first point is of course obvious, the second perhaps less so. But it is a fact that the Scalzo frescoes — the *Histories* — were composed on subtly different principles from those, for example, in the *Chiostricino* of the Servi. In the latter, the figure-grouping constantly echoes the looping curves of the arcade²⁹, while in the former the predominant pattern of verticals and horizontals has been made meaningless, and apparently unmotivated, by the change to an arcaded setting³⁰ (figs. 2, 3).

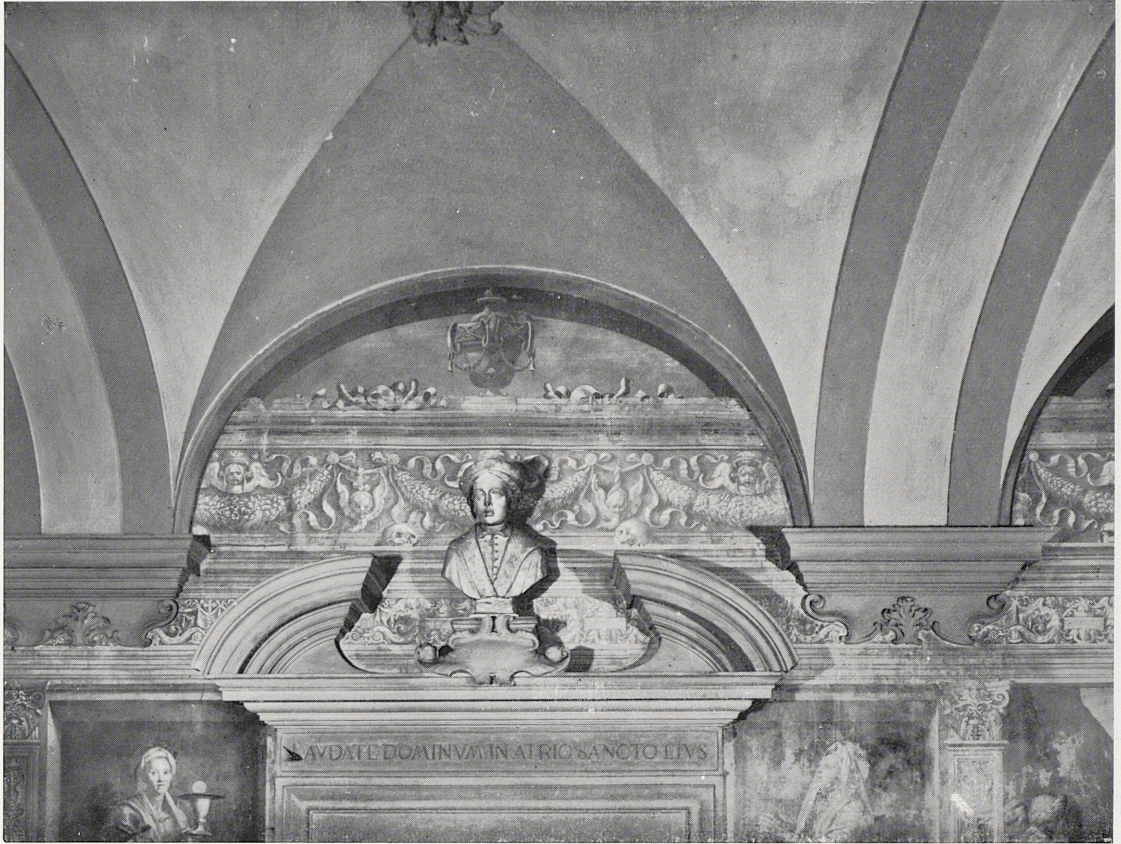
4 Chiostro dello Scalzo, detail of section above entrance door.

The reason for the neglect of this problem is that the decoration of the Scalzo has seldom been considered except as a series of masterpieces of Florentine History-painting. The more truly decorative parts, bases, pilasters, friezes and attics, are no less worth study, not only because their quality is as exceptional in this field as that of the Histories, but also because a closer attention to detail at this point reveals an alarming conflict between surviving decoration and architecture. This conflict poses several questions, some of which can be answered, and leads on to a task of reconstruction; questions are also posed by remarks in the sources, like Richa's, that the terracotta bust of Sarto over the door (fig. 4) was '... *rifatta... nel 1722 in occasione di murare le Logge*'.²

The argument passes naturally now to the walls and their decoration near the vault. In the first place, we must think away the segments above the last horizontal (figs. 4-5). The type of urn here, although it incorporates (as do the four additional bases) the crossed bones from the bases of the central columns on each side, is conceivable not around 1510, but only as an unworthy representative of *Settecento* taste; the colour of these segments is of a colder grey than any of the variations used in the rest of the decoration. Most important of all, the miserable painter responsible for them had such a crude understanding of light that he would not have been tolerated for one moment in Sarto's atelier; not only is the light gauche and insensitive, in contrast to the beautifully subtle play over the rest of the decoration, but it is inconsistent within each segment, and contrasts in direction in many cases with the uniform light falling on every detail of painted architecture, treated without exception as if it flowed from the centre of the atrium, and so outwards along each wall and corresponding to the natural light. In some cases, but not in all, the lowest part of these segments, the skulls and ribbons, can be seen even from the ground to have been painted *a secco* over the upper ledge of the attic. The reason for this is that the upper, horizontal, limit of the *original* decoration is not on a uniform level; this can be seen most clearly in the corners (fig. 5). The attic is slightly higher on the

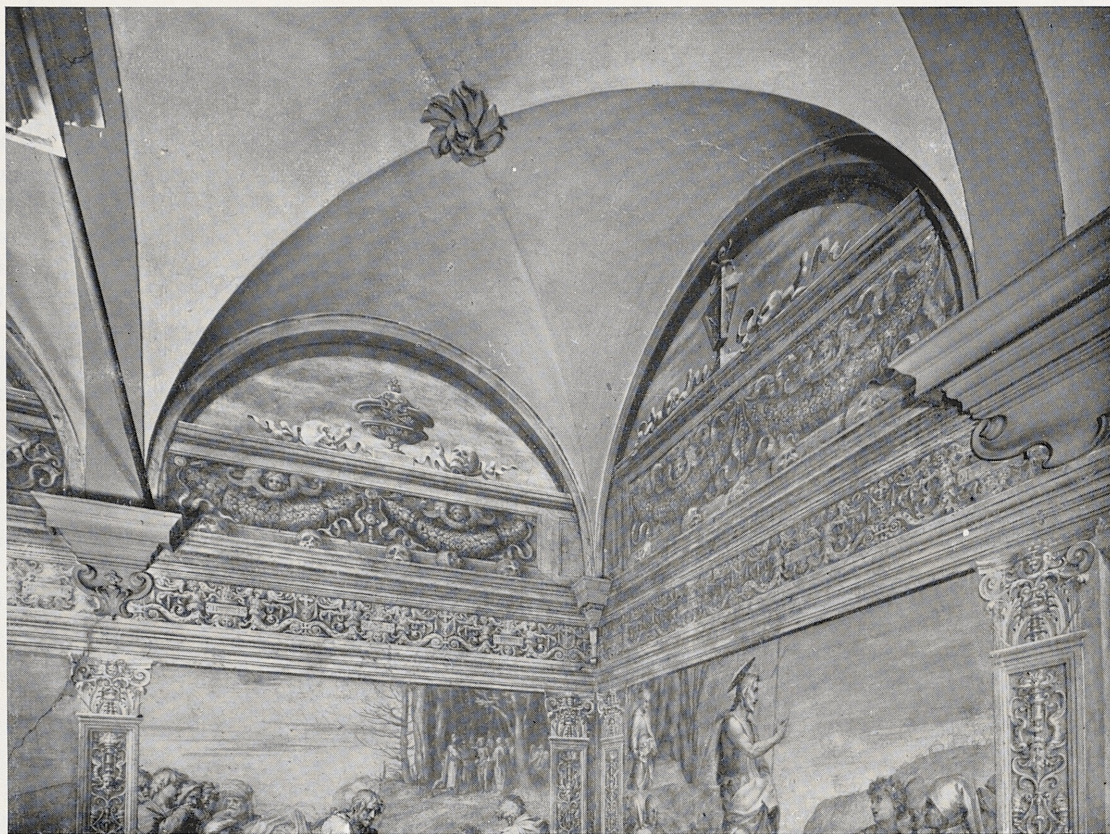
5 Chiostrò dello Scalzo, detail of far left corner.

However, the remains of the painted decoration give a clue to the general nature of the original building. The frieze (fig. 5) is a running design which was clearly not intended to be interrupted in any way. The attic, however, is panelled, as explained above in Part I; between each framed panel there is a gap, and it is now impossible to say whether the painting continued right across here. It is possible that it did, and that the caesura between the decorated panels repeated in the attic story the rhythm established by the pilasters between the other decorative panels which once filled each space below the Histories. Alternatively, there may have been an obstruction on the wall here, such as a stone bracket, opposite and somewhat above each capital; the partly fictive, partly real, plastic sequence in this case would imitate even more closely that above the cornice in an antique attic, like the one on the Arch of Constantine. In the corners, enough remains of the framing for it to seem unlikely that there was ever a bracket here, which one would not, in any case, expect.

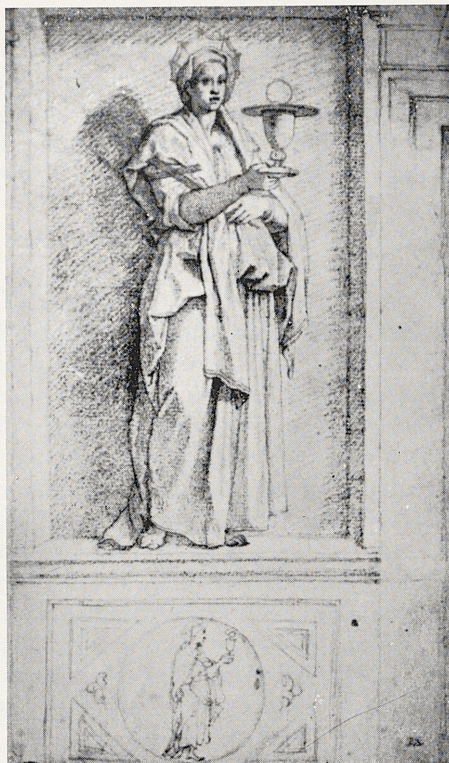
8 Late 16th century copy after *Faith* in the Chioistro dello Scalzo. (Louvre, Cabinet des dessins).

One other, minor, correction to *Paatz's* entry on the Scalzo: he states (see above n. 4) that the present door-frames are also additions of 1722, but I think that only the broken pediments above were added then. The relationship between the niches of the *Virtues* and these frames is precisely the same as that between the niches and fictive pilasters outside them, and the present frames are shown in a pair of drawings of these *Virtues* in the Louvre, which seem to have been made around 1600 (Cabinet des Dessins, Inv. 1744 — one of a set of copies after the Scalzo fresco cycle which belonged to Crozat); see fig. 8.
