Report on Salvaging Rock Fragments, 2006

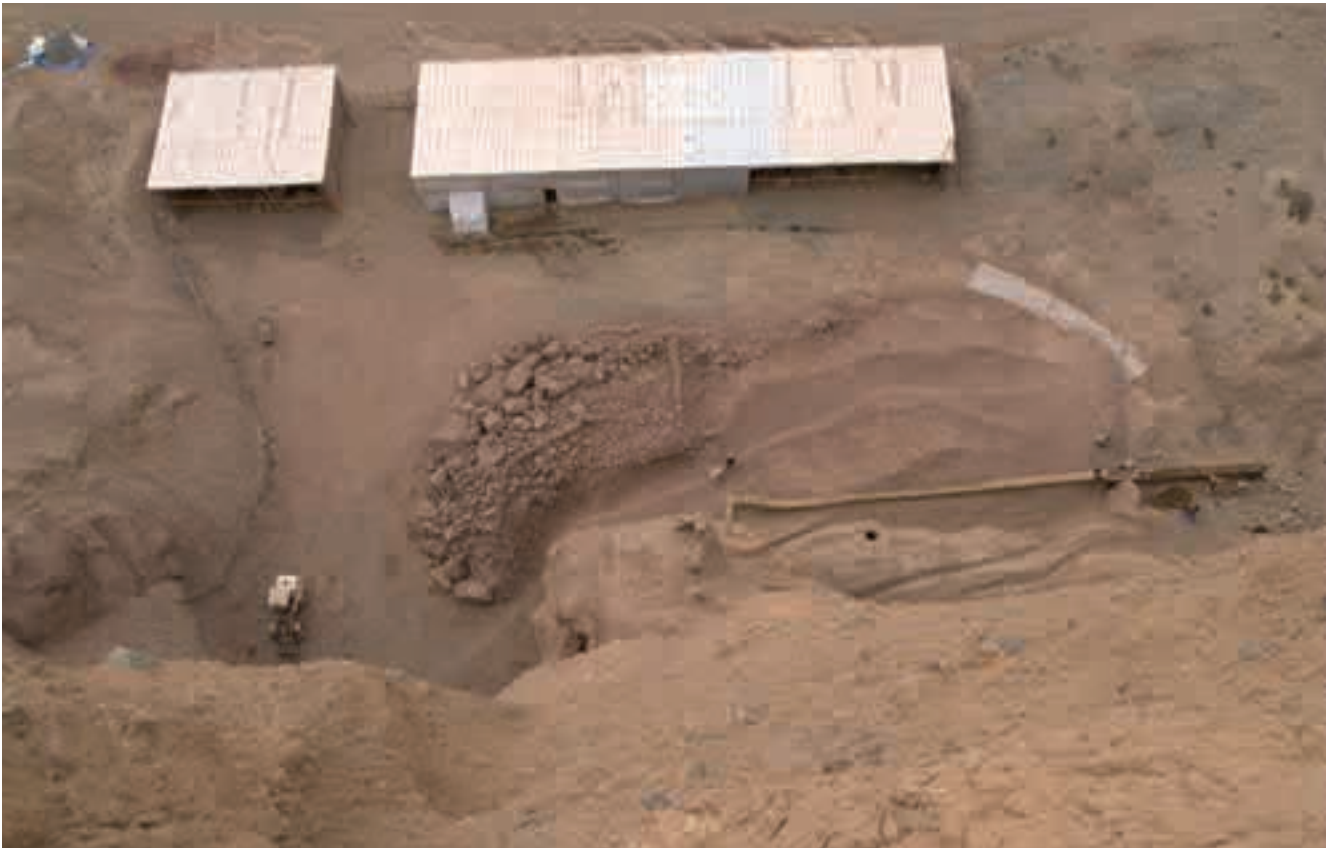
△ Depot for sand, small boulders and rocks without sculpted surface

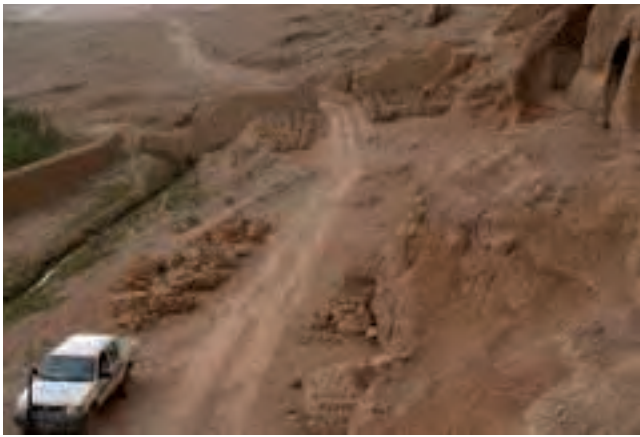
△ a

- a) Sand and small boulders piled up southeast beneath the niche's platform
- b) Construction of new provisional shelters west of the Buddha niche
- c) Niche of the Eastern Buddha from above with excavated platform and stairs
- d) Moving of large fragments of the Eastern Buddha
- e) Moving of large fragments of the Eastern Buddha
- f) Transporting the pulled-down fragments with a wheel loader
- g) Fragment of the Eastern Buddha with typical sculpted surface

leverage force. The Buddha fragments were pulled to the exit of the niche by using pulleys. Leverage force and manpower were also used for this action. The pulled-down fragments could then be transported to the depot with a wheel loader. As in the year before, sand and small boulders were piled up southeast beneath the niche's platform, using separating foils and a wall as barrier. A large part of the recovered rocks were temporarily stored west of the niche's platform. By autumn, the storage sites for this material had been enlarged and roofed. About 200 rock fragments were salvaged.

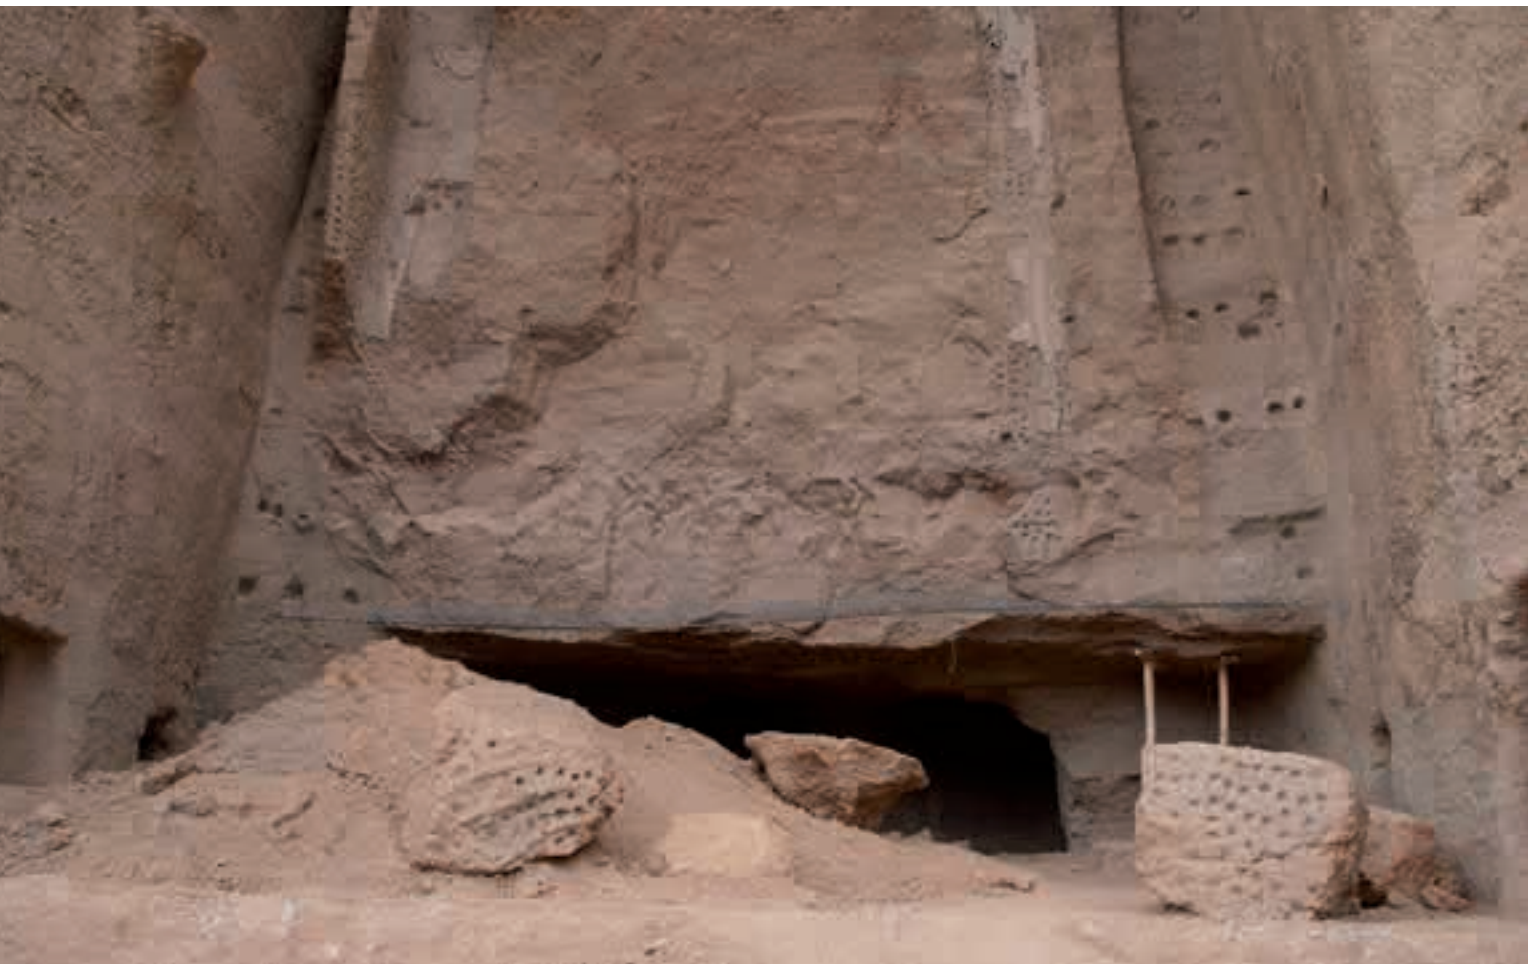
△ Eastern Buddha niche, the ground level with the destroyed caves in the background has been reached
▽ Parts of the niche's back wall had to supported as stone slabs kept on falling down
