Edwin Fecker

## Report on Rock Mechanical Aspects Concerning the Eastern Buddha Niche, 2006

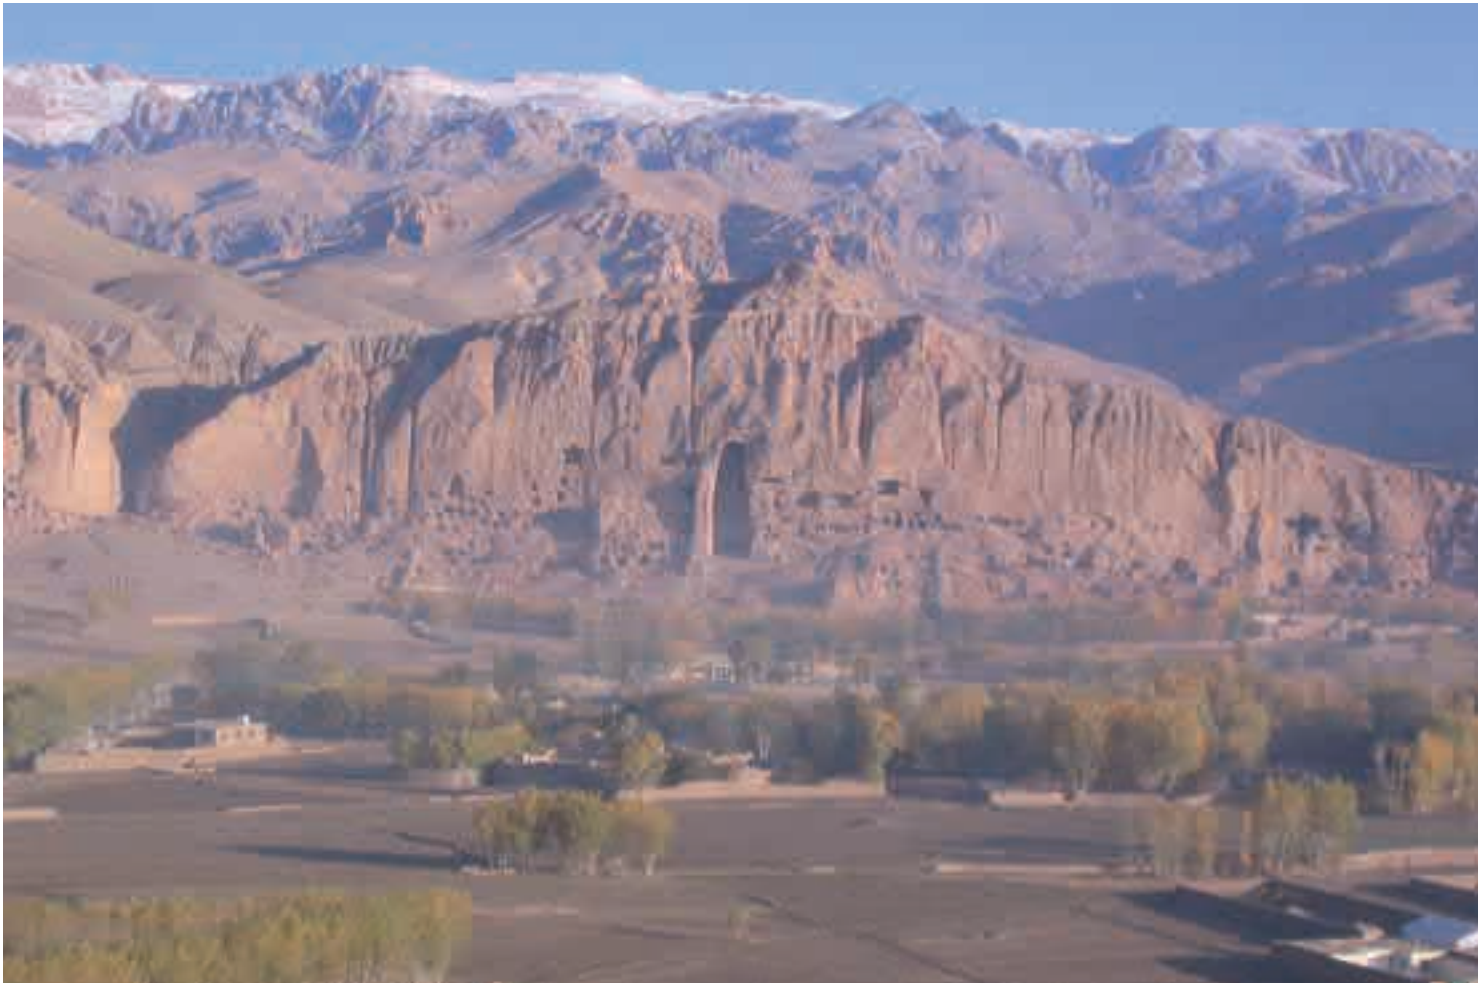
Eastern cliff of the Bamiyan valley with the niche of the Eastern Buddha. At the foot of the cliff several rock masses from slope movements can be recognised.

several other mass movements are well-cognizable; if they took place in historic times it must be reserved to more exact examinations and is not the subject of this report. What can be said about it in any case is shown in a comparison of today's situation with the drawing of Charles Masson from the year 1832 (see fig. 3, p. 20). In that drawing the most west sliding mass had not yet come off, so it must be younger than this year.

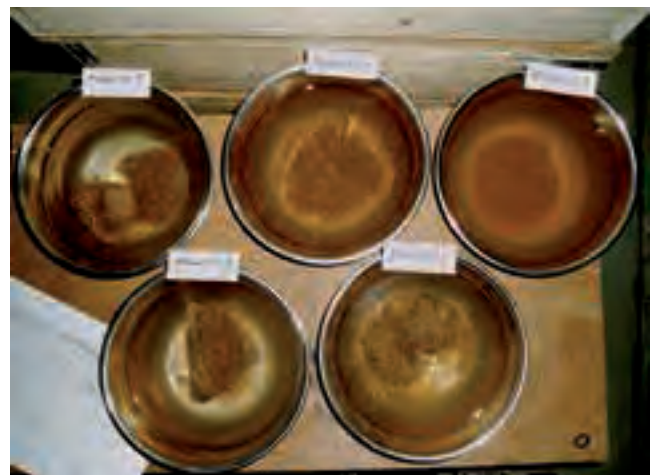
Alteration of samples no. 1 to 5 under water after 24 hours.

The five samples that we have examined with this test show the following result: Samples no. 3 and 4 without cementation are intensely alterable during this test, samples no. 1 and 2 are alterable and sample no. 5 is moderately alterable.

Also noticeable in the test result is the high water susceptibility of sample no. 3.

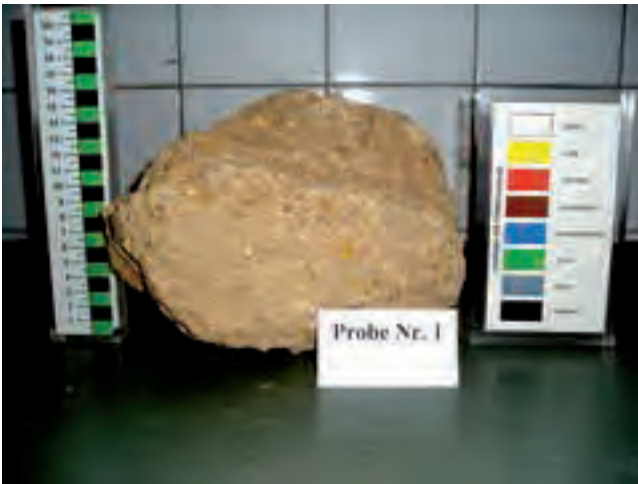
Fig. 1. Samples no. 1 and 2: fine-grained conglomerates

Figure 1 shows samples of the conglomerate which contains fine-grained pebbles (samples no. 1 and 2).

As we would not take rock samples from the back wall of the niche we collected the above mentioned samples underneath the niche (sample no. 1 to 5, figs. 1–3). It is not sure that they come from the niche of the Small Buddha, but I do not consider this to be essential, because for the conclusions that are drawn from the examination it is not relevant if the samples are from the niche or close-by. The grain size distribution of the samples is shown in figures 4–7. To determine the grain distribution the samples have been stored under water for 24 hours. After this the percentage of the different grains composing the samples has been determined by sieving and sedimentation analysis. At sample no. 5 this method could not be used, because the alteration under water was moderate and the sample did not decay in its individual grains.

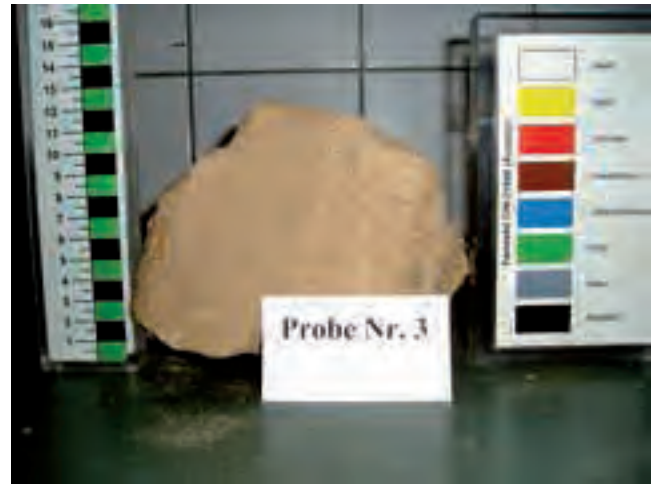
Fig. 2. Sample no. 3: siltstone; Sample no. 4: fine-grained conglomerate

Figure 2 shows a sample of the siltstones (sample no. 3) and figure 3 a sample of the conglomerate with medium-sized pebbles (sample no. 5). The cementation of both rock types, conglomerates as well as siltstones, is not very strong and two of them (samples no. 3 and 4) do not contain cementing agents, that's why they totally decay in their individual grains in the case of water immersion. These rocks are only compacted by overburden, without a chemical cementation. The conglomerate of sample no. 5 seems to have at least a little cementation.

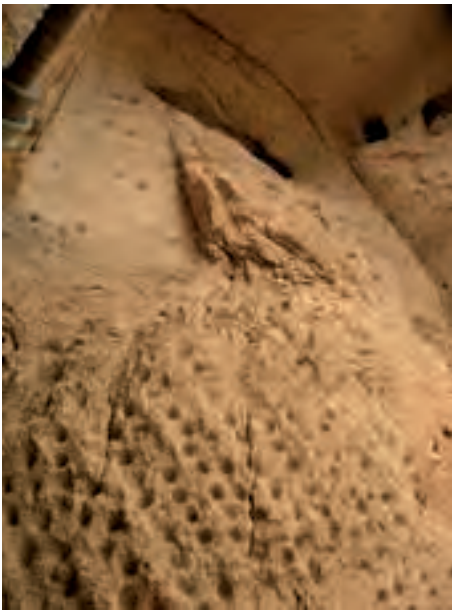
Fig. 17. Remains of the head of the Eastern Buddha

The back wall of the Eastern Buddha is still showing in its highest part rests of the head of the Buddha. This is a large rock plate which is affected in joints parallel to the slope by

new formed ones (see figs. 17 and 18). The joints are slightly open. The whole part must be secured. I am considering the danger of larger rock falls in the near future to be low.

As I do not consider an interference in the historic substance desirable, e.g. by an anchorage of the dangerous rock zones in the back wall, I would like to propose a support measurement which would not influence the historic substance. The fundamental idea of this support is a steel girder construction which leans against the back wall and supports the dangerous rock zones by the retaining force applied to the back wall.

It would be self-evident to erect two vertical H steel beams at the point where the rests of both feet of the Eastern Buddha are located. The steel beams should have load distribution plates as contact surface which could be adapted to the feet surfaces. In the height of the beginning back wall, about 3.5 m above the bottom of the niche, a first crosslink

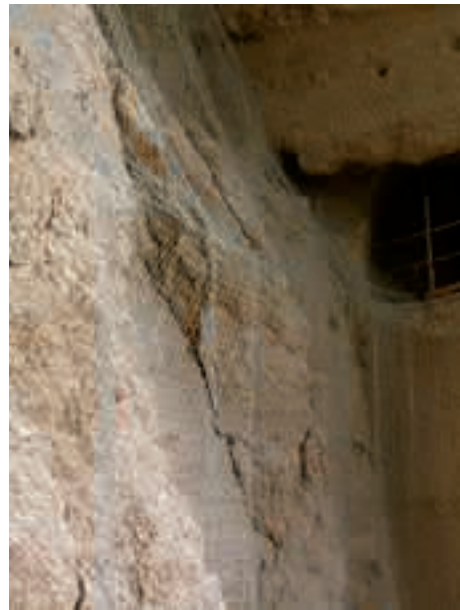
Fig. 20. Left shoulder of the Eastern Buddha

The left shoulder is also affected in many parts due to several new formed joints parallel to the slope and loosened from the back wall (see figs. 20–22). Some joints are open up to about 10 cm. In these open joints decimetre large rock pieces can be seen which have been fallen into the open joint from the upper side of the shoulder. Only a rock gusset of about 1.5 m<sup>2</sup> avoids the falling of the section. The rock gusset is also showing disintegration. In my opinion the danger that the whole part will fall is very high. Although this shoulder part seems to have been in the condition of a possible fall since 2001 we suspect that this part may fall even without the effect of an earthquake.

From the back wall area up to the shoulders both inclined beams could be connected by steel framework, which could serve as holding device for blasted parts of the Buddha body. A first draft of the framework is shown in figures 27 and 28.

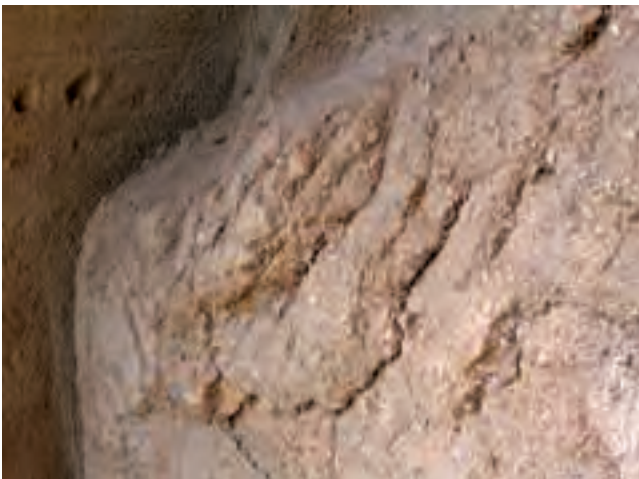
Fig. 19. Right shoulder of the Small Buddha (new discontinuities parallel to the back wall)

The right shoulder is affected in many parts due to several new formed joints parallel to the wall and loosened from the back wall (see fig. 19). Some joints are open. In my opinion the danger that some parts may fall down and the total section may follow is high. Especially caused by an earthquake – even of low magnitude – the section may lose its hold and fall down.

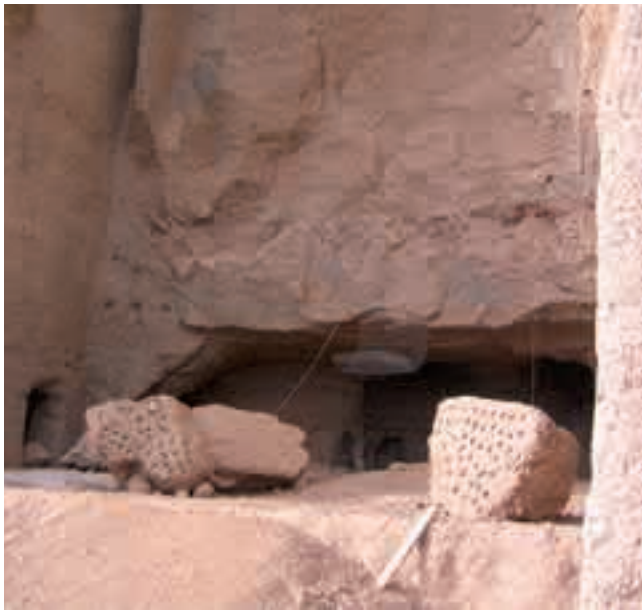
Fig. 23. Discontinuities under the dress pleat

Underneath the right hand of the Eastern Buddha a dress pleat partially in good condition continues downwards which is slightly loosened from the back wall at the east edge below by some joints parallel to the wall (see fig. 23). The joints are scarcely open and seem to end under the pleat. I consider the danger of falling of this section to be very low.

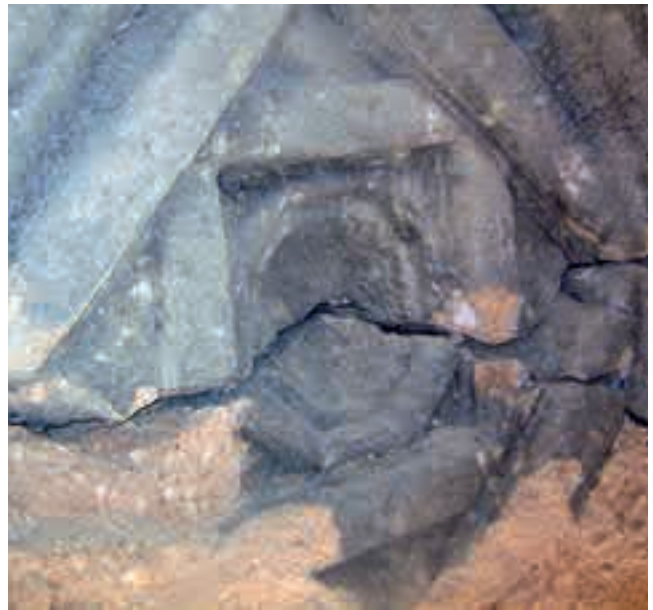
Fig. 24. Cave no. 5 after the explosion

It was in the middle cave behind the feet of the Eastern Buddha (cave no. 5) where the explosive charge has been initiated. Hereby the partition walls to caves no. 4 and no. 6 as well as the front wall of all three caves were completely blasted out. Caves no. 4, 5 and 6 have a common ceiling now which is crossed by a newly formed gaping vertical joint (see figs. 24 and 25). This joint parallel to the slope extends only partially into the cave no. 6, and is feathering in the west wall of cave no. 6. In the east wall of cave no. 4 it is still some centimetres open. How it continues in the rock could not be found out with the available means.

The rock parts which are on the verge of falling from the ceiling of the caves no. 4 to 6 have been temporarily supported with wooden props in the meantime. When these props will be removed for a final support they have to be loosened with extreme attention. Removing the props is always much more dangerous than putting them up, because wedges are driven in when putting up the props. Hereby the supported plate may be moved and existing rock bridges may possibly be broken. When removing the props the rock part falls down.

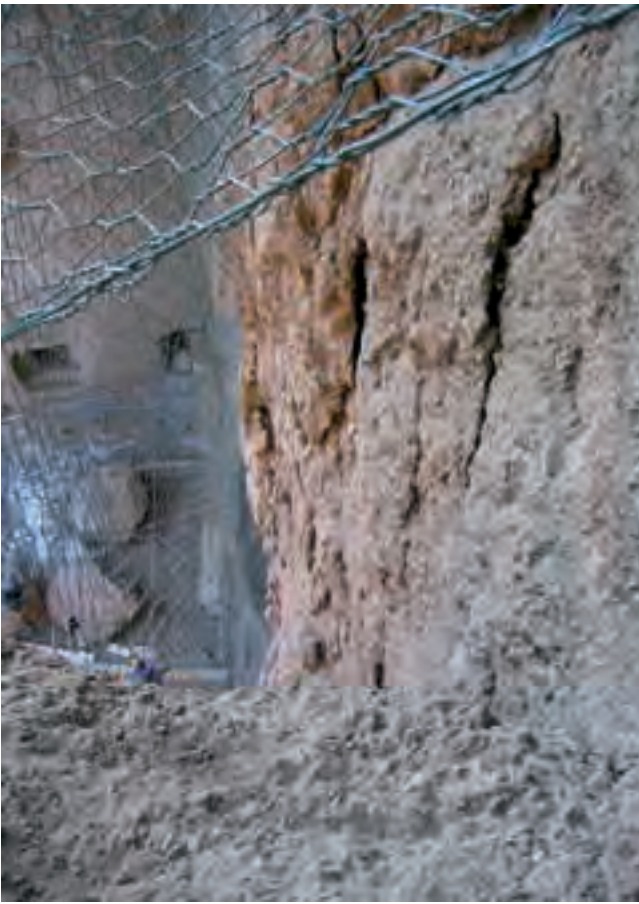
Fig. 26 Steel wire mesh covering the back wall

Since October 27, 2004, the back wall of the niche of the Eastern Buddha has been covered with a steel wire mesh to catch falling rock debris. It is a double-twisted hexagonal wire mesh with a mesh width of  $D = 84 \times H = 121 \text{ mm}$ , the diameter of the wire is 2.7 mm.

According to Muhunthan et al. (2005) this wire mesh is suitable to sustain rock impacts of  $0.6 \times 0.6 \times 0.6 \text{ m}$  pieces which are falling from the back wall. It will not be able to catch larger blocks. For double-twisted hexagonal wire mesh, impacts near the top of the installation should not exceed 10 kJ. Especially if the wire mesh does not sit snugly against the back wall larger blocks can fall free for several meters and get as much impact energy to break through the wire mesh (see fig. 26). Therefore, it is recommended to safeguard the wire mesh with steel wire ropes. Especially both shoulders should be crossed from several sides and the cross points should be connected with rope clips. The wire ropes (DIN3060,  $D = 11.0 \text{ mm}$ ) are to be well anchored on top and at bottom. How to do this without interfering in the historic substance can be decided on site.

Before executing further works in the niche of the Eastern Buddha I urgently recommend to increase the carrying capacity of the wire mesh by additional steel wire ropes. As a permanent support of the loose rock formations a fastening by anchors is imaginable. Alternatively, without intervention of the historical substance, I take a steel framework for suitable which leans against the back wall and serves as a support for the rock formations in danger of falling. At the same time this steel framework could be used as a load carrying system for a partial anastylosis.
