Bert Praxenthaler

Report on Safeguarding the Remains of the Buddha Statues, 2008

Eastern Buddha

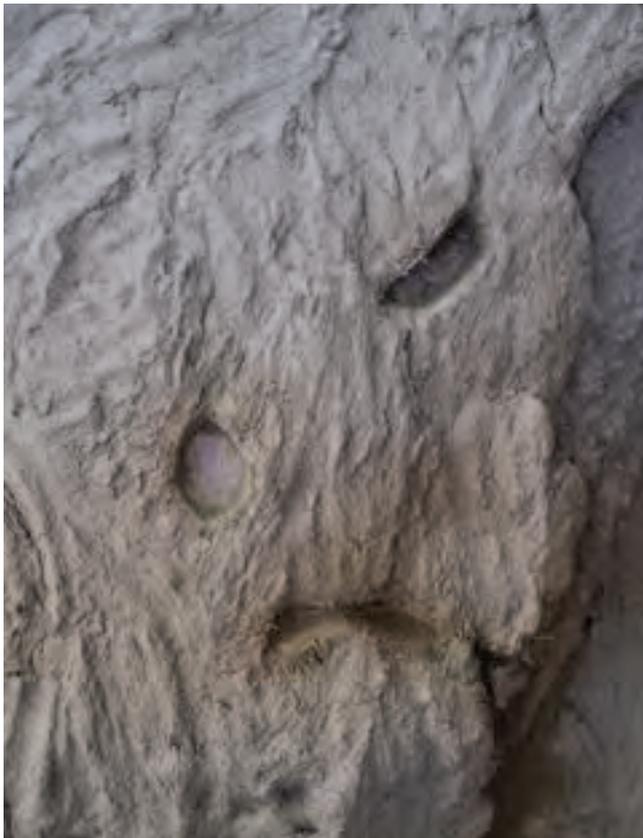
△ △ Finger traces in the lowest clay plaster layer

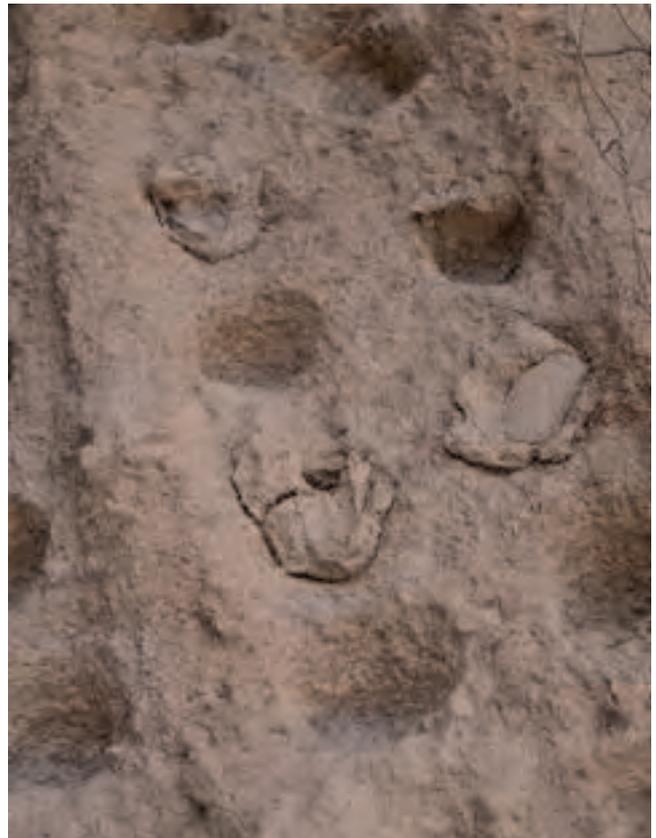
▽▽ Clay lumps pressed into the holes with stones

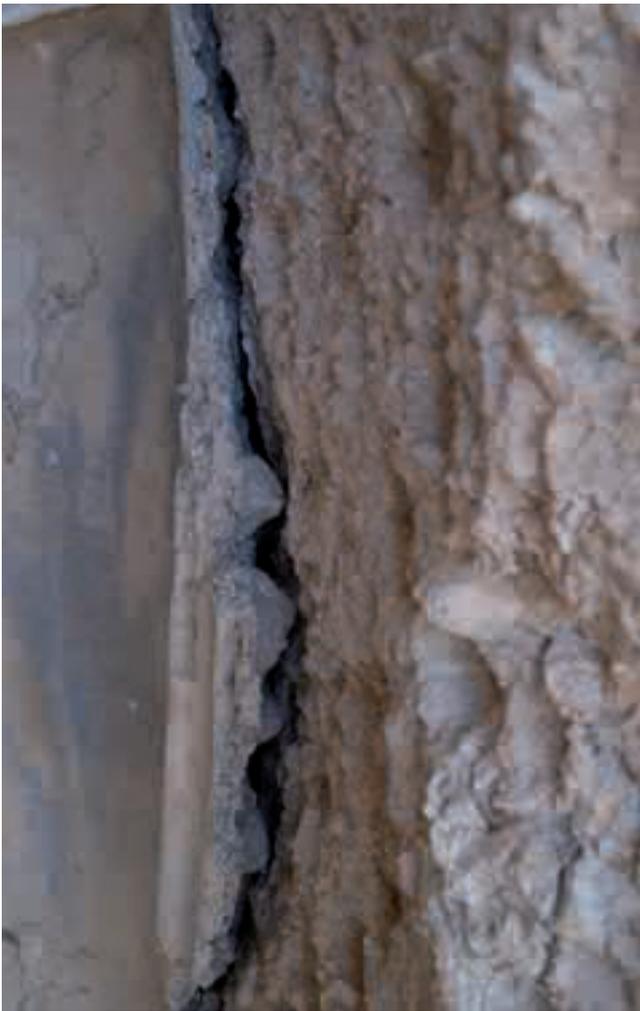
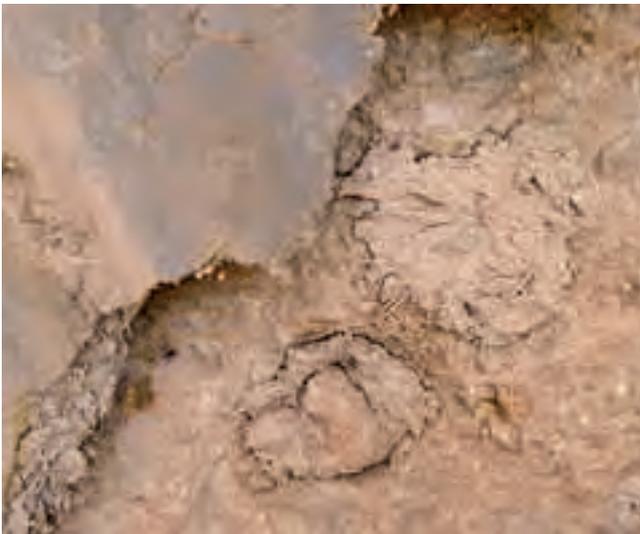
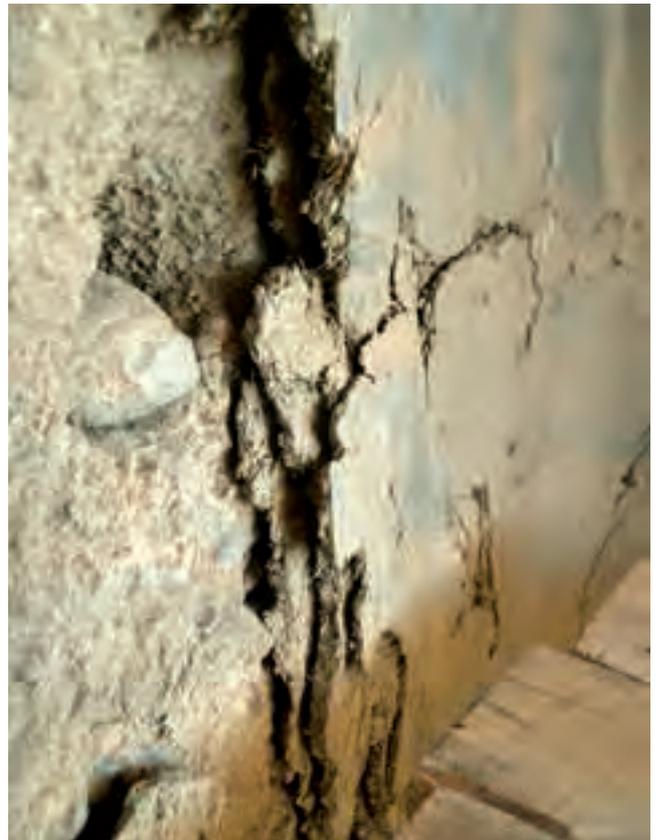
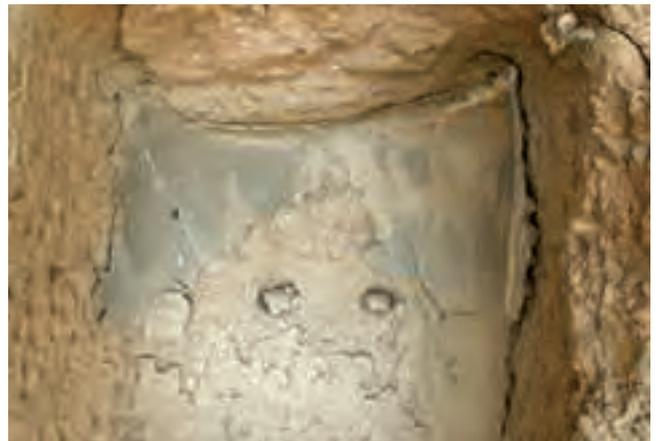
- a, d Eastern Buddha: remains of clay plaster on the left, with lapis lazuli. Photo shows condition before treatment. All fragments are slightly detached from the rock face and are only kept together by being wedged on the left and right with the “clay-stone burling”.
- b Clay plaster with greyed lapis lazuli pigment, below in the centre the bond coat with bond holes; see also the stone used for pressing the moist clay into the holes.
- c Three layers of clay plaster, partly detached from one another

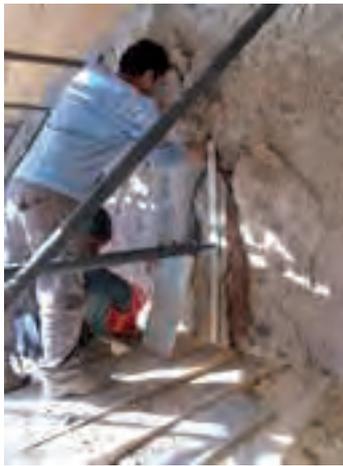
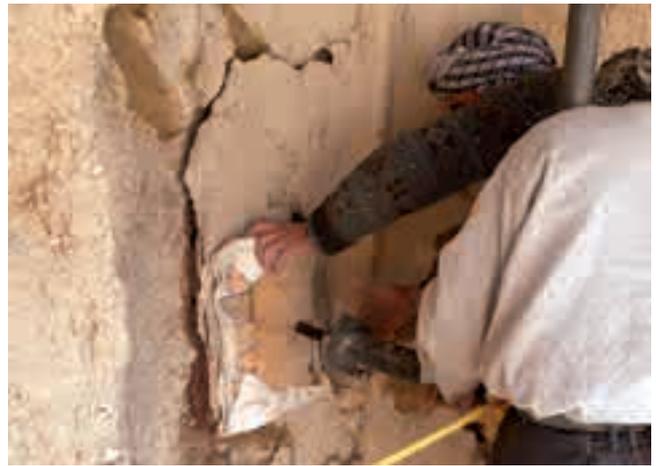
Original clay plaster fragments (right side of the Eastern Buddha) are carefully pressed to the rock face by means of a splaying apparatus after bond mortar had been backfilled. In most cases this apparatus was hinged to the scaffold. The surface of this apparatus was adapted to the texture of the clay plaster and was made of small wooden boards. ▷▷

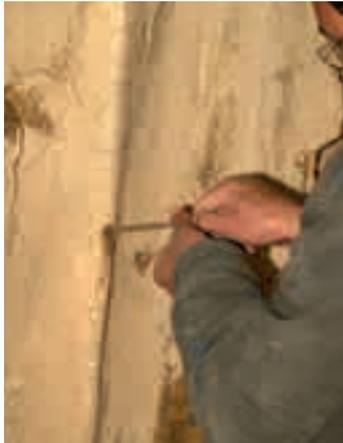
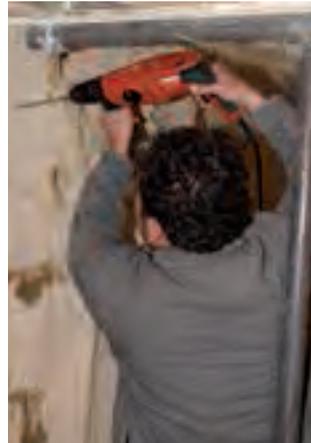
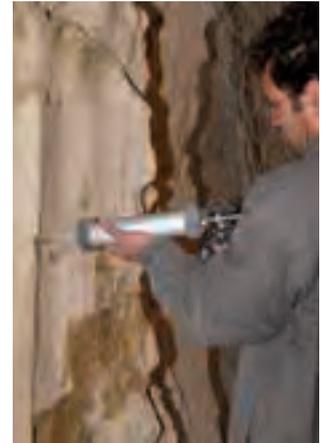
Original clay plaster fragments (right side of the Eastern Buddha), preparation for the setting of anchors: Mujtabah Mirzai drilling a hole into an existing bullet hole for an anchor. ▷▷▷

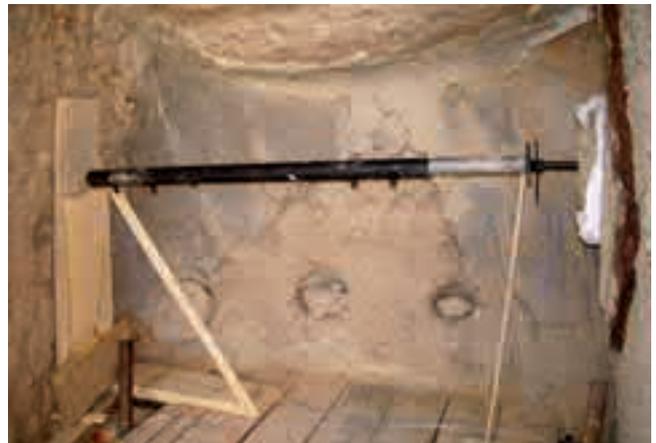
Bonding of clay plaster fragments; by means of a splaying apparatus pressure is carefully put on the clay plaster fragments; on the left underneath the arm hole. ▷▷

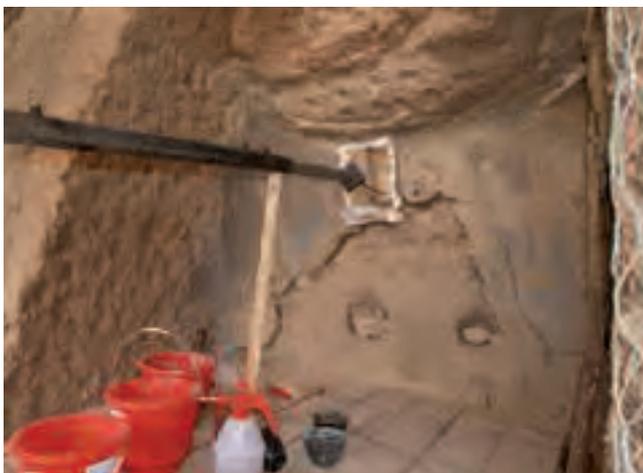
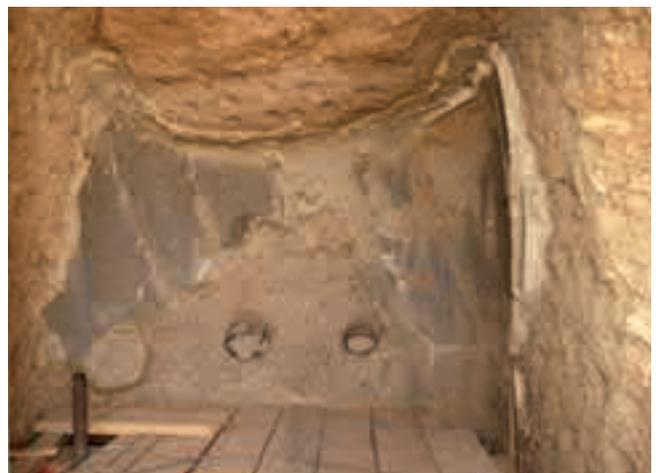
▽ Bonded and secured clay plaster fragment underneath the arm hole.

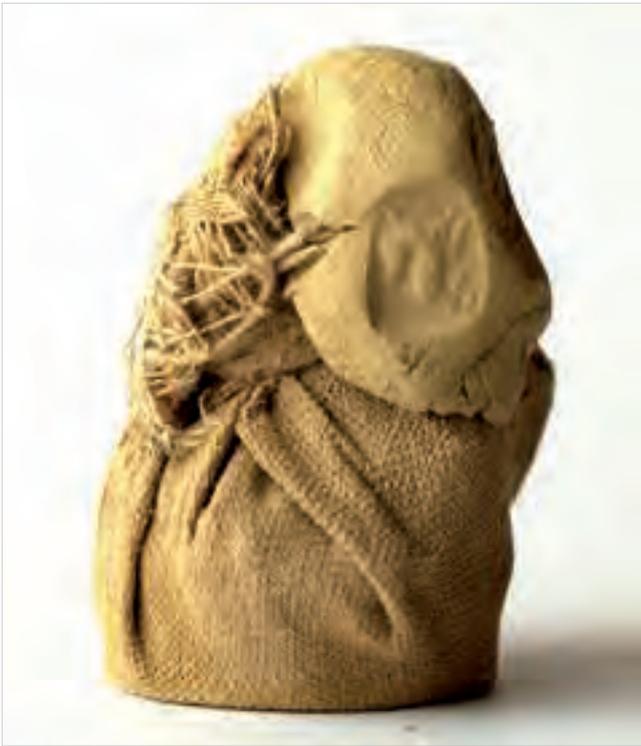
△ Eastern Buddha, Buddhist relic found on October 3, 2008

During the works on the Eastern Buddha an object was found on 3 October 2008 in a cavity about 17 m above the ground level of the niche and above the clay plaster fragments on the left. This is most likely a Buddhist relic, which apparently was deposited while the statue was erected in a 10 cm-hole together with parts of plants and then closed with a stone. This cavity is the backmost base of the hole which used to hold the beam of the Buddha's right arm. It is located below the undestroyed rock parts of the Buddha's right shoulder. Effectively, the relic was hidden at the place of the Buddha's elbow joint.

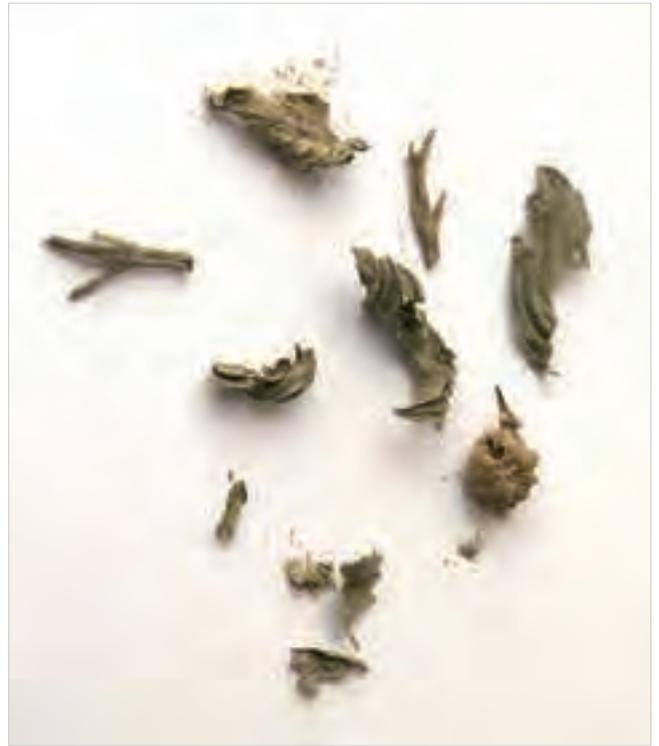
△ Dried remains of 'esfand', found together with the relic. Until today the seeds of esfand are used for thurification. The smoke is believed to keep away evil ghosts.

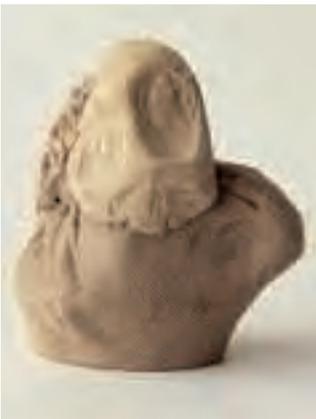
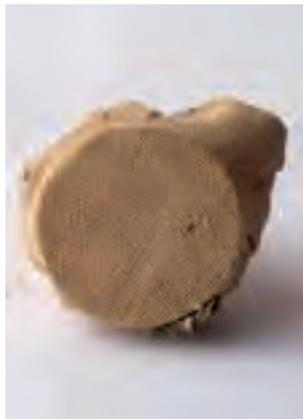
The object consists of a cloth sack measuring 4 x 6 x 3.5 cm, tied with a thread and sealed with a clay seal. The base is circular with a diameter of 3 cm. The clay seal has two different oval stamps. Some of the dried plant parts could be identified as belonging to the local plant by the name of "esfand". The find was handed over to the Governor of Bamiyan, Dr Habiba Sorabi, on Friday, 3 October by Prof. Emmerling and Bert Praxenthaler and the relic is now in the care of the provincial government of Bamiyan.

△ Eastern Buddha, Buddhist relic, view from below: circular diameter, inside a coin?

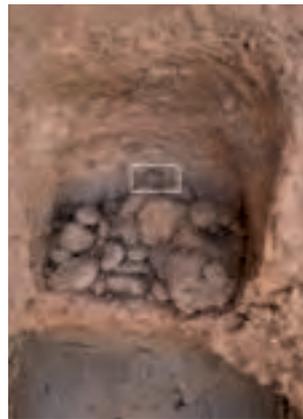
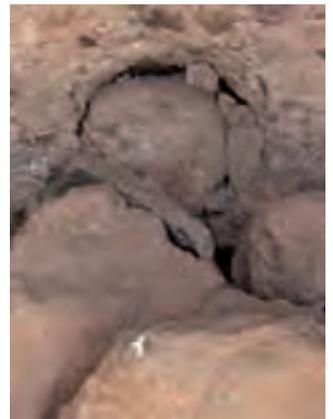
△△ Eastern Buddha, rock cavity with hole in the back wall where the relic was found. The hole is the remains of the beam hole for inserting the Buddha's right arm beam

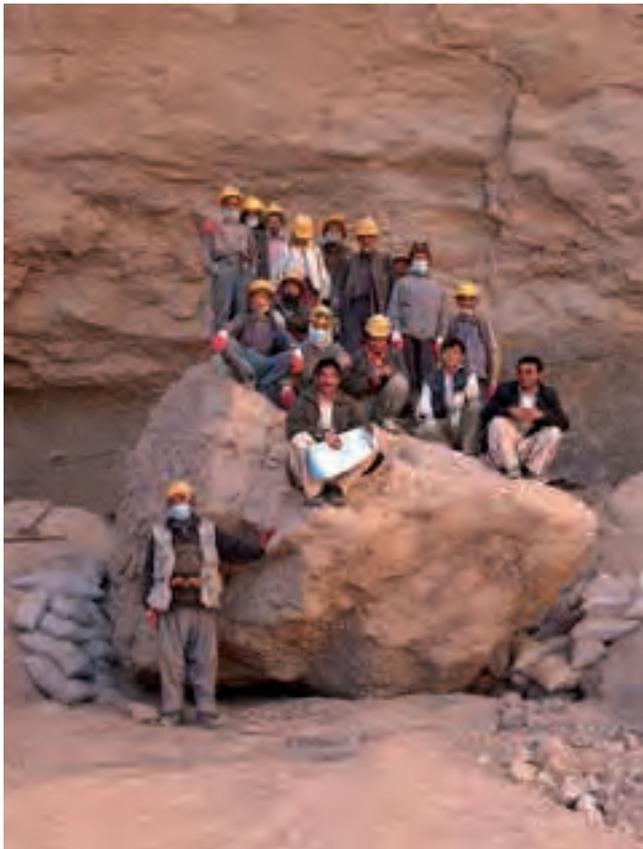
▽ Recovery of fragments at the Western Buddha

At the Western Buddha site the salvage work was continued by means of a wheel loader. Most of all, the cave entrances were exposed and all caves were cleared.

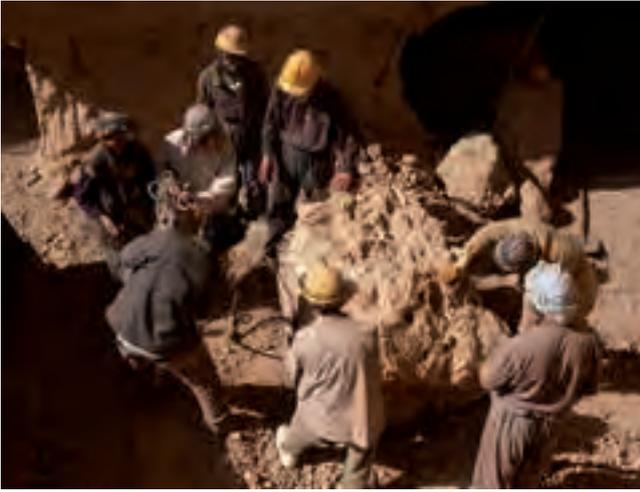
△ Recovery of fragments at the Western Buddha

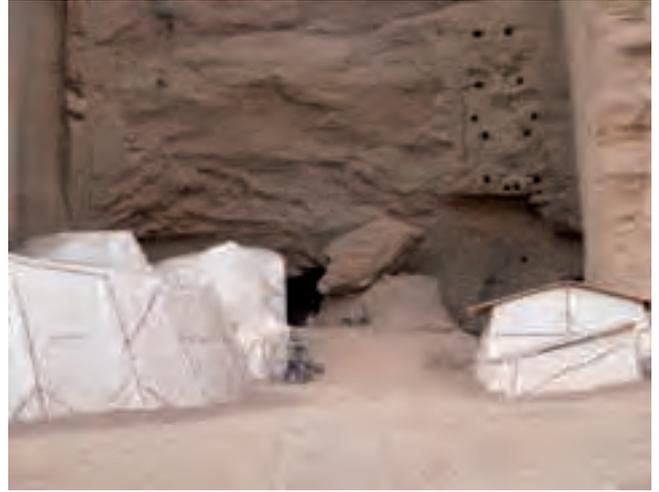
△ In front of the niche another small interim shelter for fragments, as the other storage halls in front of the niche are already full. The Buddha's feet are already recognizable.

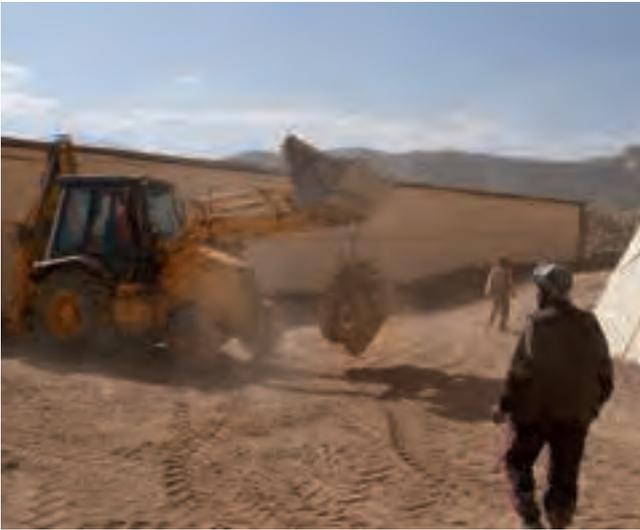
△ Recovery of fragments at the Western Buddha

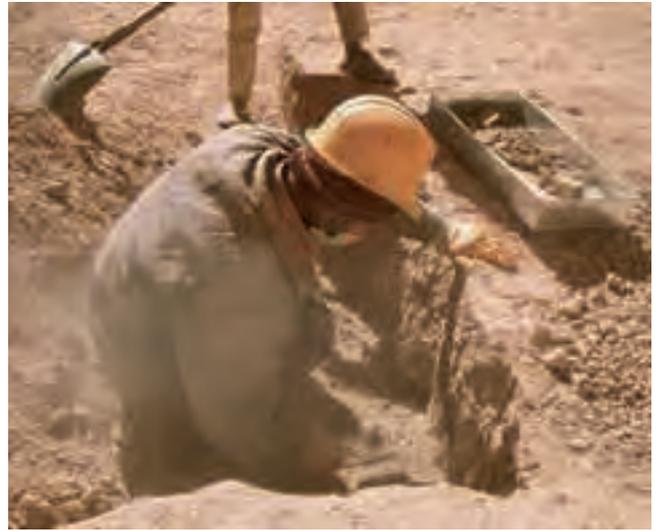
△ Careful examination of the Buddha rubble; finds are stored in zinc plate boxes

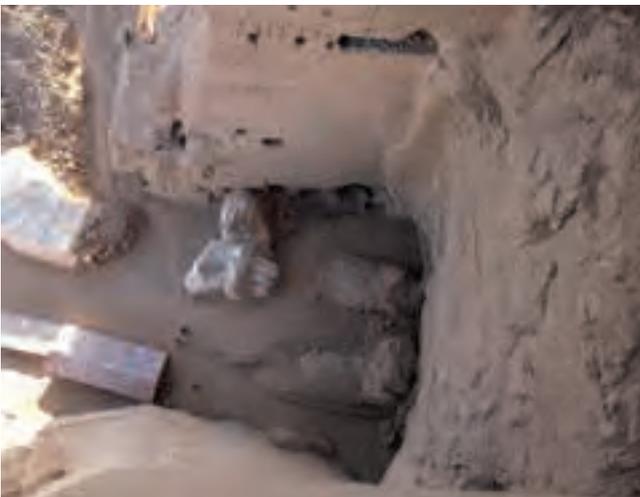
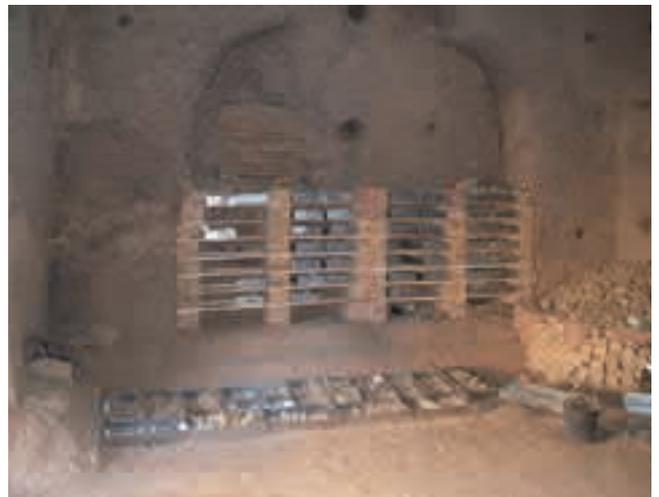
▽ View of the Western Buddha niche from above: Large, very heavy fragments weighing between 50 and 80 tons could not be moved without an adequate crane; they were wrapped up on site to protect them against moisture

▽ For the time being, the fragments are stored in a cave at the niche's entrance
