THE NETHERLANDS

Ellen L. van Olst Building traditions in the Netherlands

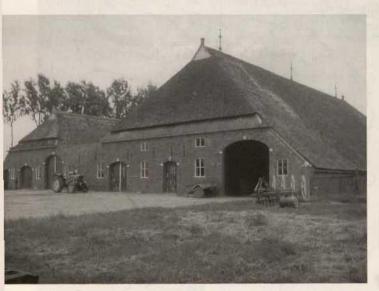
Frisian farm at Usquert, Groningen, with large double barns. Photo: SHBO.

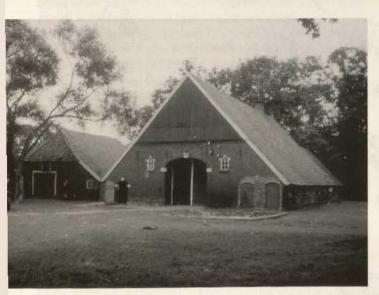
Hall farm building tradition: farm at Eibergen, Gelderland. The building to the right contains both dwelling area and working part. The second building is a separate barn. Photo: SHBO.

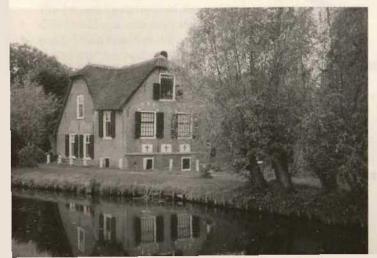
A rich brick building tradition, farmstead at Hoogmade, Zuid-Holland. Photo: SHBO.

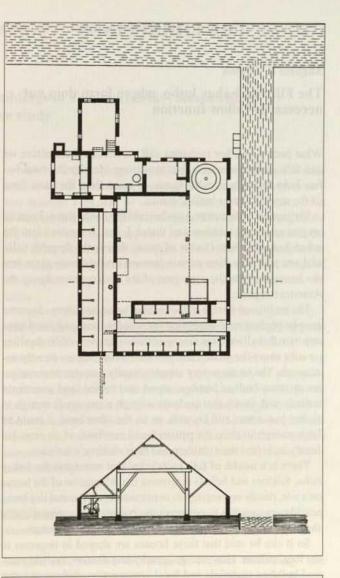
Measured drawing of farm at Ruinerwold, Drenthe. Drawing: K. Uilkema, 1926, Coll. SHBO.

The farm (which is a listed monument) is a rare example of a historically valuable monumental building that is still fully used as a working farm. The farm largely dates from 1786, as stated in the ornamental wall clamps of the façade. The original interior of the dwelling part is almost entirely intact, with its huge living room with highly decorated tiled walls, fireplace, and panelled wall containing a row of box beds and cupboards. Next to the living room is a cellar and mezzanine room, which serves as bedroom. The cellar, which served for the storage of dairy produce and provisions, is accessible from the kitchen. The extremely wide nave in the working part of the farm contains the threshing floor, with cow-stalls on either side in the aisles. The high double doors are situated in the centre of the rear façade. Because of the low height of the exterior walls, the doors had to be placed in a recess. The attic over the threshing floor was used for crop storage. The area next to the kitchen still houses the original pump. Here the milking pails and other dairy implements were rinsed. This area also used to contain the horsedrawn churning mill. The walls of the washing area traditionally have a tarred plinth, with whitewash above. The original oak anchor-beam framework is still intact.
