## Report on Salvaging Rock Fragments, 2004

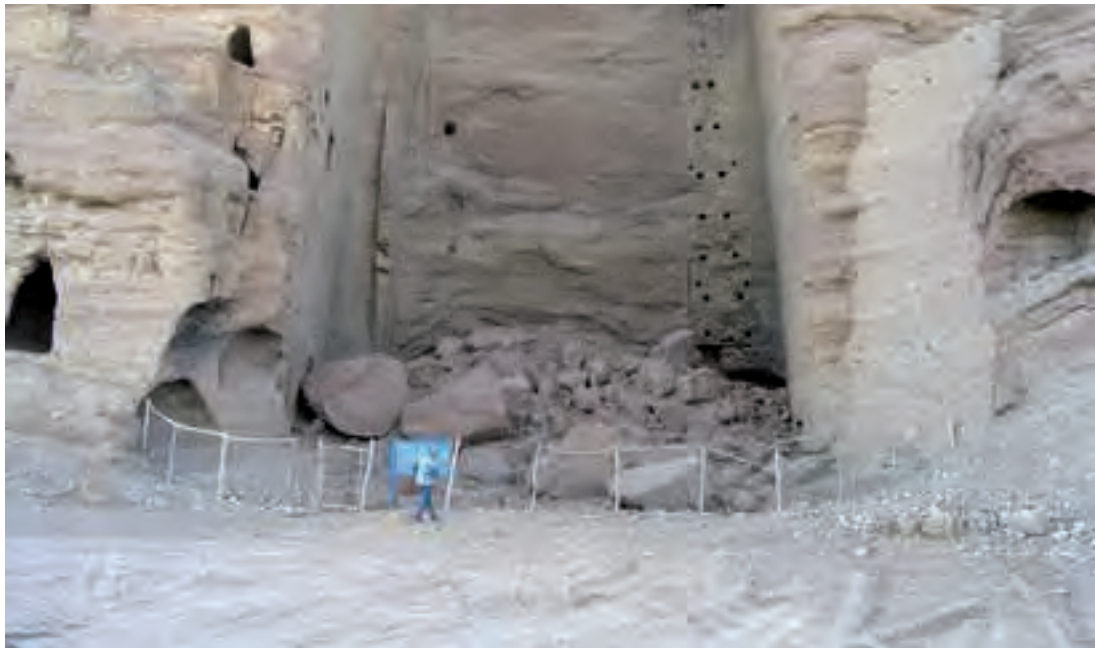
Niche of the Western Buddha with rubble heap before beginning of the salvage work in July 2004

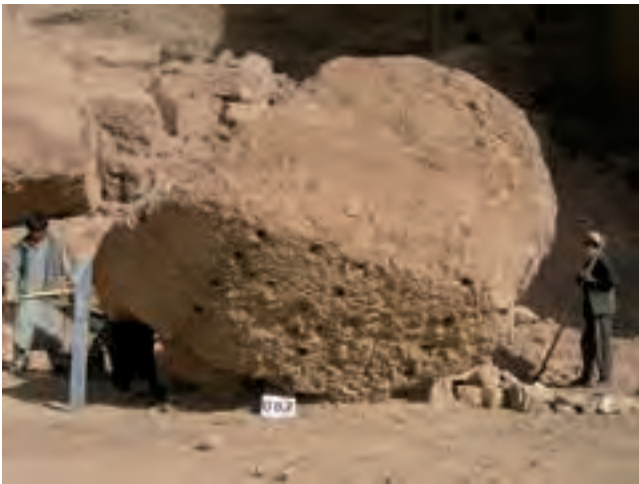
△ a

Fig. a. Rock fragment weighing tons with typical rows of reinforcement holes

were traces of hewing by means of pick hammers. Another unmistakable feature were the typical conical reinforcement holes of 4–5 cm diameter for the wooden pegs that gave the clay plaster a better adhesion and supported the modelled course of the folds. Additional features were the blackened spots. This blackening could be the result of the explosions or of smoke and soot, if the pieces originate from somewhere near the caves.

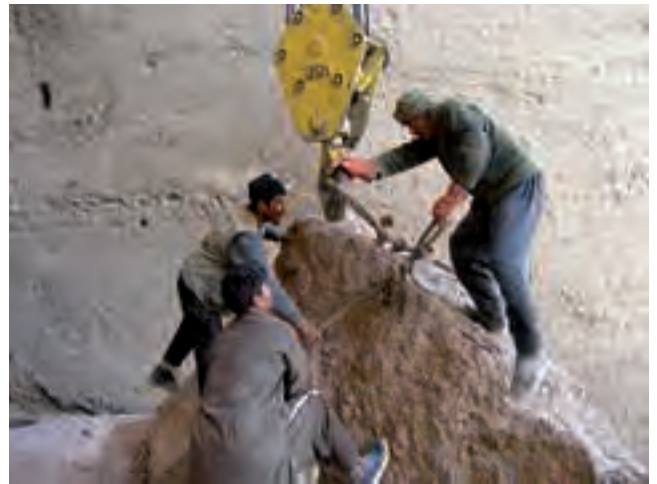
△ c

Fig. c. Salvaging fragments with a crane

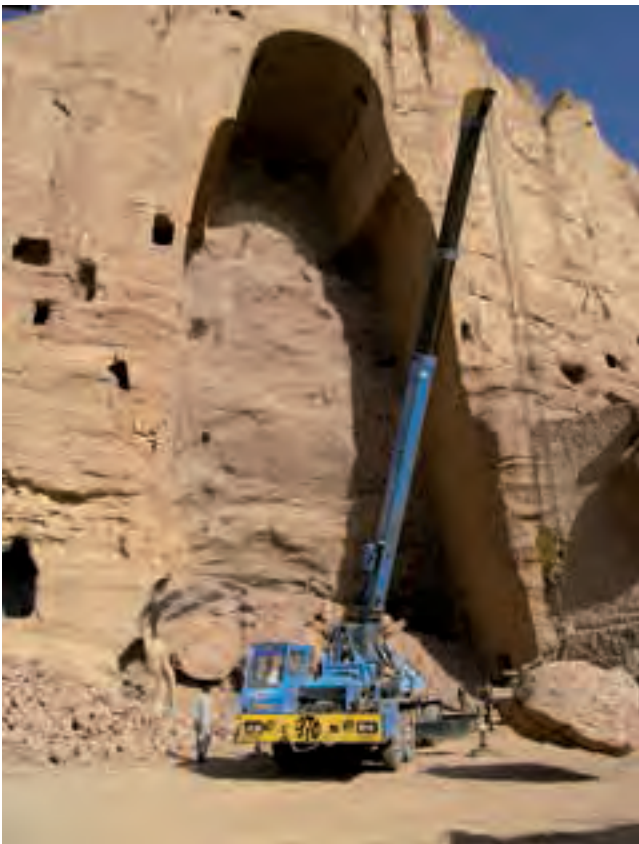
▽ d

Fig. d – Fig. f. De-miners at work

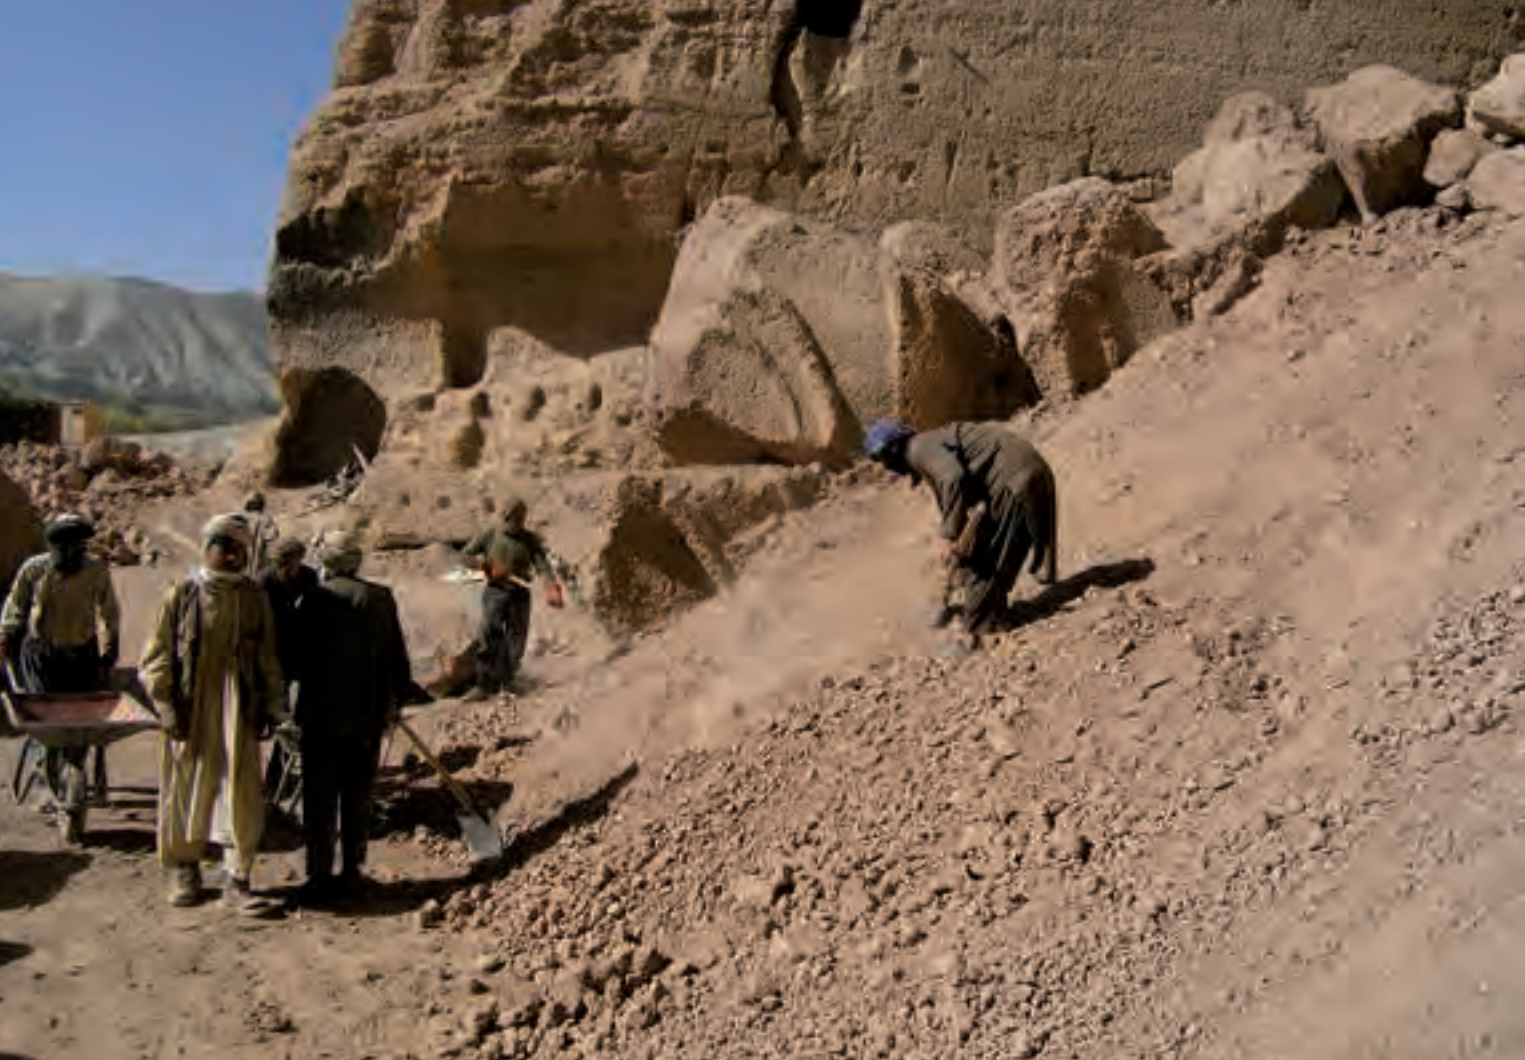
△ ▽ Afghan workers removing the rubble with shovels and wheel barrows

The fragments were salvaged by hand (shovel and wheelbarrow) and with the aid of machines (forklift, heavy-duty crane). During the process of loading the wheelbarrows every shovel of rubble from the niche was checked for fragments of clay plaster, wooden pieces and other distinctive features. Larger stone fragments could be transported by means of a Volvo forklift (up to six tons) and a heavy-duty crane (Nissan-Kato, maximum capacity 30 tons). For the crane transport the rock fragments were equipped with

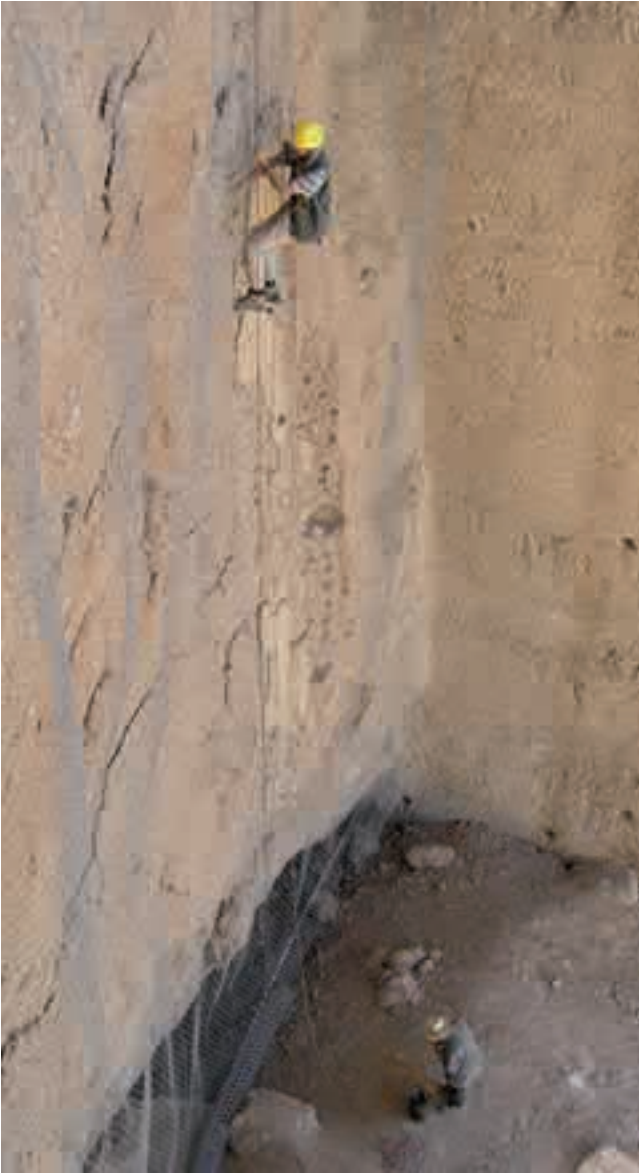
△ Clay plaster fragments in situ at the Eastern Buddha: loosened after the explosions, partly detached from the rock surface and in danger of falling off

This rubble was removed. To prevent these original pieces from falling-off, putty links were applied between rock surface and clay plaster. Beforehand, the composition of the putty was experimentally tested and adapted to the fragment materials that needed to be stabilised. A mixture of 3:1 clay powder and gypsum was found suitable. The mass was sufficiently stable and adhesive, but was also elastic and soft enough not to damage the original clay plaster fragments.

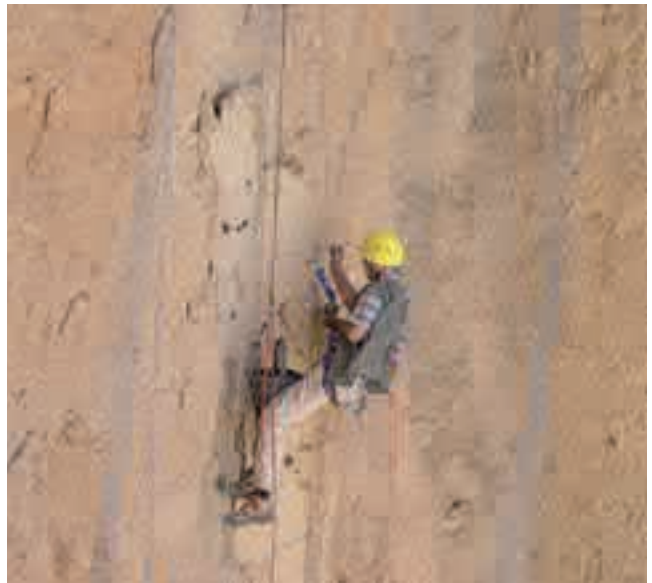
△ △ Emergency measure, alpine style, spot-bonding of clay plaster fragments in situ

This emergency stabilisation was carried out by abseiling from the back wall of the niche. It seems the danger of plaster fragments falling off through vibrations (rockfall, minor earthquakes) has been prevented for the time being. (Only in 2007 after the clearing of the niche scaffolds could be erected and the complete consolidation of the clay plaster sections could be carried out.)

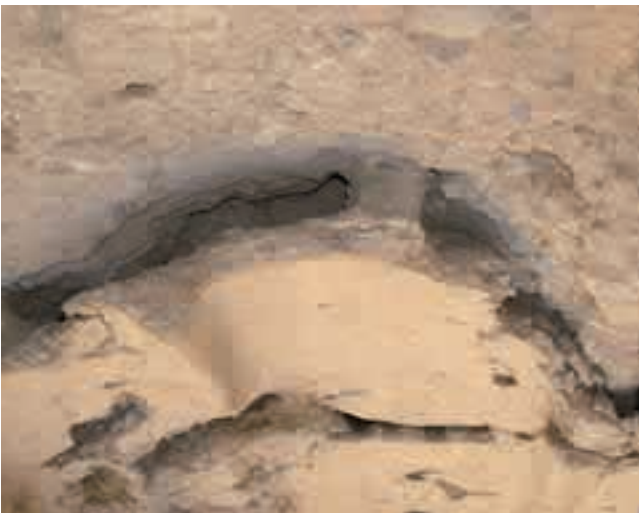
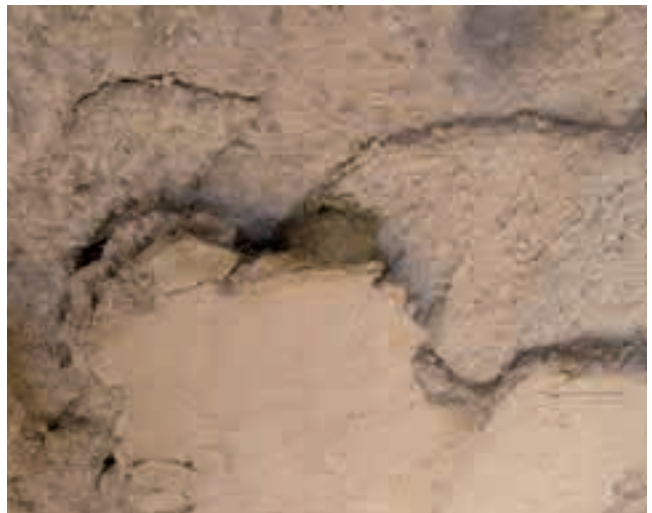
▽ ▽ Clay plaster fragments in situ at the Eastern Buddha, spot-bonding with clay-gypsum mixture
