Bert Praxenthaler

Report on Safeguarding the Remains of the Buddha Statues, 2009

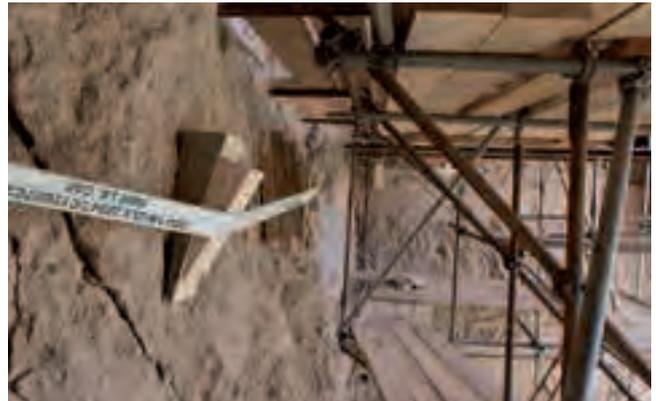
△ The protective net against rockfall had to be taken down

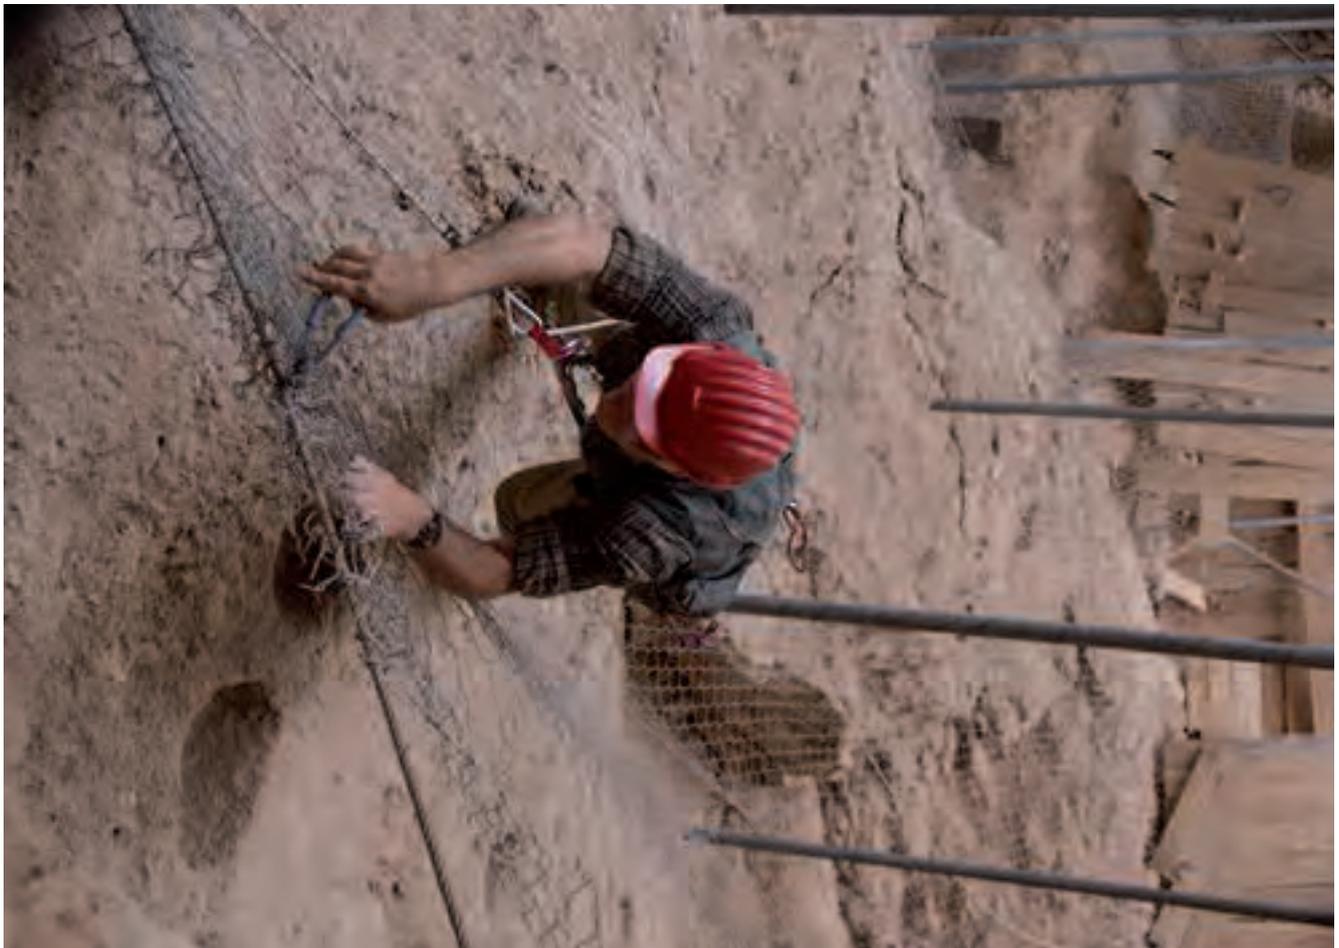
▽ Temporary covering of the brittle parts at the Eastern Buddha by means of heavy-duty tension belts as a first step of securing the back wall

1. Stabilisation with heavy-duty tension belts

At first, on both sides of particularly brittle spots anchors with ring eyelets were inserted. At these anchors tension belts were attached, which together with timber wedges as interlayers could prevent rock pieces from falling down. These tension belts are only meant as an interim measure and can be removed once the stabilisation is complete.

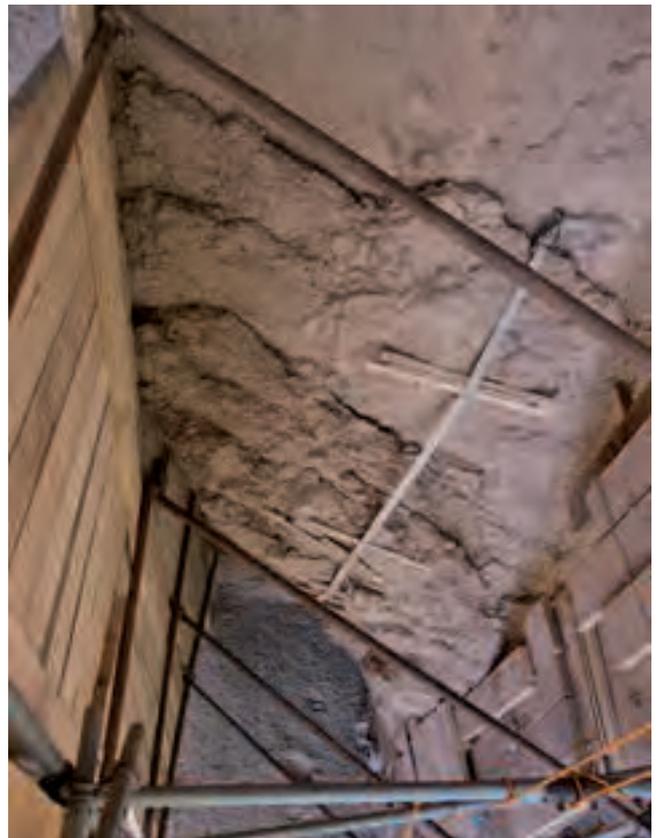
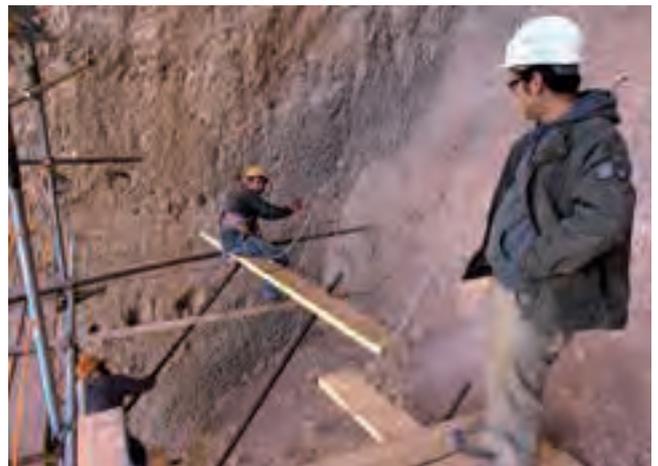
Bracket-like cantilevers are added to the scaffold so that the niche's back wall can be reached

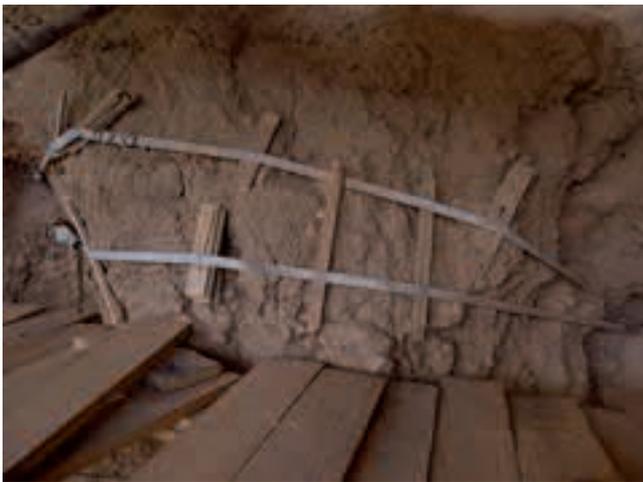
△ a

- a Temporary covering of the brittle parts
- b Sealing the cracks and backfilling step by step with mortar
- c Drilling of holes for the anchors (Ali Reza and Mujtaba Mirzai)
- d Removal of dust from the drilling holes with compressed air
- e Backfilling of mortar
- f Insertion of steel bars
- g The team at the Eastern Buddha
- h Exposing the Western Buddha's feet

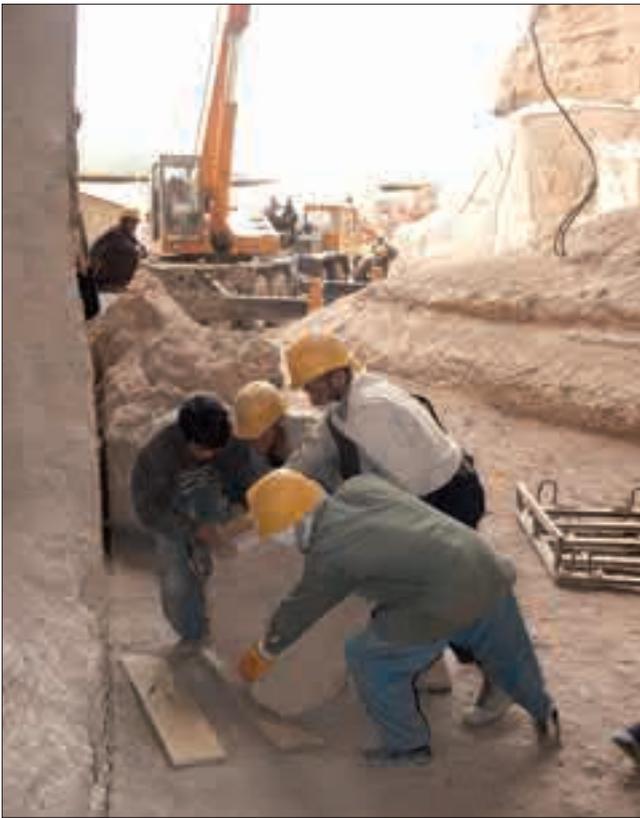
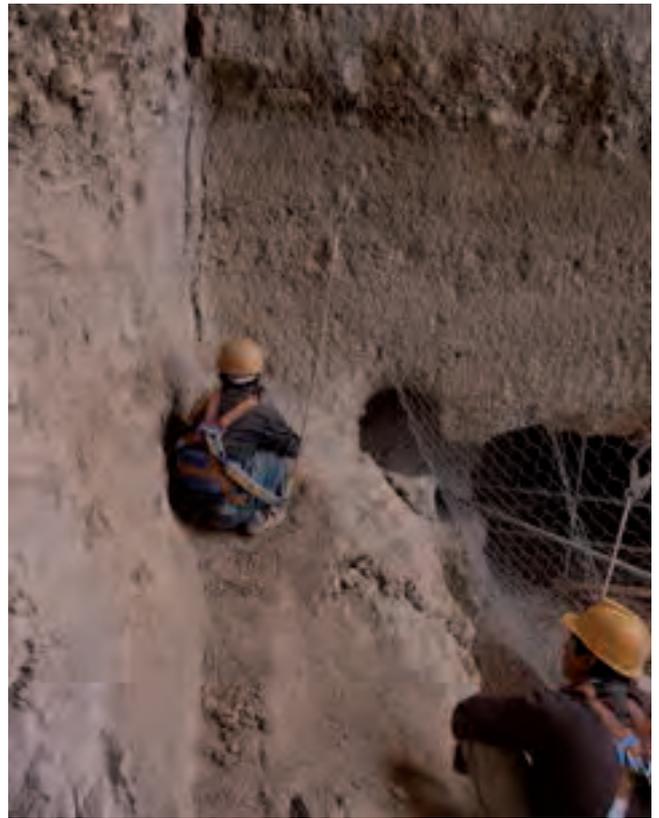
Removal of rock fragments with a heavy-duty crane (left). The steps near the Buddha's shoulder are cleared of rubble so that a temporary base for the upper zone of the scaffold can be added (right).

At the Western Buddha the salvage was continued, at first only with shovels and wheel barrows. Later on, a 25 t crane was used for removing smaller fragments which were blocking the entrances to the caves.

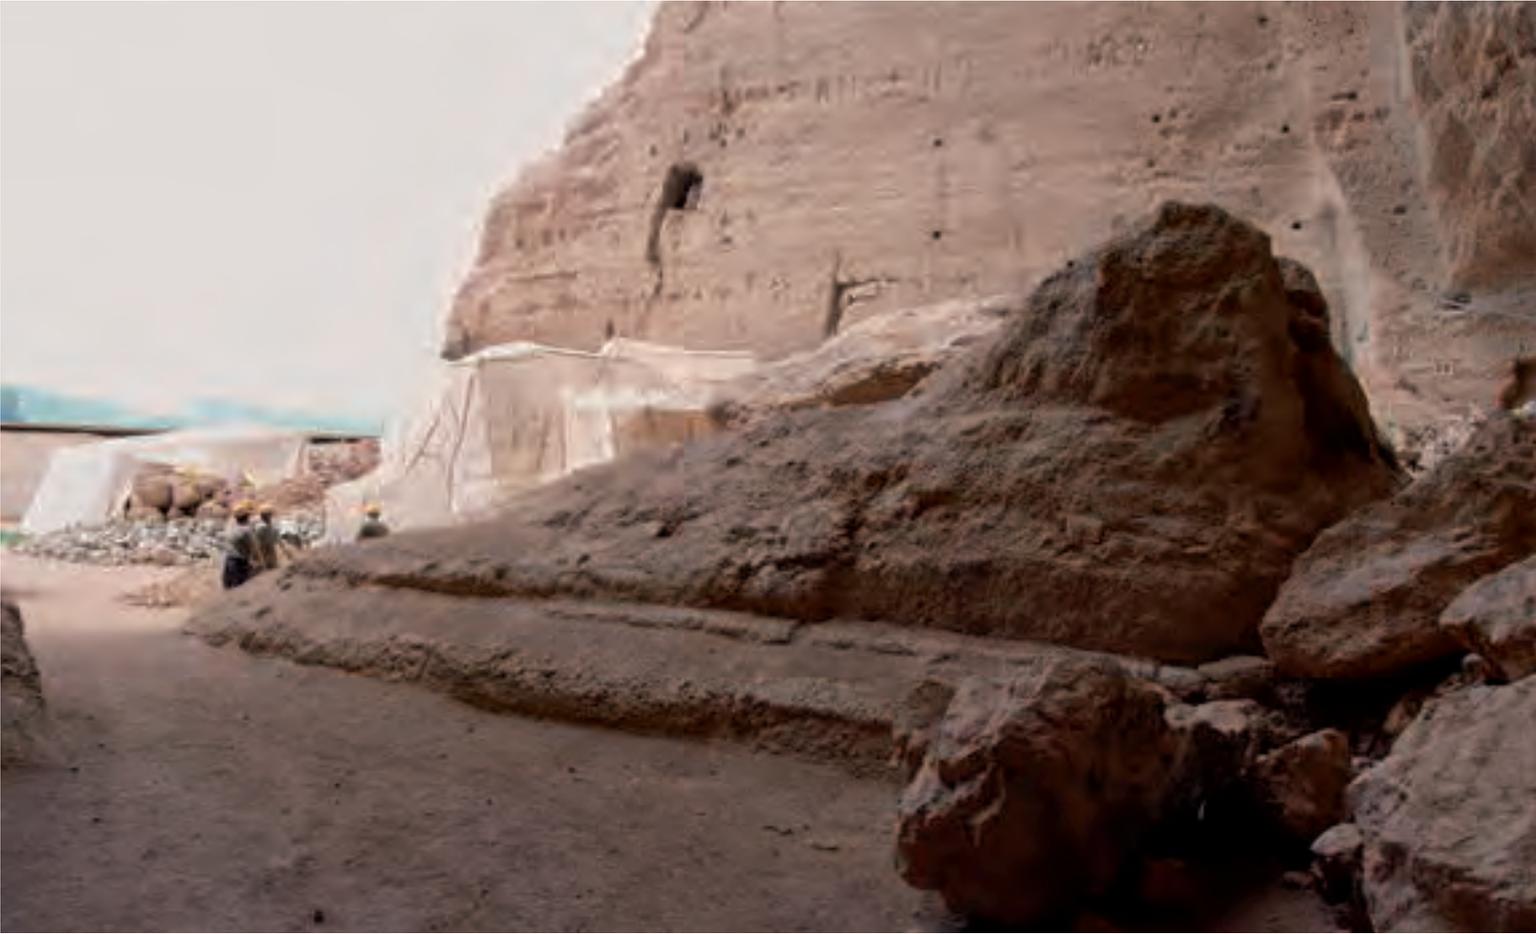
△ The feet of the Western Buddha are exposed

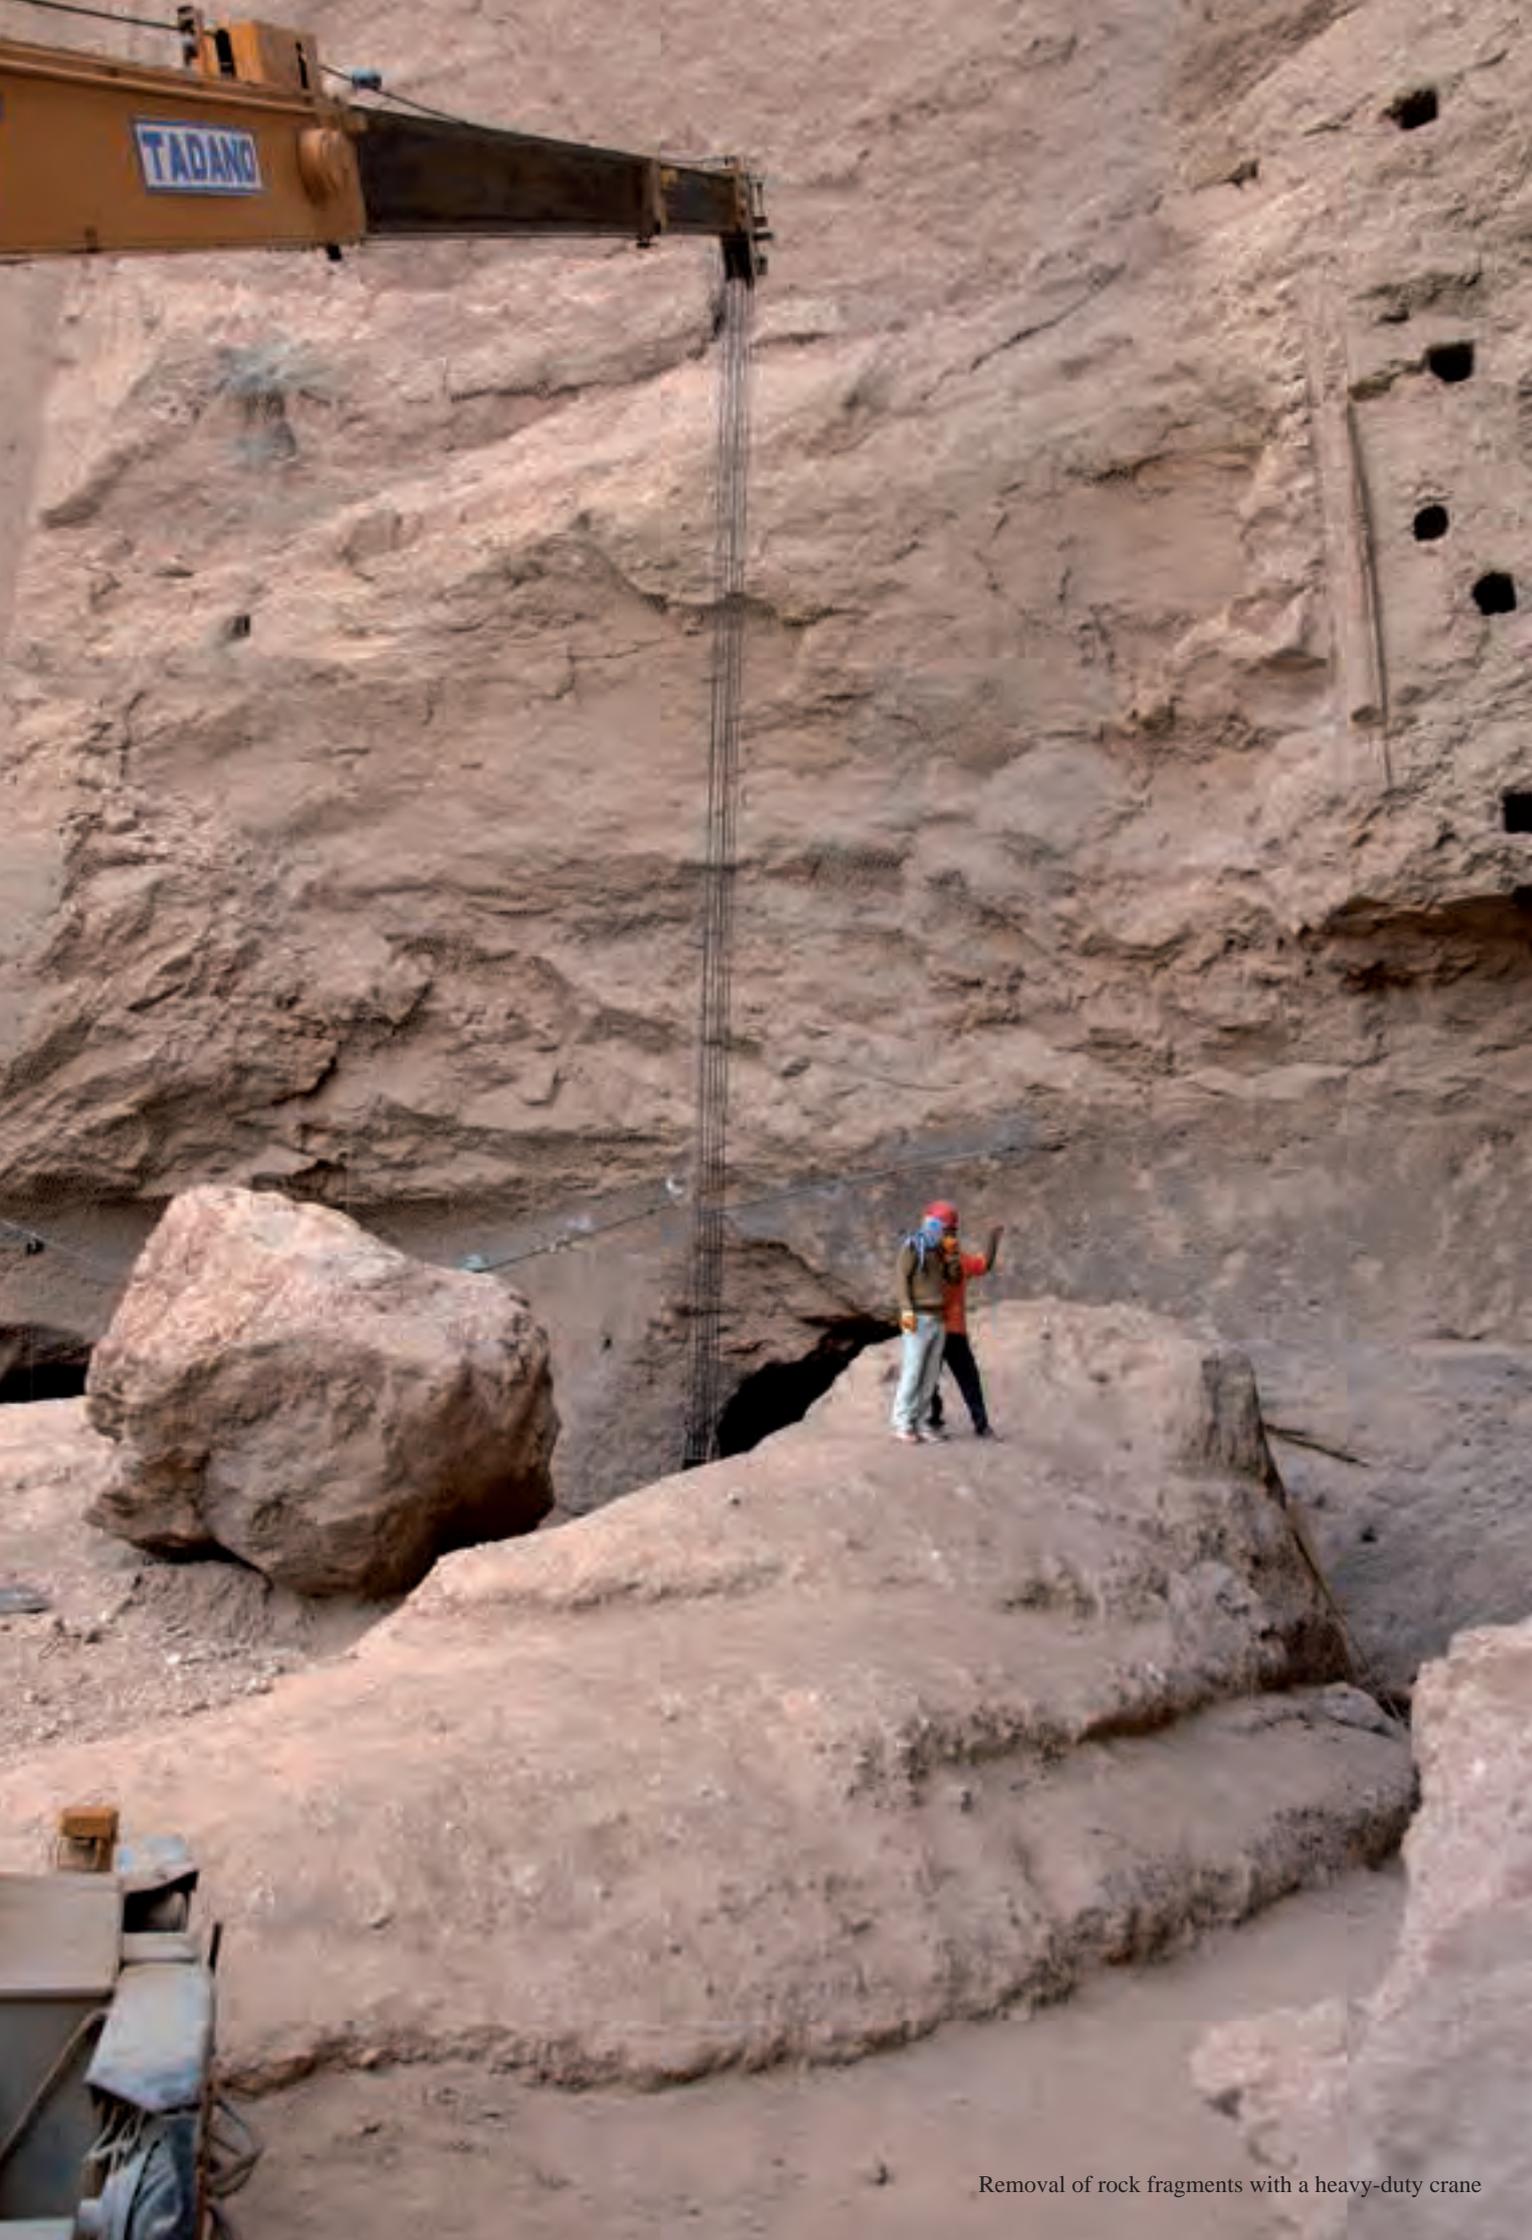
Removal of rock fragments with a heavy-duty crane

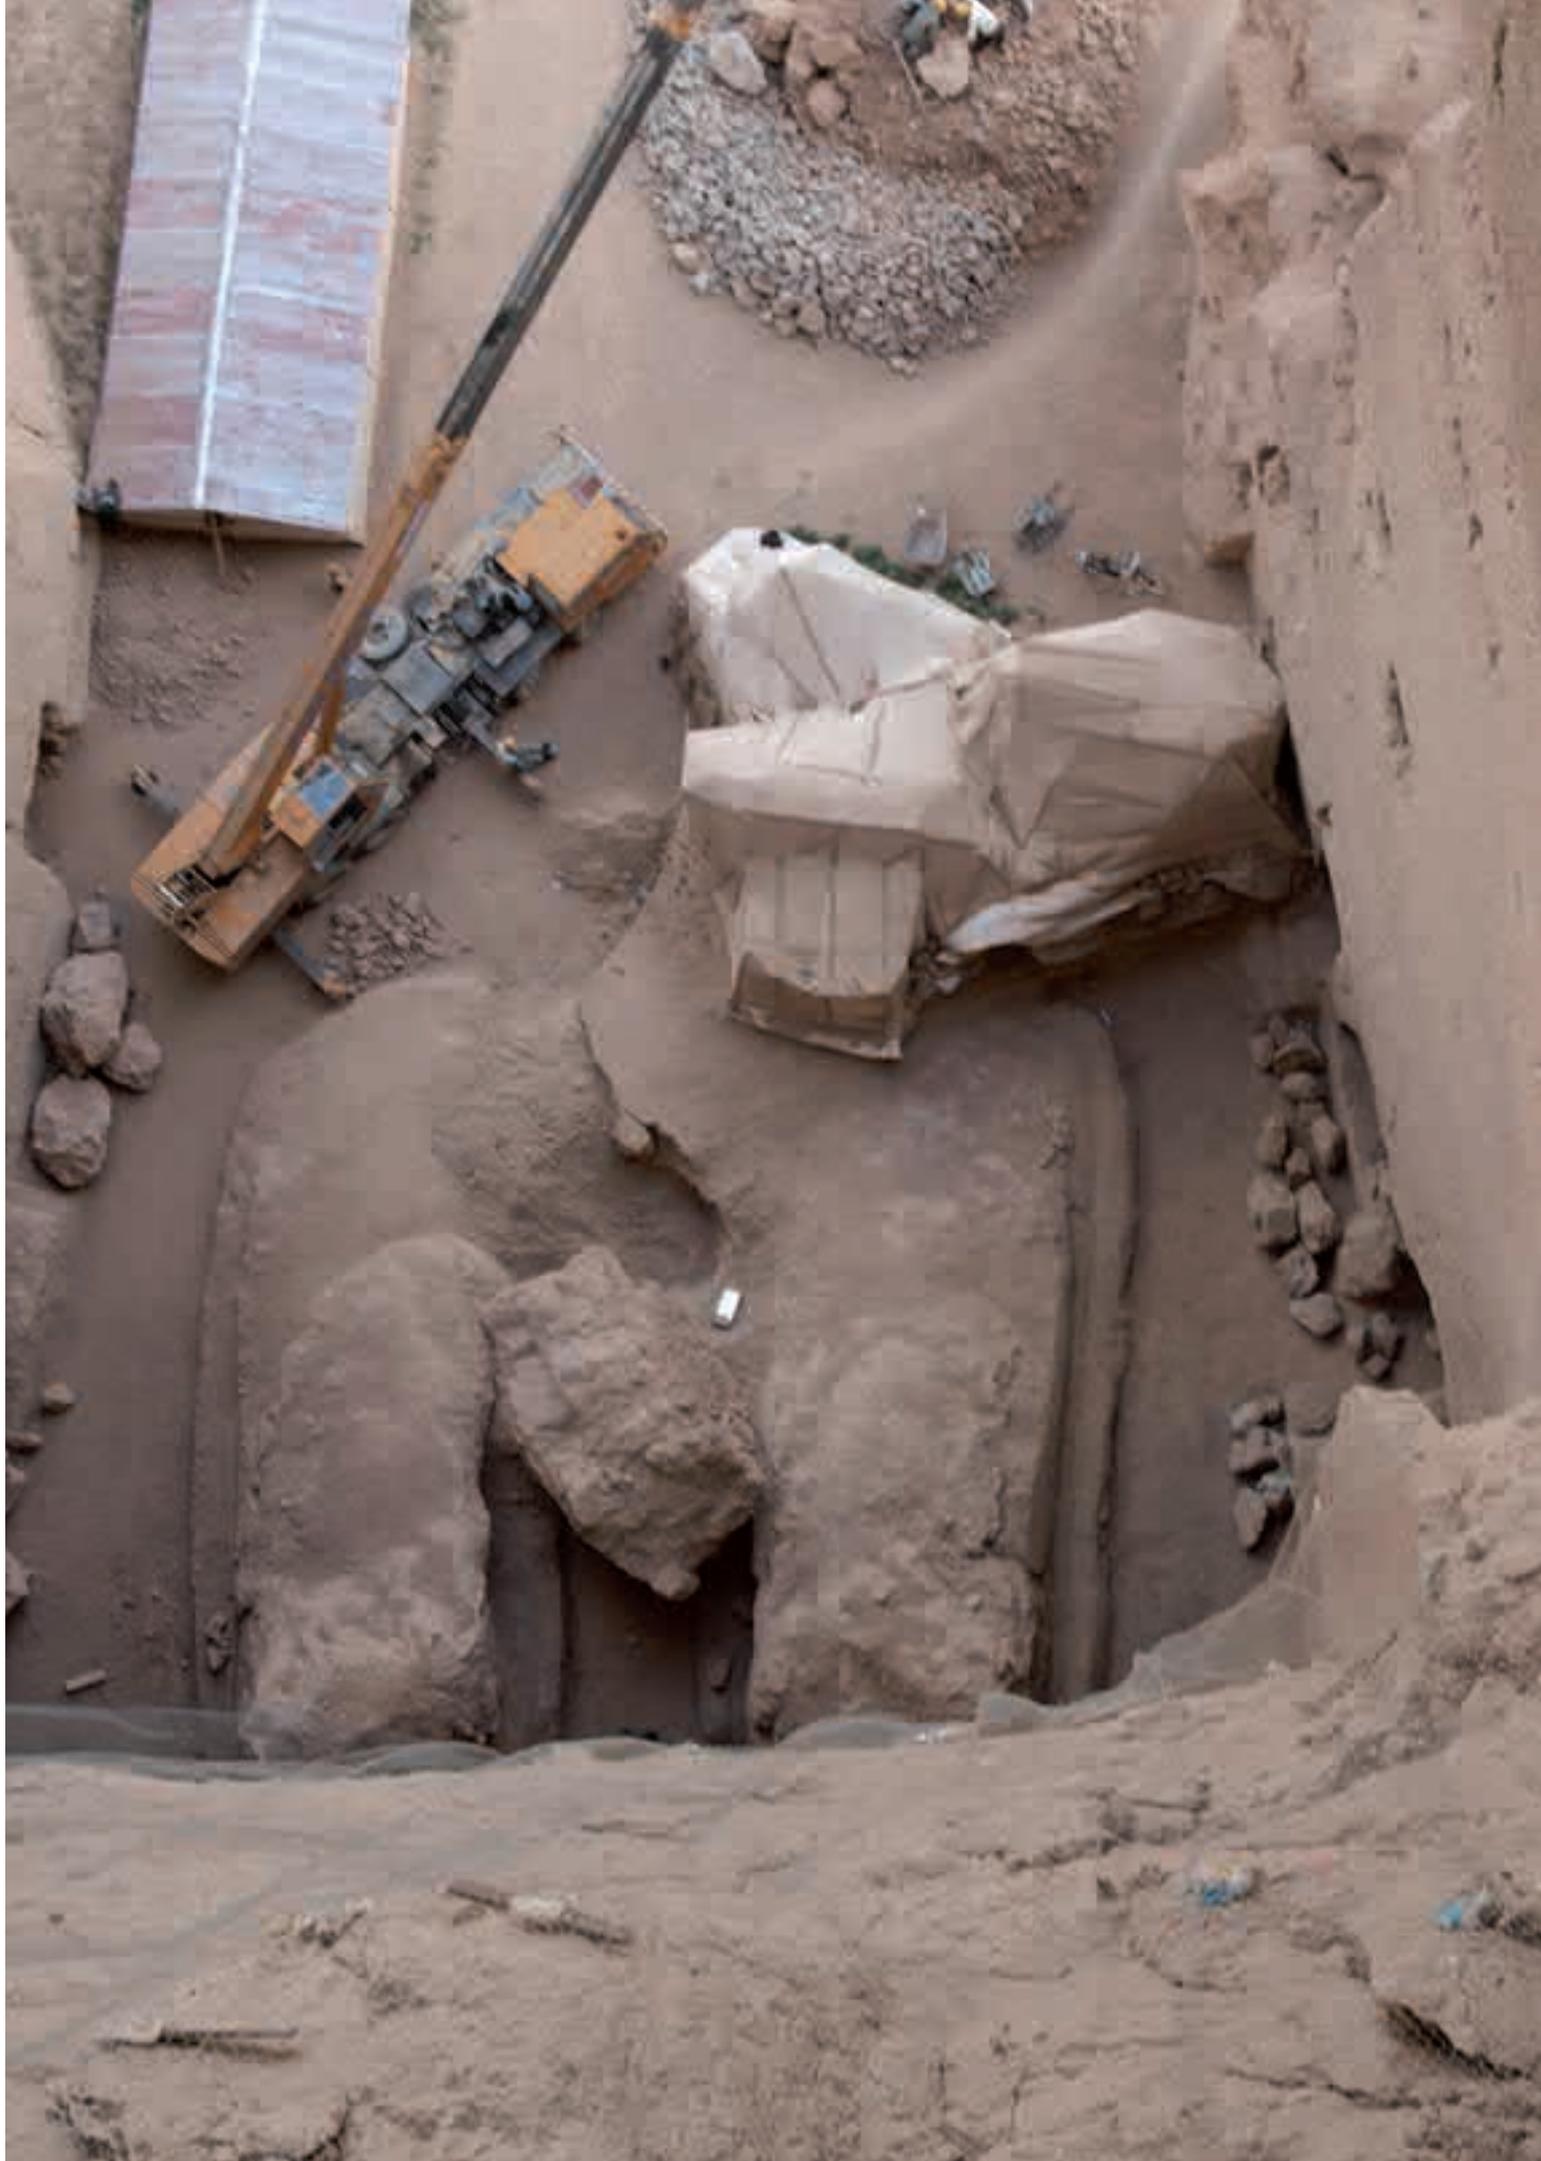
From above the Western Buddha's feet are now clearly visible
