Catharina Blänsdorf, Edmund Melzl

## Technique of Modelling the Buddha Statues

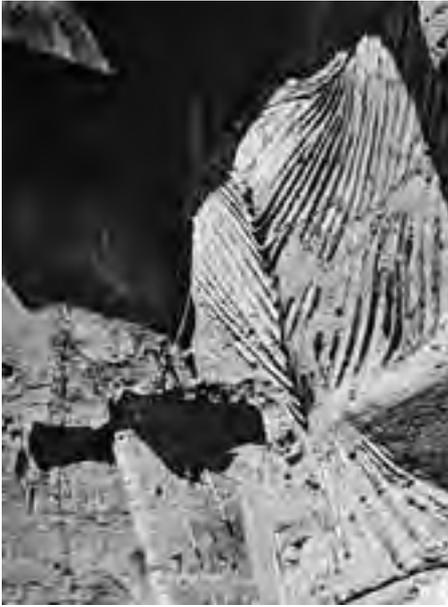
△ Fig. 1

Fig. 1. Jean Carl standing on the right forearm of the Western Buddha [HACKIN/CARL 1933, detail from fig. 23]. The wooden substructure of the forearm is lost, but Carl is standing on the upper coating of the arm which Hackin described as made of bricks. In the *sangati* the holes for the pegs and the partly damaged fold ridges can be recognised.

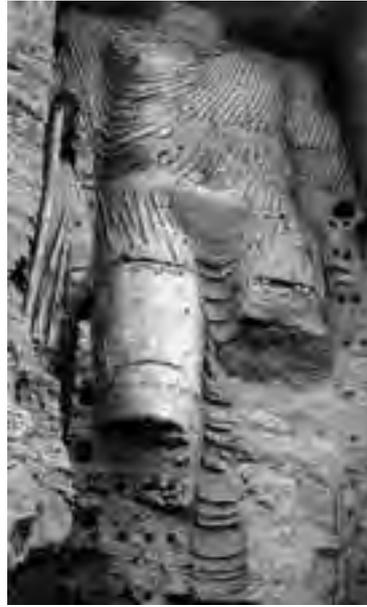
△ Fig. 2

Fig. 2. Western Buddha, holes of different sizes to insert wooden substructures. At the left arm, the part sculpted from the rock ends at the elbow. Forearm and hanging folds were modelled in clay over massive substructures. All fold ridges were applied in clay except for the deep ones between the legs. [ASI]

At the Western Buddha, the fine details are not created in stone: The *sangati* is smooth except for the large and deep folds between the legs. The forearms seem to stick out of the rock as well as the hem of the *sangati* hanging down over the forearms in thin, far-protruding ridges (fig. 2).

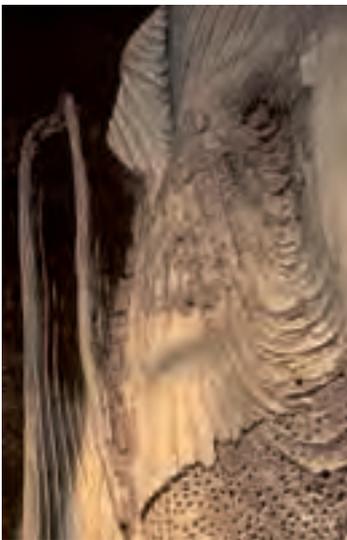
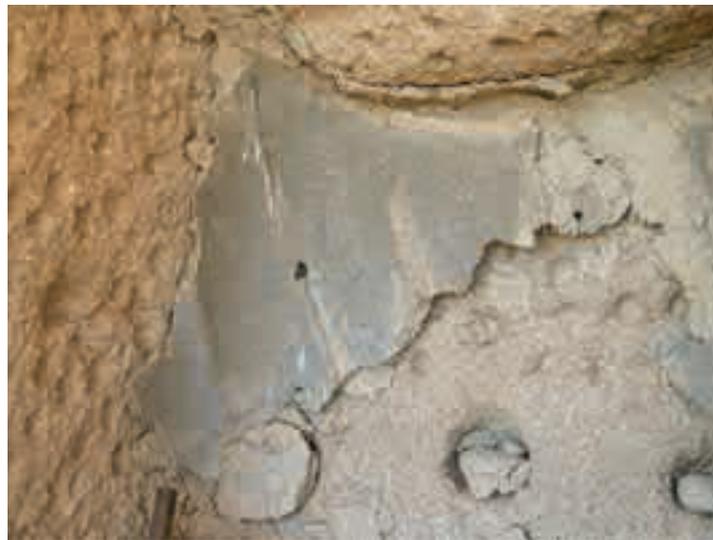
Fig. 3. Modelling system of the Eastern Buddha. Left: Right arm and right leg with holes in the stone visible in the lower part of the *sangati*. [NAMIKAWA 1999] Right: Detail under the right arm with preserved blue paint layer. In the holes the pebbles for anchoring the clay are visible. [Praxenthaler]

The examination within our project showed that the holes are about 7 cm wide and of the same depth. They are positioned with a distance of 10 to 12 cm between each other. When the clay was applied, pebbles were pressed into the holes together with the clay, thus serving as mechanical interlocking between the stone and the clay layers. Some of the pebbles, together with remnants of the clay layer, have been found in-situ below the right arm (fig. 3).

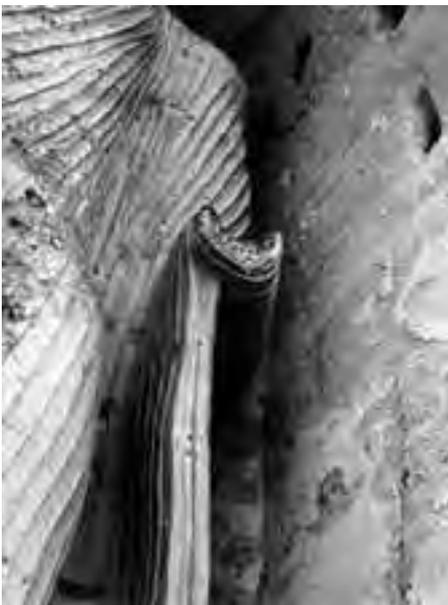
Fig. 4. Left arm of Eastern Buddha in 1965: U-shaped part cut from the stone with holes visible at the hem of the sleeve cuff. The wooden support and clay cover of the top are already lost. [ASI]

The holes can also be seen on the edge of the sleeve cuff of the left arm, indicating that the whole forearm was worked in stone. The hands were already lost in the 19<sup>th</sup> century. In the historical photographs the forearms seem to be open on the upper side: It seems that the forearms were sculpted from the stone in a U-shaped form (fig. 4). At the end (i.e. the elbow) a deeper square hole was driven into the stone which can still be seen today. An anchoring construction was inserted into the U-shaped channel in the arm and pushed into the hole at its end where the stone stabilised it against tilting forward due to the weight of hand. The upper side of the arm was then closed, probably either with bricks or with clay. The anchoring construction was probably made of wood, either of a thick beam or of several beams put together.

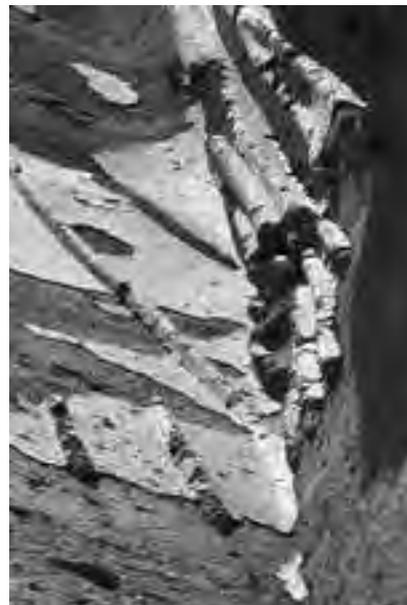
Fig. 5. Below the right arm of the Western Buddha: The fold ridges are modelled in clay on the smooth stone surface. [Keith Worsley-Brown, June 1972]

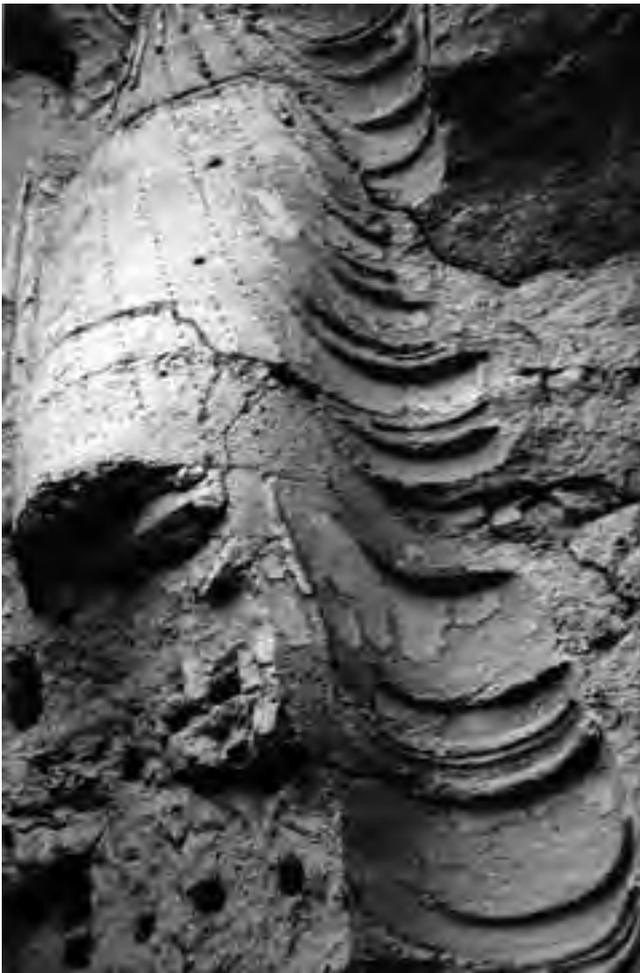
Fig. 6. Western Buddha, detail of right leg in 1965 [ASI] and sketch demonstrating the system with wooden pegs and ropes [Tarzi 1977, vol. 2. p. 117]

The system of ropes and pegs was a phenomenon that the authors of the 19<sup>th</sup> and early 20<sup>th</sup> centuries described as peculiar and amazing. In 1977, Z. Tarzi published sketches demonstrating the anchoring system of the fold ridges and of the larger broken-off parts part of the right leg (fig. 6).<sup>8</sup>

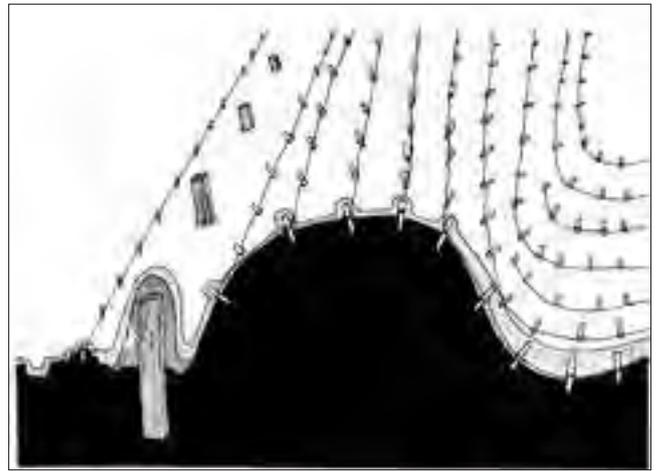
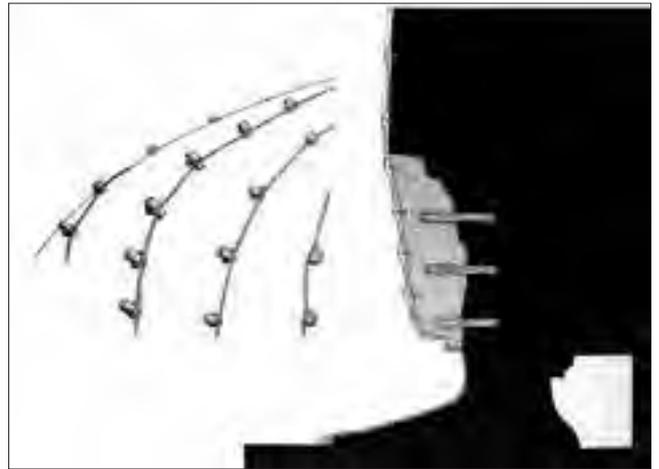
Fig. 7. Demonstration of system with fragments found in the rubble [Melzi]: Peg inserted into a hole in the stone (left) and peg inserted into a preserved eye in a rope (right).

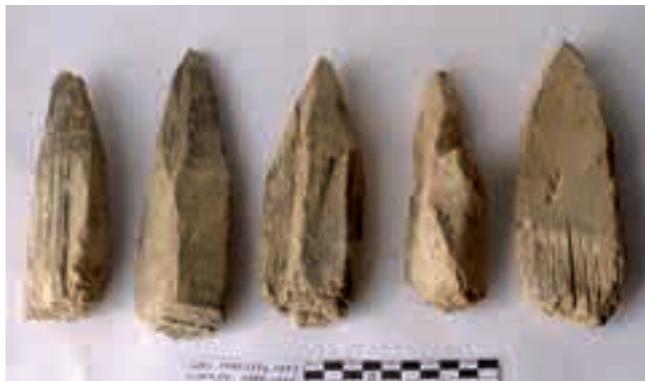
Fig. 8. Selection of pegs, GBL 1371-75. Peg GBL 1375 shows weathering at the end [Melzl]

The pegs are usually square or trapezoid in diameter and pointed. They measure between 12 and 20 cm in length, with an average of 16 cm (fig. 8). Many show traces of a saw at the cross section (fig. 9). The sides were hewn with an axe or a knife. Smaller pegs, sometimes wedge-shaped, of 8 to 12 cm length, apparently served to stabilise the peg inside the hole.

clay was reduced or lost (fig. 8, right).<sup>10</sup> Very few pegs show signs of wood pest or fungi attack.

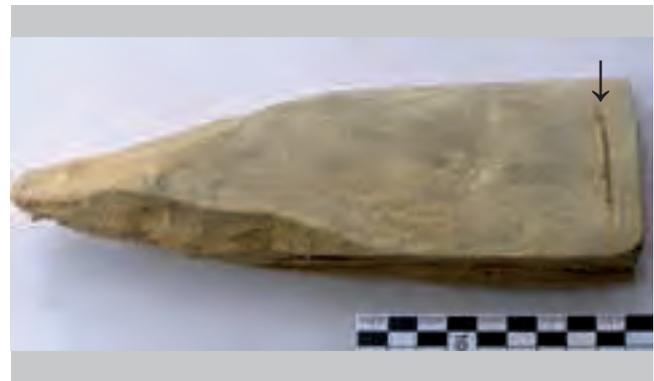
Fig. 9. Peg GBL 810 with cut of a saw (arrow) [Melzl]

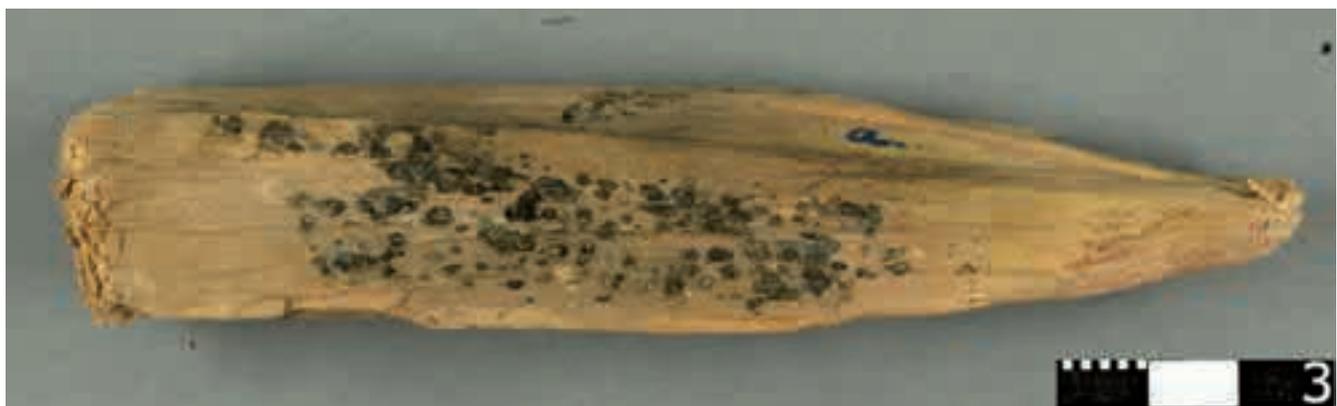
Fig. 10. Peg no. 'a'. Black dots on the wood. Traces of pink slurry on the tip of the peg [Blänsdorf]

Many pegs and also the reverse sides of some fragments show black dots, sometimes covering large parts of the wood (figs. 10–12). These black dots are of microbiological origin. Normally humidity is extremely low in Bāmiyān. Thus, this microbiological growth may date back to the creation of the statues when thick layers of clay provided enough moisture to allow microbiological growth.

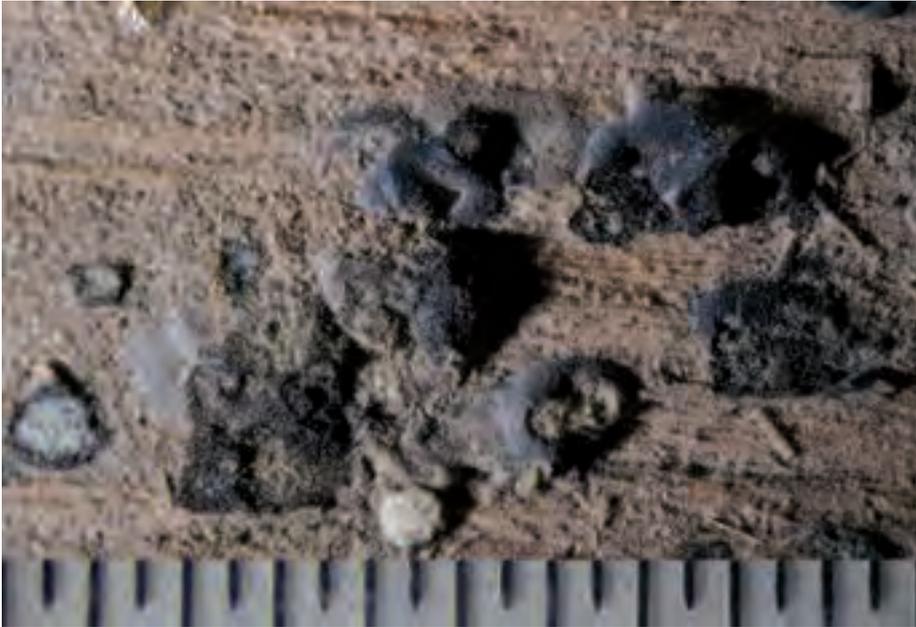
Fig. 11. Peg no. 'a'. Detail of black dots [Blänsdorf]

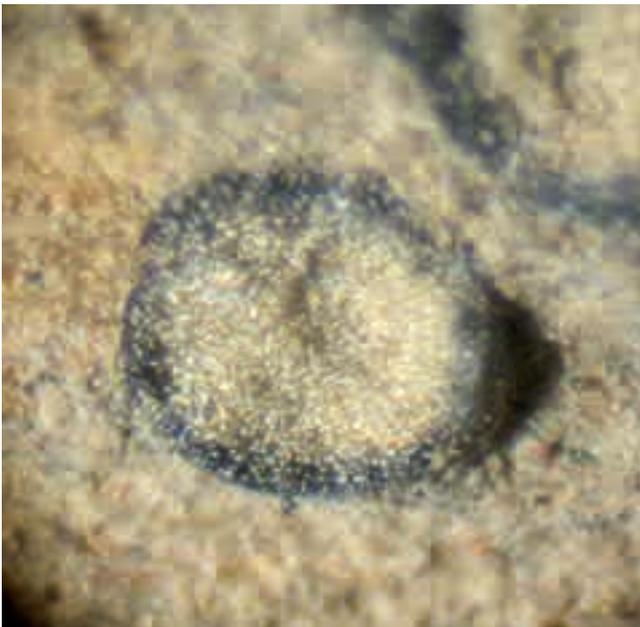
Fig. 12. Peg no. 'a'. Shell of dot opened to reveal white round material, indicating the microbiological origin of the dot [Blänsdorf]

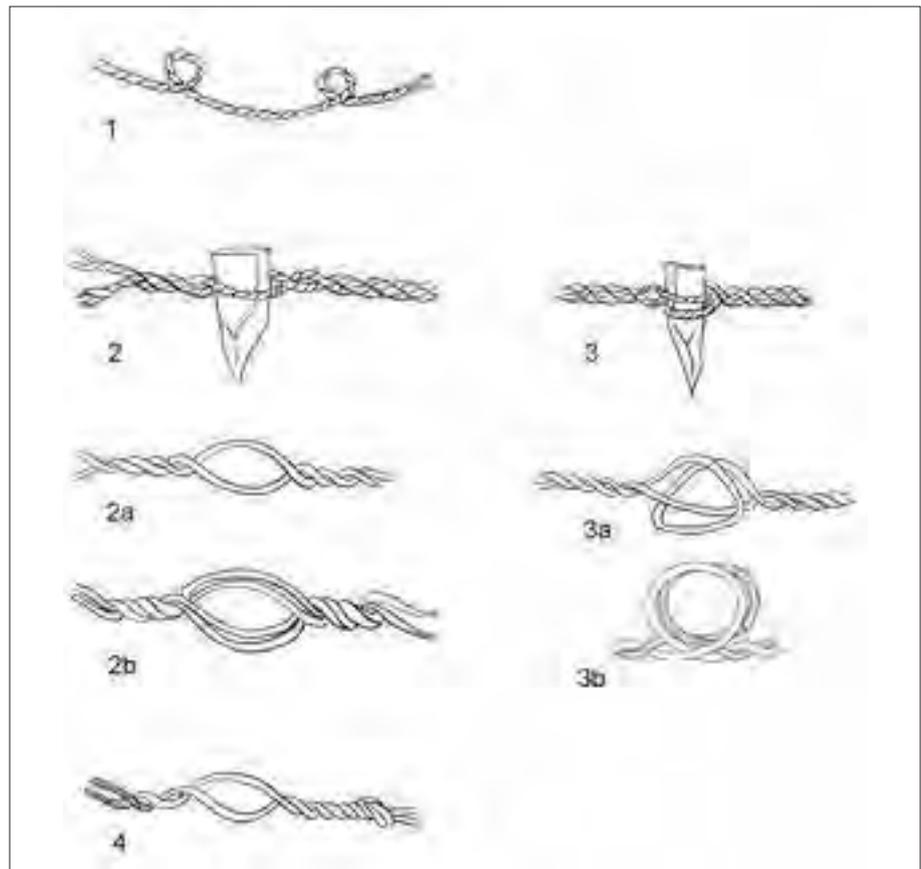
Fig. 13. Different ways of inserting pegs into the rope [Blaensdorf, Melzl]:

- 1 S-plyed rope with simple loop
- 2 double rope with simple eye
- 2a Z-plyed double rope with simple eye
- 2b two Z-plyed double ropes with simple loop
- 3 double rope with loop
- 3a Z-plyed double rope with loop in one rope
- 3b Z-plyed double rope with loop in both ropes
- 4 Z-plyed rope split to insert rope

The ropes are rather thin, but show a durable quality. They vary in thickness, colour and manufacture technique.<sup>12</sup> The ropes were attached to the pegs in different ways (fig. 13). The simplest way was to take one rope and wind it around the peg once before continuing to the next peg (fig. 13, 1). Mostly two ropes had been plied together to form a double rope. To insert a peg, the twist was opened to form an eye (fig. 13, 2, 2a). Four ropes were plied together as well and used the same way (fig. 13, 2b; 14). Often one of the ropes or both (fig. 13, 3a and 3b; 15) are wound around the peg once, thus allowing to regulate the tension of the rope. In a rare case, a rope was split and the peg inserted between the strings (fig. 13, 4 and 16).

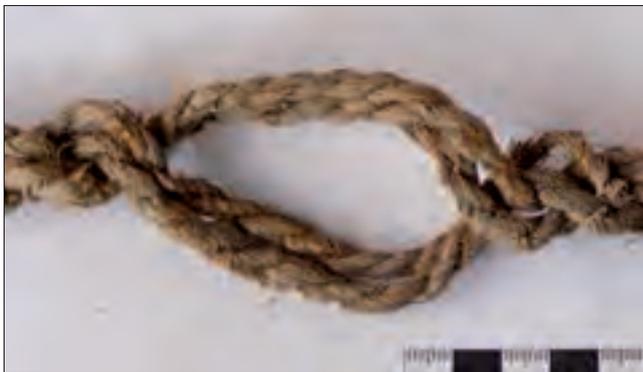
△ Fig. 14. GBL 1447: Double ply of four ropes with simple eye [Melzl]

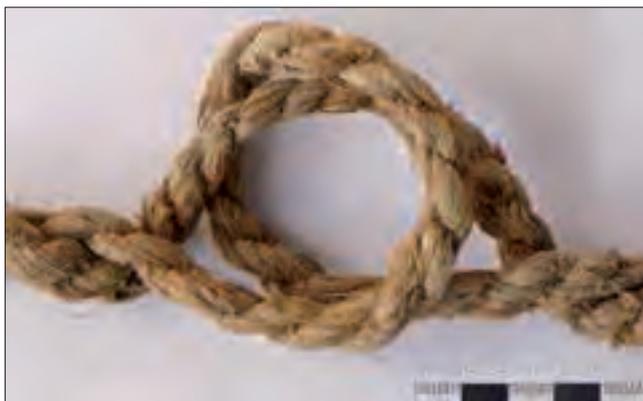
▽ Fig. 15. GBL 1386: Plyed double rope with loop in one rope [Melzl]

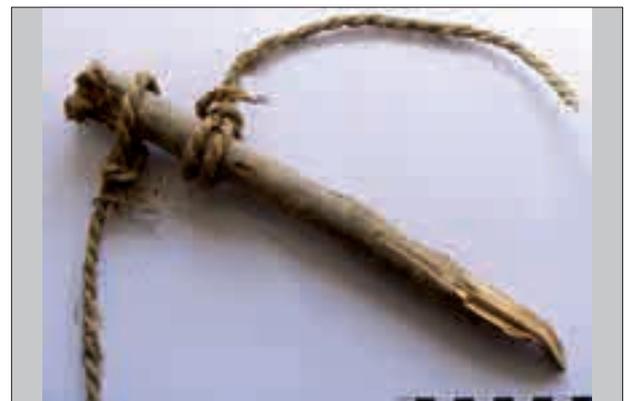
▽ Fig. 17. Round peg GBL 1773 with two ropes [Melzl]

Generally pegs and ropes were separated during the destruction of the statue. Only very few pegs have been found that are still connected to pieces of the rope.<sup>13</sup> In one case two ropes were affixed to a round wooden armature with two knots (GBL 1773, fig. 17).

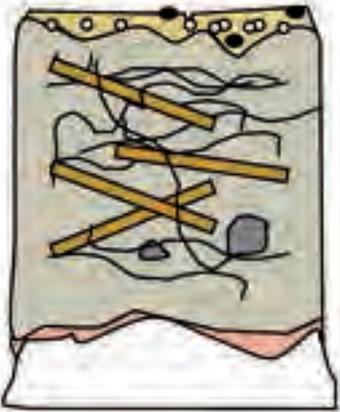
◁ Fig. 19. Traces of pink slurry on the back of a clay fragment. Plant material is visible in the undercoat. [Melzl]

Observations have been made during the collection of the fragments and on the sample material sent to Munich. On most of the fragments two layers can be distinguished, consisting of a thick undercoat (‘arriccio’) and a thin finish coat (‘intonaco’). Underneath traces of a slurry have been found (fig. 19).

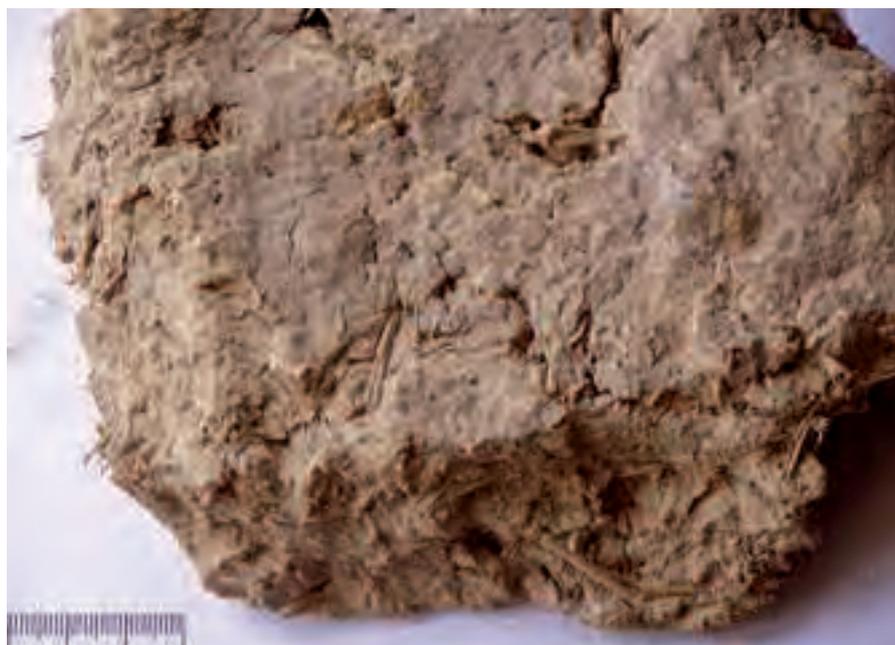
type of layer	colour/properties	additive	thickness
	finish coat ('intonacco')	more yellowish, hard, compact	sand, hair, charcoal	0.05–0.5 cm (often 0.2 to 0.3 cm)
	under coat ('arriccio')	more greyish, less compact, rather inhomogenous, inclusions of lime	threshing, residues, hair, pebbles	max. 15–19 cm (depending on shape)
	clay-lime slurry	reddish pink, rarely grey or yellow		< 0.2 cm

△ Fig. 18. Schematic structure of clay layers

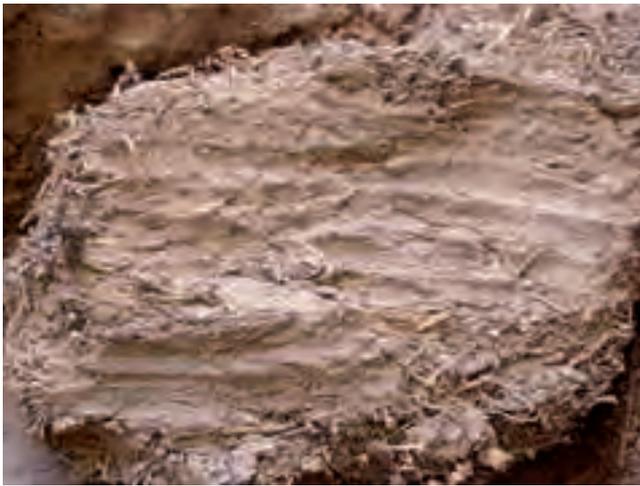
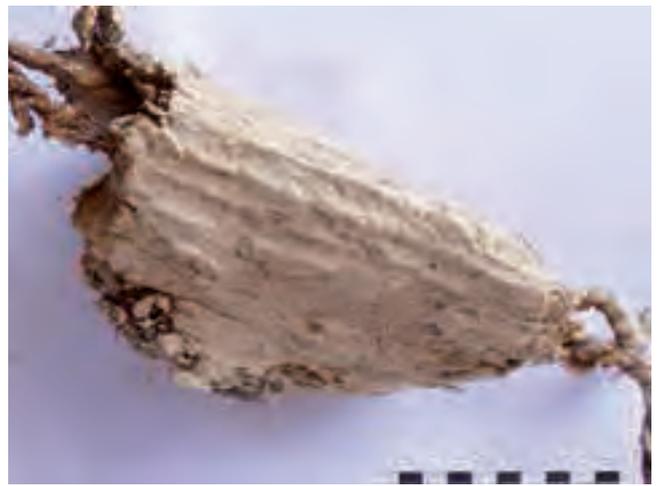
Fig. 20. Traces of fingers in the undercoat layers: Left: Fragment on-site. Right: Fold ridge of Western Buddha, fragment GBL 1088: Undercoat of a fold ridge of the Western Buddha [Melzl]

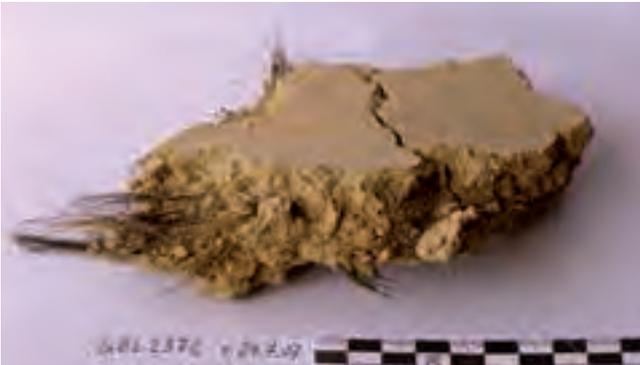
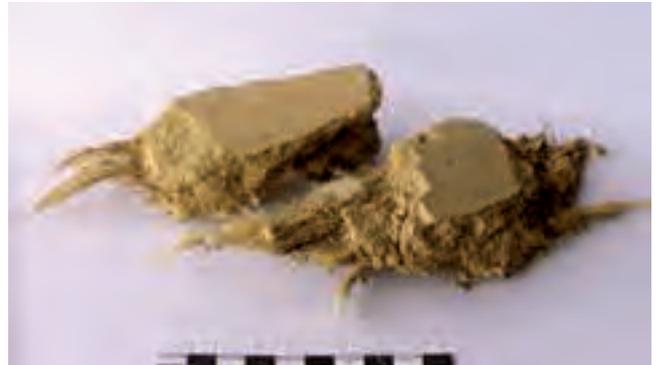
Fig. 21. Hair, sometimes in tufts, in the undercoat of the Western Buddha [Melzl]

The added animal hair is white, brown, and black. At the Western Buddha it sometimes occurs in surprisingly big tufts (fig. 21). The addition of animal hair is an important peculiarity of the clay from the statues. Animal hair is not found in the plasters of the cave murals. In fragments from caves next to both statues, the coarse clay plaster contains straw and chaff and very few, very fine bast fibres (maybe jute). The fine clay layer does not contain any organic additives. Using these criteria, clay fragments from the statues can be distinguished from the ones of the caves. An additional criterion is that on fragments from the caves the surface usually is rather blackened by soot.

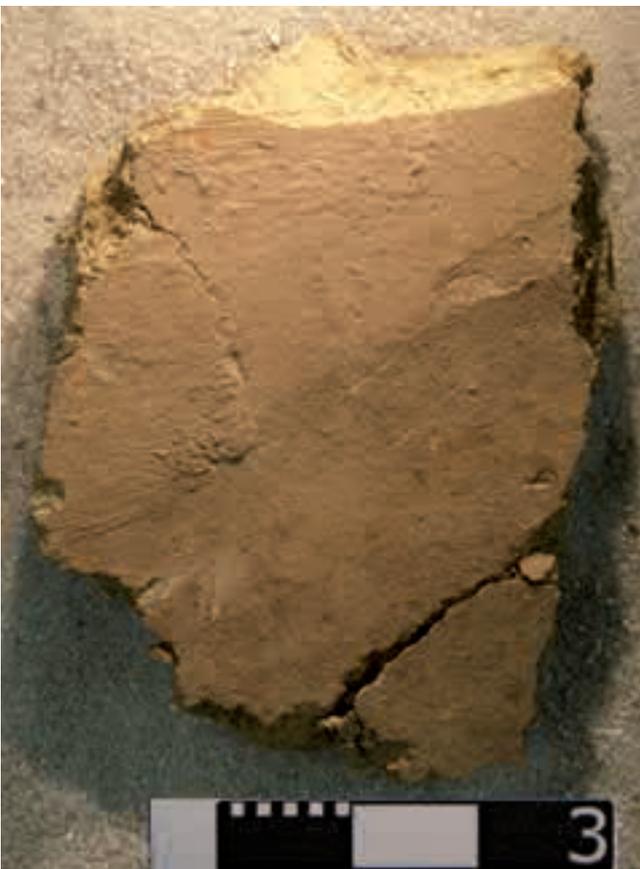
◁ Fig. 22b. Fragments photographed in raking light showing 1 cm wide traces of modelling tools, ID 282 of GBL 775, size of sample 4 x 5 cm [Thiemann]

1 cm width indicate that flat modelling tools were used (fig. 22)<sup>29</sup>. Two pieces of leather detected in the rubble<sup>30</sup> can be interpreted as polishing tools.

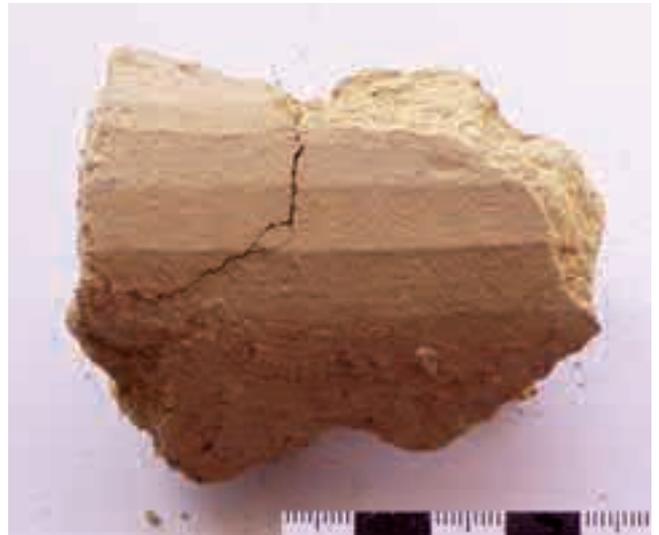
▽ Fig. 22a. Fragments photographed in raking light showing 2.5 cm wide traces of modelling tools, GBL 2425, length of fragment 7 cm [Melzl]

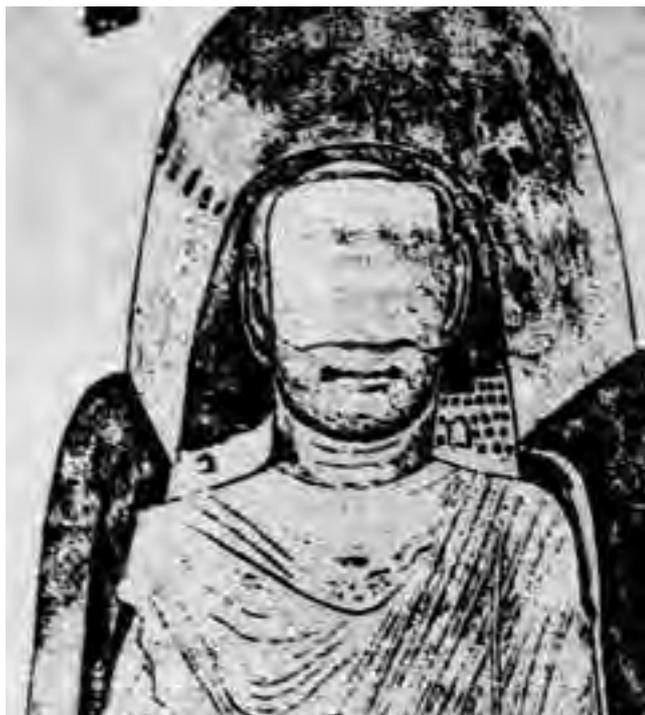
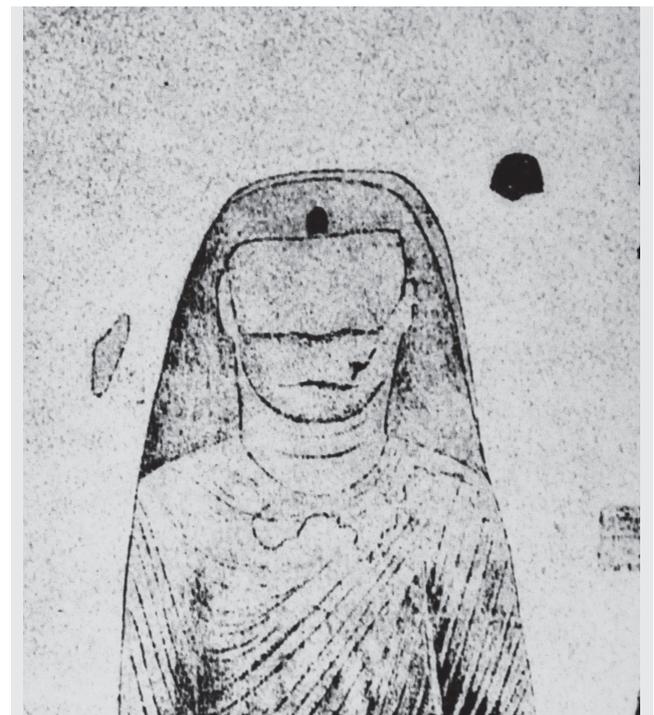
Fig. 23. Earliest correct drawing by Maitland 1885 showing that the faces were cut-out and not weathered or mutilated [Talbot/Simpson 1886, p. 348]

In 1885, Maitland sketched the two statues in a remarkably detailed way. His drawings show clearly that the faces were not broken off, but cut-out systematically, leaving a smooth vertical wall above the mouth. All later photographs corroborate the state indicated in his drawings (fig. 23). Cutting out the faces meticulously to leave a regular recess without damaging the surrounding parts does not look like the result of spontaneous violence – comparable to the shooting with cannons or hacking holes into the faces of deities painted on murals.

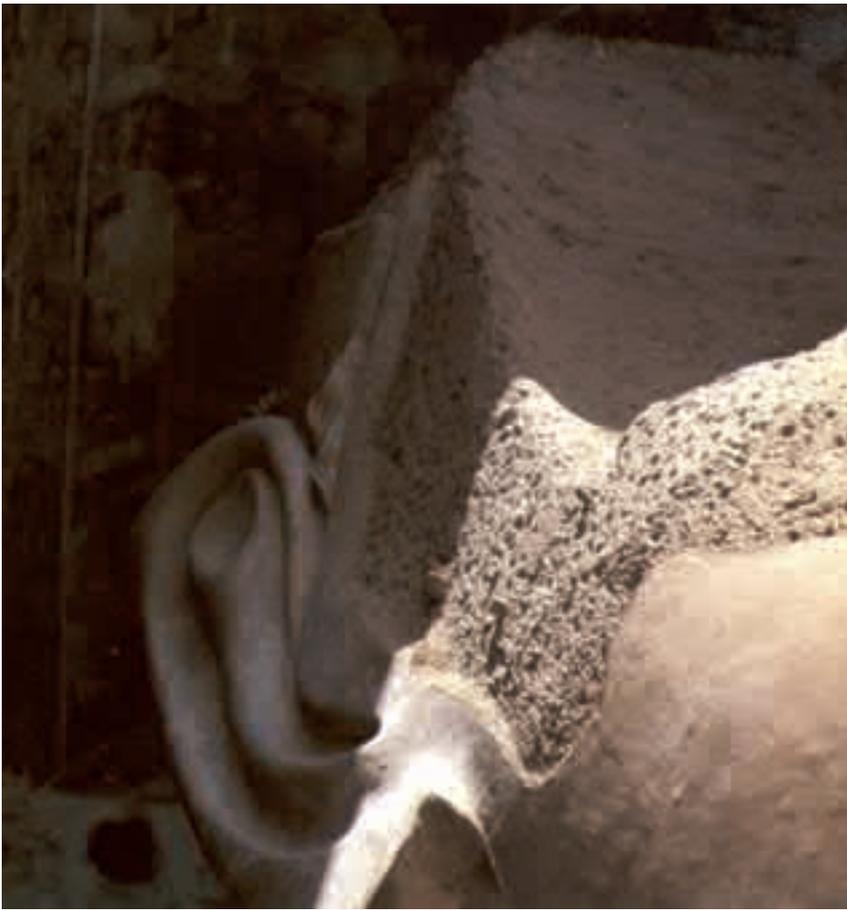
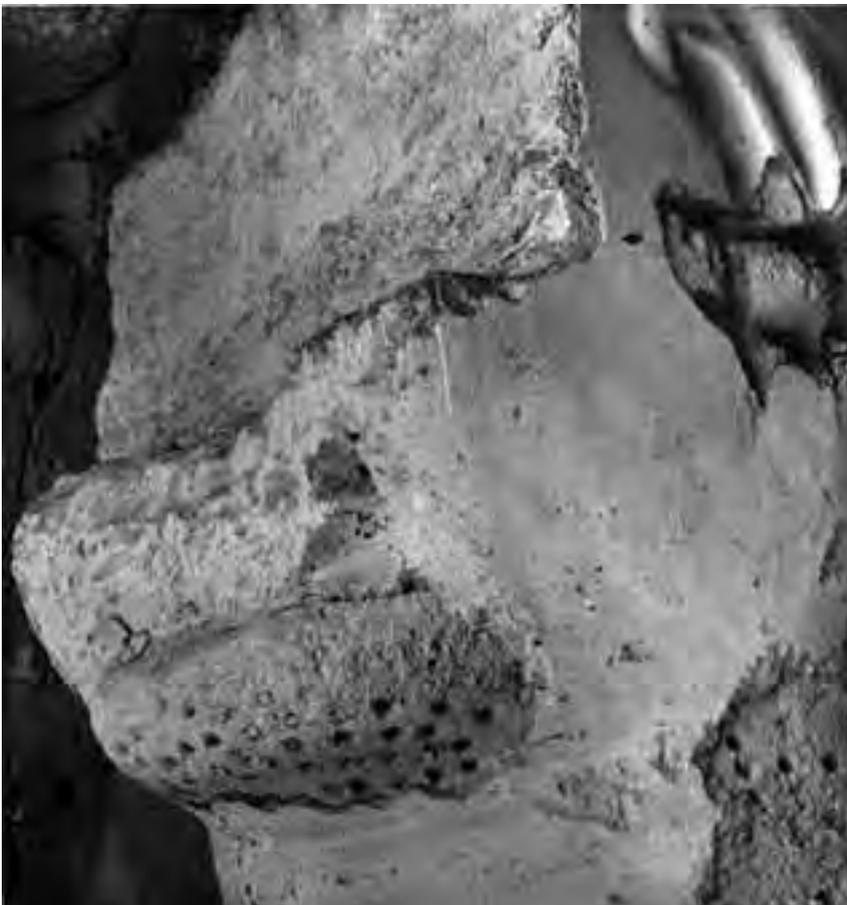
Fig. 24. Faces: Photographs and drawings showing the cut-out faces and the trench at the bottom to insert a wooden substructure

During the Indian restoration in 1969-78, the faces could be reached from a scaffold and examined in a much closer way than before. A trench was discovered between the horizontal and the vertical wall of the recess (fig. 24), suited to insert a support structure. Pieces of charred wood and charcoal were detected as well. This led to the conclusion that the faces were probably cut-out from the beginning and modelled over a rack of wooden poles which afterwards was covered with clay plaster.<sup>44</sup> The reasons why such an unusual and unique design for the faces was chosen cannot be explained yet.
