CHEMICAL CHARACTERISATION OF THE ORGANIC MATERIALS USED FOR THE CONSTRUCTION OF THE TEMPLES AND BUILDINGS IN MỸ SƠN (VIETNAM) FROM THE CHAMPA KINGDOM

Diego Tamburini^{1,a,*}, Jeannette Jacqueline Łucejko^{1,2}, Erika Ribechini¹ and Maria Perla Colombini^{1,2}

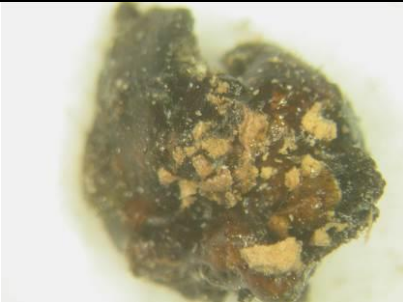
Sample name	Brief description	Image
R	Ca. 5 g of fresh natural resin used for restoration (dầu rái resin from <i>Dipterocarpus alatus</i>)

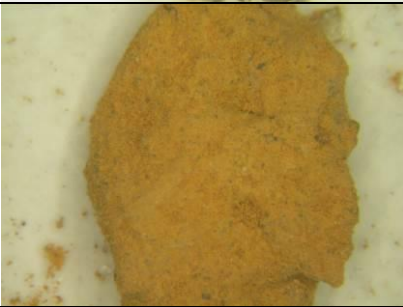
G	Sample taken on 22.01.2011 from the G Group: it is from the mortar between two bricks

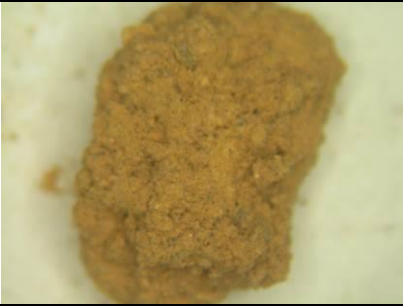
G1	Sample taken on 21.04.2011 from the G Group: it is from the mortar of G1 cella

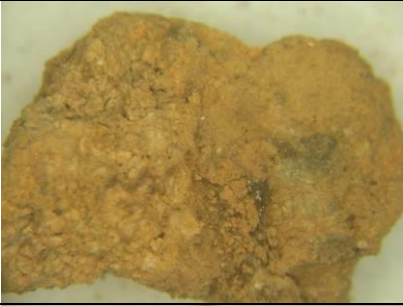
G1a	Sample taken on 21.04.2011 from the G Group: it is from the mortar of the entrance of G1 cella

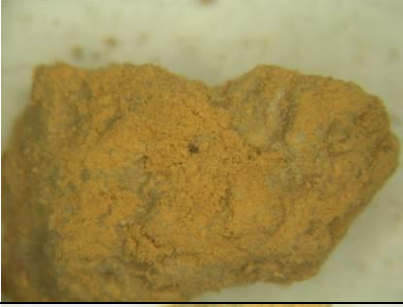
G1b	Sample taken in June 2013 from the G group: it is the plaster of G1 cella

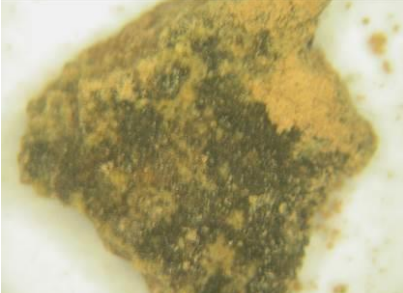
A1	Sample taken on 21.04.2011 from the A1 cella: it is the plaster on the bricks

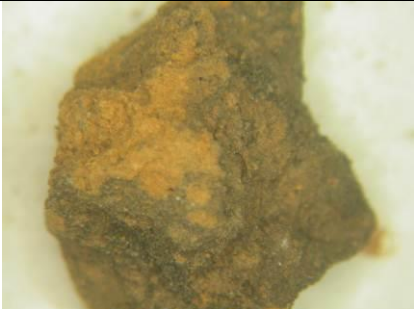
<p>A1a</p> <p>Sample taken on 22.04.2011 from the A1 architectural stone block: plaster</p>

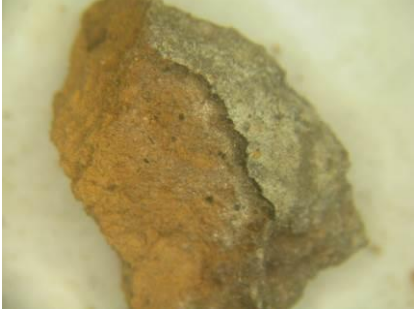
<p>E7</p> <p>Sample taken in June 2013: plaster</p>

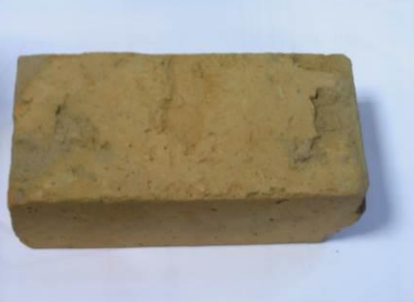
<p>Brick</p> <p>Whole brick dated back to 12th century. A sample was taken from the surface, corresponding to the plaster.</p>

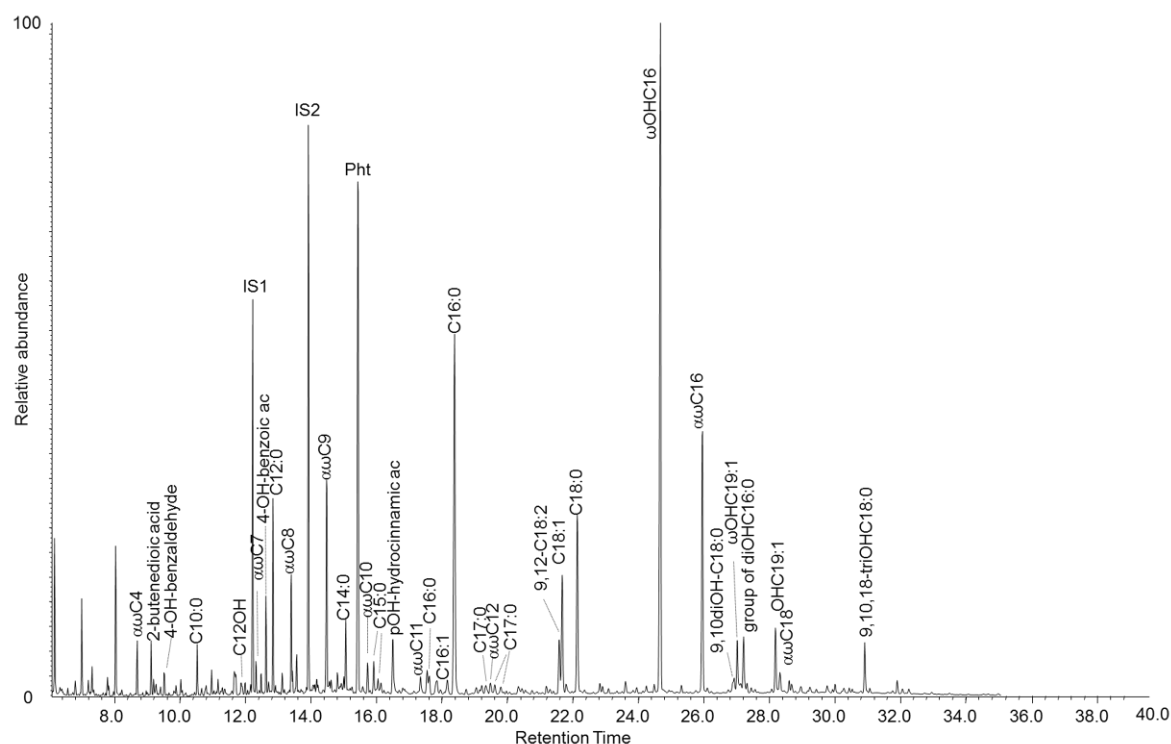
Sample G1, on the contrary, showed some differences in the chromatographic profile. Figure 8 shows the chromatographic profile of sample G1. Despite some qualitative differences in the relative abundances of the compounds, a similar lipid fraction was present in this sample compared to sample G and G1a, but no other compounds were

identified. Therefore, the triterpenoid resin was not present in this sample. Very similar results were obtained for sample G1b, which corresponded to a plaster sample.

Figure 8. TIC obtained by GC-MS analysis of sample G1 (Internal standards: IS₁ = hexadecane, IS₂ = tridecanoic acid; Pht = phthalate present as contamination). The absence of triterpenoid compounds is highlighted. For the legend, see Figure 7.
