CURRENT STATUS OF NEUTRON RADIOGRAPHY IN THAILAND

Current Status of Neutron Radiography in Thailand

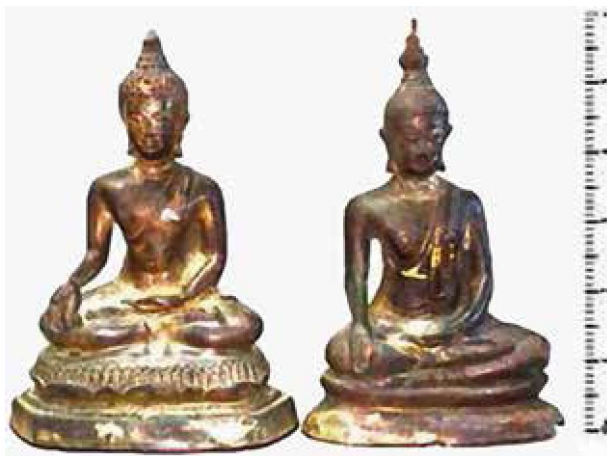
Fig. 2 A visual image of Buddha sculptures. – (© by the authors).

XR were taken of two Buddha sculptures (fig. 2) using a GE ERESO portable industrial X-ray generator model 65MF3 at 250 kV 1 mA-min. NI with the sculptures was also performed at 100 cm distance from the NI facility. The neutron fluence on the sample was 1.30×10^8 n/cm². Fuji BAS-MS and BAS-ND imaging plates were used to record the transmitted

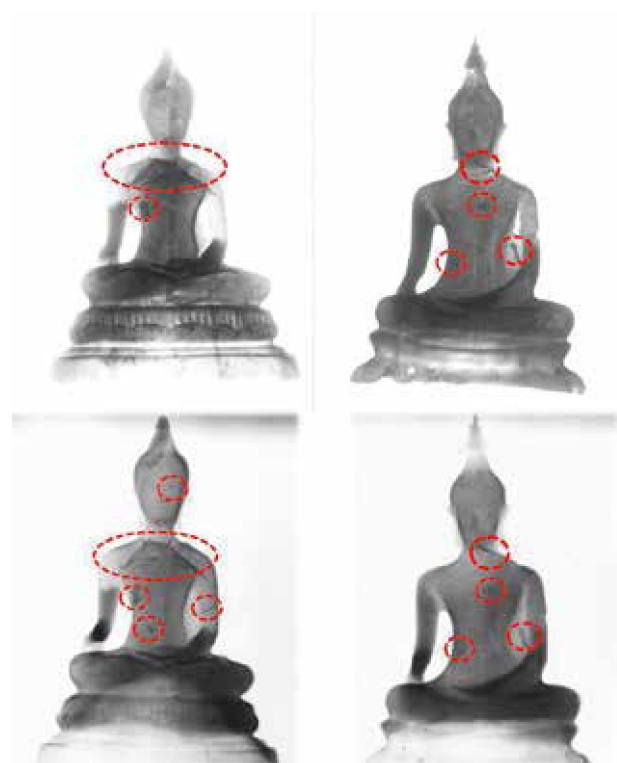
Fig. 3 Comparison of XR and NI greyscale images of two Buddha sculptures (S1 and S2). – (© by the authors).

Regarding to **figure 3**, the historical data, for example, damaged parts, restoration marks and manufacturing technology can be observed. The restoration marks are obvious in both XR and NI. This implies that the restorer might have used metal-based glue to fix the marks. In traditional practices, aside from the insertion of holy objects, the Buddha sculptures are usually filled with burnt clay for strengthening the structure and hiding objects at the same time. This study shows that the material inside the S1 sculpture has a discontinuous pattern in comparison with the S2 sculpture. The S1 sculpture was partly filled with burnt clay and the joints of different materials are clearly seen in the upper arm areas. In contrast, the material inside the S2 sculpture looks

very homogenous. Additionally, the image of the S2 sculpture demonstrates at least three tiny pieces of objects attached inside. The manufacturer probably added some things inside the sculpture on purpose during construction. Unfortunately, it is too unclear to judge what kind of materials they are. They are, however, most likely a high density object or thick metal because they can absorb both X-rays and neutrons well. The investigation on the object needs to be performed further using neutron tomography.
