Wangduephodrang Dzong Seriously Damaged by Fire

**Survey for Remaining Structure of
Wangduephodrang Dzong
After June 24, 2012 fire**

15 October 2012

Division for Conservation of Heritage Sites
Department of Culture
Ministry of Home & Cultural Affairs
Royal Government of Bhutan

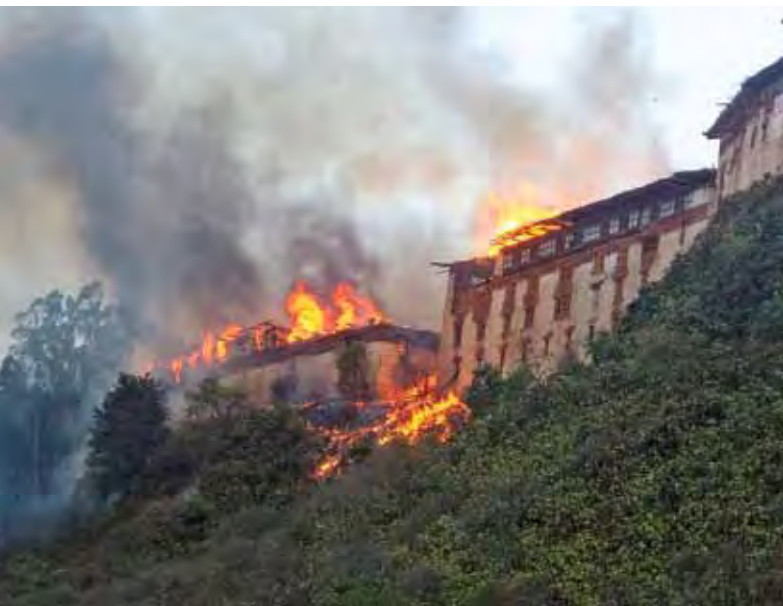
Wangduephodrang Dzong, the fire of June 24, 2012
(photo: Dawa Knight)

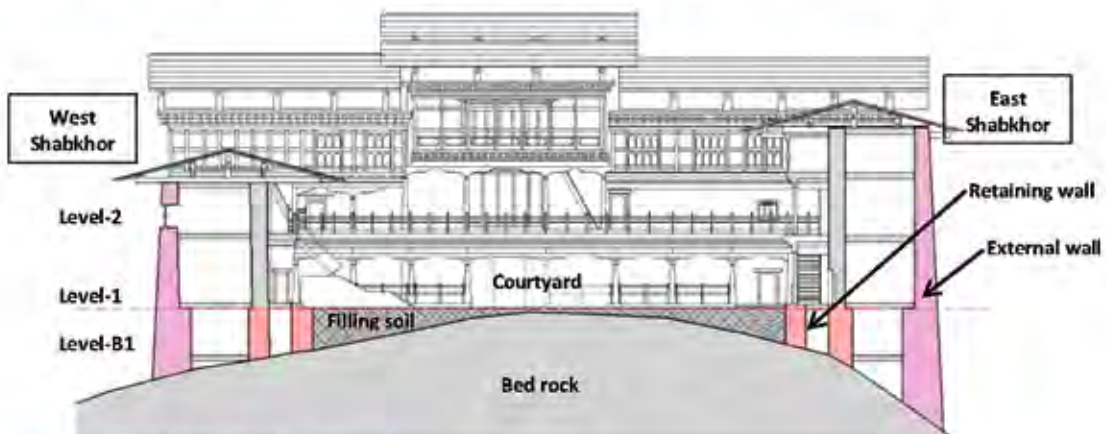
Although the walls of this Dzong are mainly of stone masonry, significant amount of rammed earth walls can be found at the eastern *shabkhor* (facing Dangchu River) of the first courtyard area, which is part of the original extension work undertaken by Gyalsay Tenzin Rabgay.

Rammed earth wall (indicated in yellow) and stone masonry wall at the Level-1

Rammed earth wall at the first courtyard area is expected of the extension work in 1683. As it will be served for a future study on medieval construction especially when compared with other Dzongs and buildings which were built of a mixture of construction materials, it is highly recommended to retain these rammed earth walls. Although the walls of the Level-1 have been deteriorated by fire-fighting water and subsequent rain, the rammed earth walls on the Level-B1, which is in good condition, should be maintained.

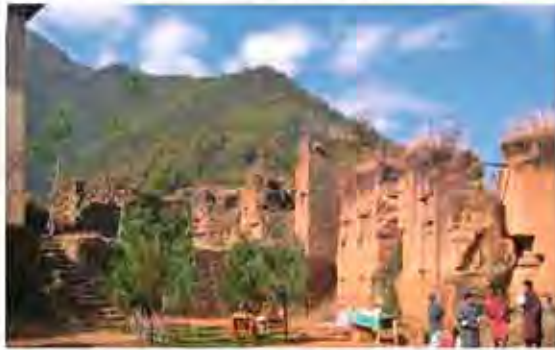
It is important to note that use of different construction materials can be observed in some of the other ancient Dzongs in Bhutan. For example, Drukgyal Dzong and the ruin Dzong in Chubjakha, Paro has some of the inner walls constructed of rammed earth. A comparative study among the Dzongs in Bhutan could assist in providing more clarity to the use of different construction materials within an overall structure.

Inner wall of Drugyal Dzong, Paro

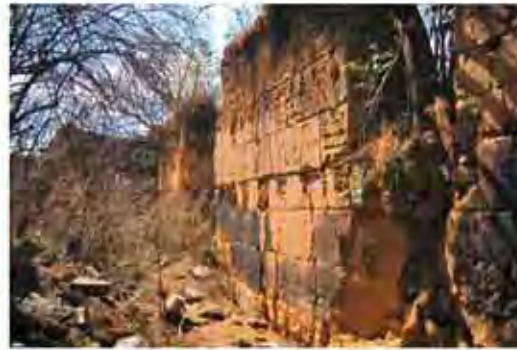
Inner wall of Chubjakha Dzong, Paro
