IMPACT OF THE 15 OCTOBER 2013 BOHOL EARTHQUAKE ON THE BOHOL CHURCHES

Prepared by **Ma. Joycelyn Bolhayon-Mananghaya, M. Arch, uap**
Trustee, ICOMOS Philippines

Paper that came out of the Assessment Mission to Bohol 18-26 October 2013

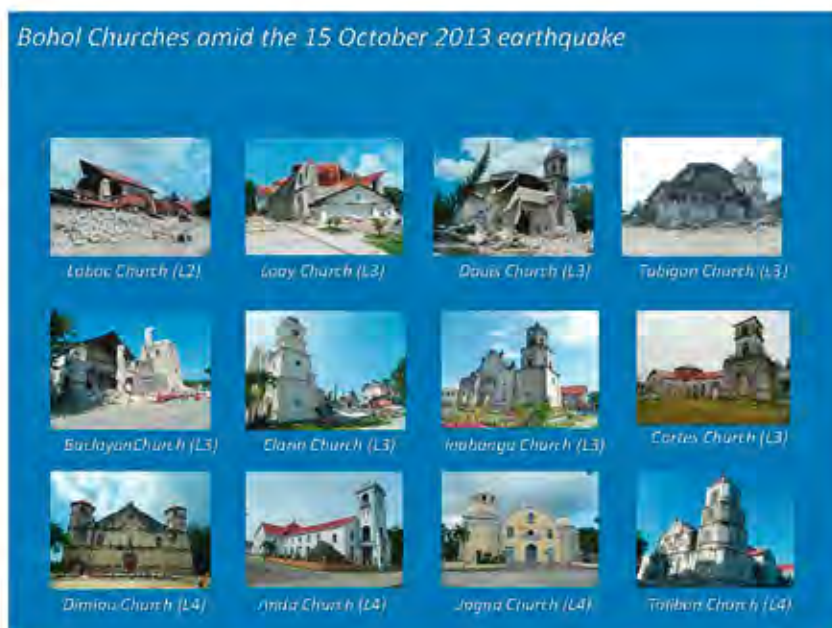
Due to the still on-going tremors which lasted weeks after the earthquake in Bohol, it has been noted that some churches visited on 18 October 2013, which were re-visited after 4 days, have sustained much worse damage. This is the case of Loay, Dauis and Dimiao. It is highly probable that other churches of the same condition with parts that may have been initially found with lesser damage or still intact, may have become worse in condition following the tremors that occurred after initial inspection.
