Microclimatic Measurements and Laboratory Research in Historical Buildings with Medieval Wall Paintings at Croatian Adriatic Coast

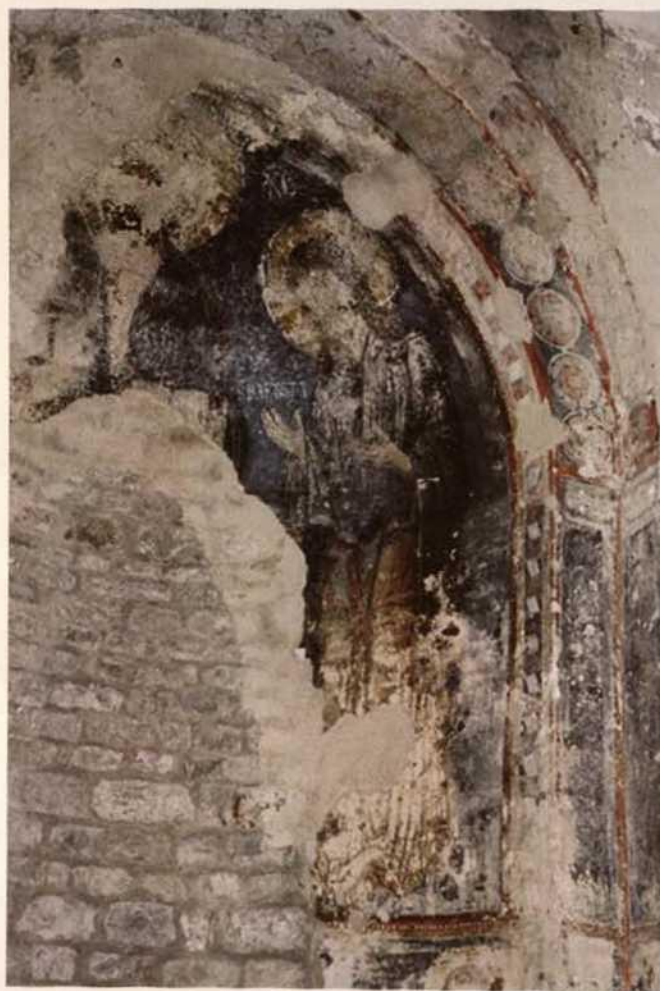
ble inadequate restoration, their condition at the time and the microclimate in the cathedral also contributed to their deterioration. After removal of several layers of lime coatings and plaster that protected the wall paintings from harm caused by crystallisation of salts on their surface and the area close to it, the destructive processes in fact continued at a faster pace, destroying the *intonaco* and the painted layers that were partly damaged earlier (Fig. 2).

Fig. 1. Zadar, Cathedral of St Anastasia (Sv. Stošija), south apse, wall painting (c. 1284), detail.

Based on these reflections, it can be concluded that the problem of increasing fragmentation of the support of the painted layer in the south apse of *Saint Anastasia's Cathedral* in Zadar could be solved in a manner similar to one suggested some thirty years ago: either by taking the wall paintings off the wall, conserving both the wall and the wall paintings, and returning the wall paintings *in situ*; or by trying to stabilise the microclimate in the apse of the south nave, after which certain conservation-restoration procedures can be applied to the wall paintings without taking them off the wall. Considering the fact that both actions require stabilisation, it seems safer to preserve the wall paintings and carry out all procedures needed to conserve them without removing them. However, on the other hand, if these actions are not undertaken as soon as possible, it could be too late for the wall paintings, and so the first solution mentioned should not be incautiously refused (Fig. 19–20). One of the ideas for improving microclimatic conditions in the south apse is to install a glass partition between the apse and the nave, so that the apse would be isolated and an adequate microclimate would be easier to establish (Fig. 21).

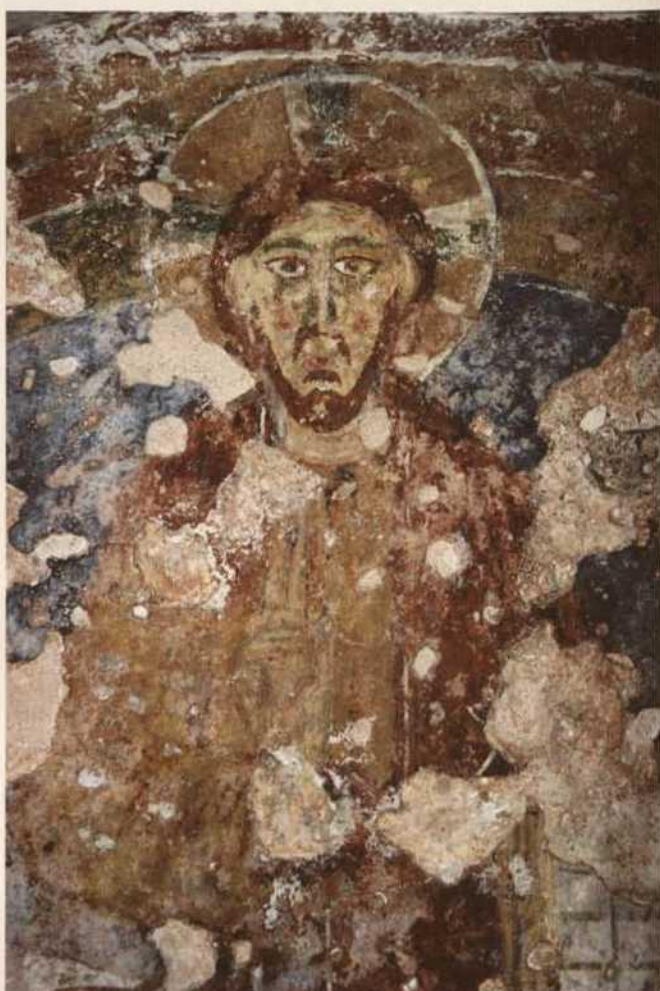
Wall paintings from the first half of the 12th c. on the first floor of the belfry of St Mary's Church in Zadar were discovered through an unhappy concurrence of events, following heavy destruction of the town's centre just before the end of the Second World War. Among other buildings, the convent complex, including the church, the Capitulum Hall and the Convent, suffered damage, whereas the belfry remained unharmed. Because of strong detonations in close vicinity to the belfry, the upper plaster layers that covered the wall paintings fell off.⁸ Conservation-restoration research proved that the paintings had been in fragments before they were covered with plaster and lime-coated, and that their destruction was mainly caused by natural processes of deterioration. Rainwater flowing down the openings of the belfry for centuries onto the vault and walls of the room on the first floor, together with specific microclimatic conditions, contributed to rapid deterioration of the painted layer, *intonaco* and lower plaster layers (Fig. 3).

Fig. 4. Zadar, St Mary's Church, belfry, south-east wall, wall painting (first half of 12th century), detail: Christ.

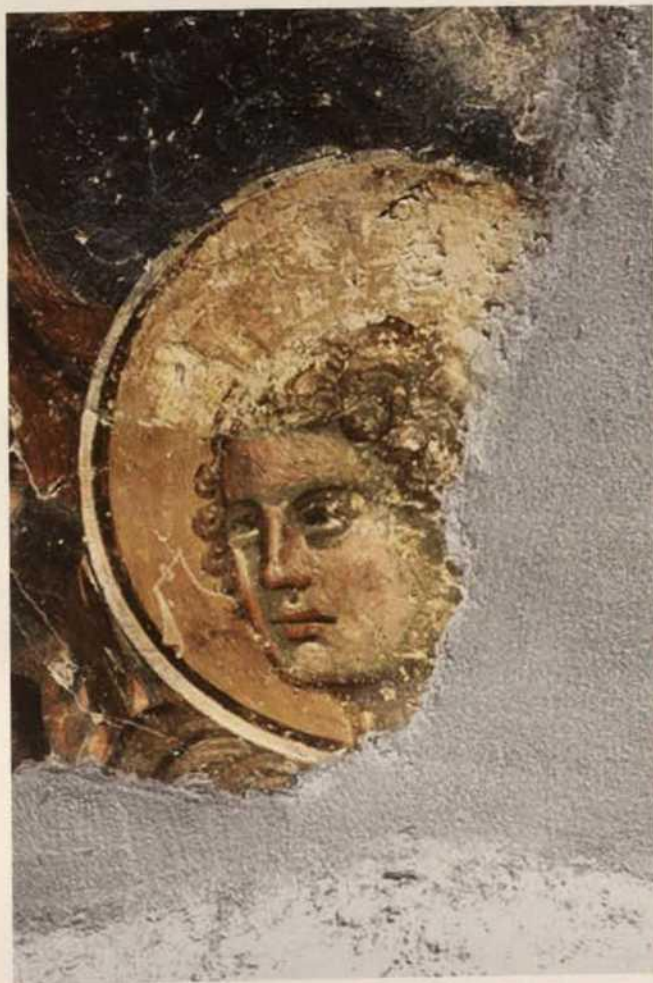
Fig. 8. Dubrovnik, Franciscan Monastery *Mala braća*, room above sacristy vault, detail: angel (after conservation-restoration).

An example of fragmentation of wall paintings from the first half of the 14th c. where damage was mainly caused by human impact involves the paintings preserved on the walls above the vault of the sacristy in the Franciscan monastery *Mala braća* in Dubrovnik. The initial damage to the wall paintings occurred on the eastern wall of the sacristy after a chapel with an altar was added there at the end of the 15th c. Soon after replacing the original wooden beam in the sacristy with a vault made of stone and tufa, the wall paintings above the vault, which were damaged but still visible, were buried under rubble material. What happened to the wall paintings in the sacristy remains unknown; the results of preliminary conservation-restoration probing were negative (Fig. 7–8).

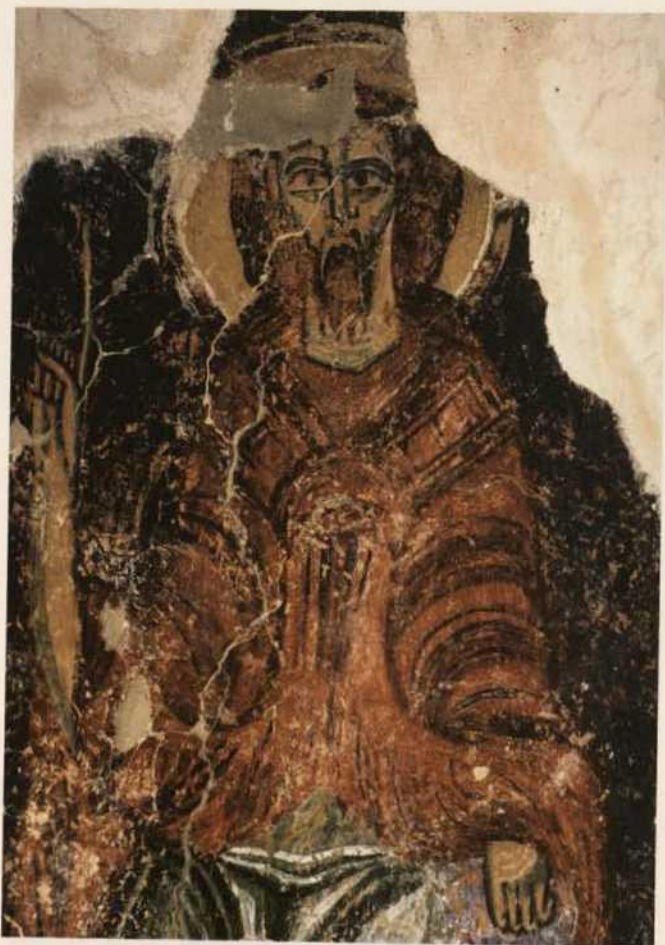
In terms of the material of the *intonaco*, which consists of slaked lime and sand together with a lot of brick-powder, wall paintings from the belfry of St Mary's Church in Zadar are similar to those in the Church of St Michael near Ston. Fragmentation of the paintings in Ston, from the second half of the 11th c., is caused by capillary moisture in the foundation which completely destroyed the paintings on the lower parts of the wall, rainwater leaking through the badly maintained roof, and perhaps also the impact of airborne salts from the salt-pans near Ston (still the subject of research) (Fig. 13 and 18).

Based on laboratory analyses of plaster samples and crystallised salts from the Church of St Michael in Ston carried out so far, it could be concluded that certain types of harmful salts are determined by the very structure of the wall paintings' support, the use of slaked lime of dolomite origin. This could then explain the presence of *magnesium sulphate* in several forms (*epsomite*, *hexahydrate*). Nevertheless, its appearance can be related to airborne salts that could make their way from the sea in wind-driven rain. The identification of *halite* (NaCl) and harmful concentrations of *chlorides* in all the buildings analysed also lead to the same conclusion (Fig. 13).

Fig. 17. Ston, Church of St Michael, interior, wall paintings (second half of 11th century), detail.

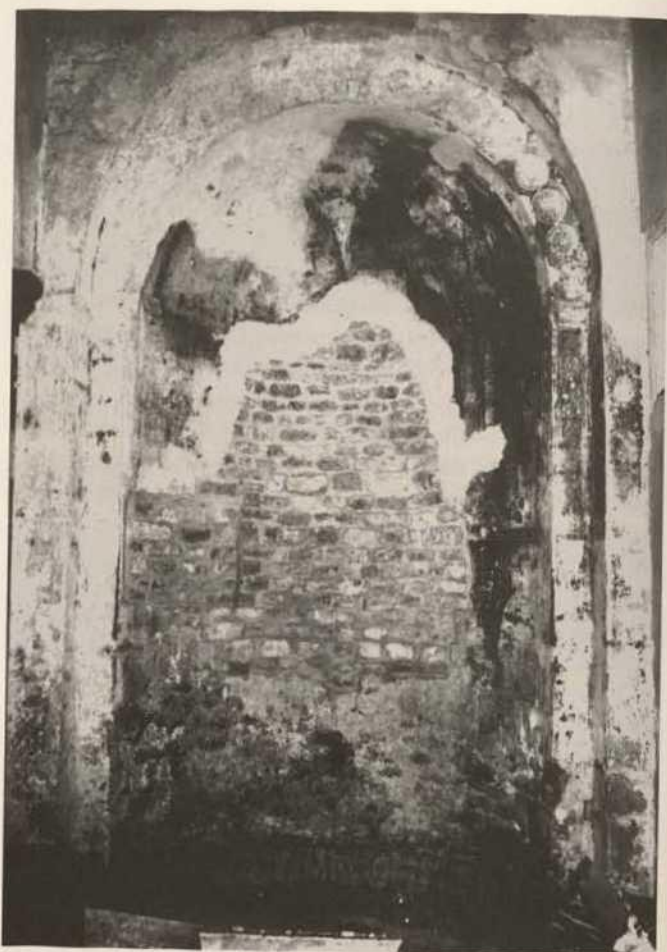
Fig. 19. Zadar, Cathedral of St Anastasia (Sv. Stošija), south apse, wall paintings (1971).

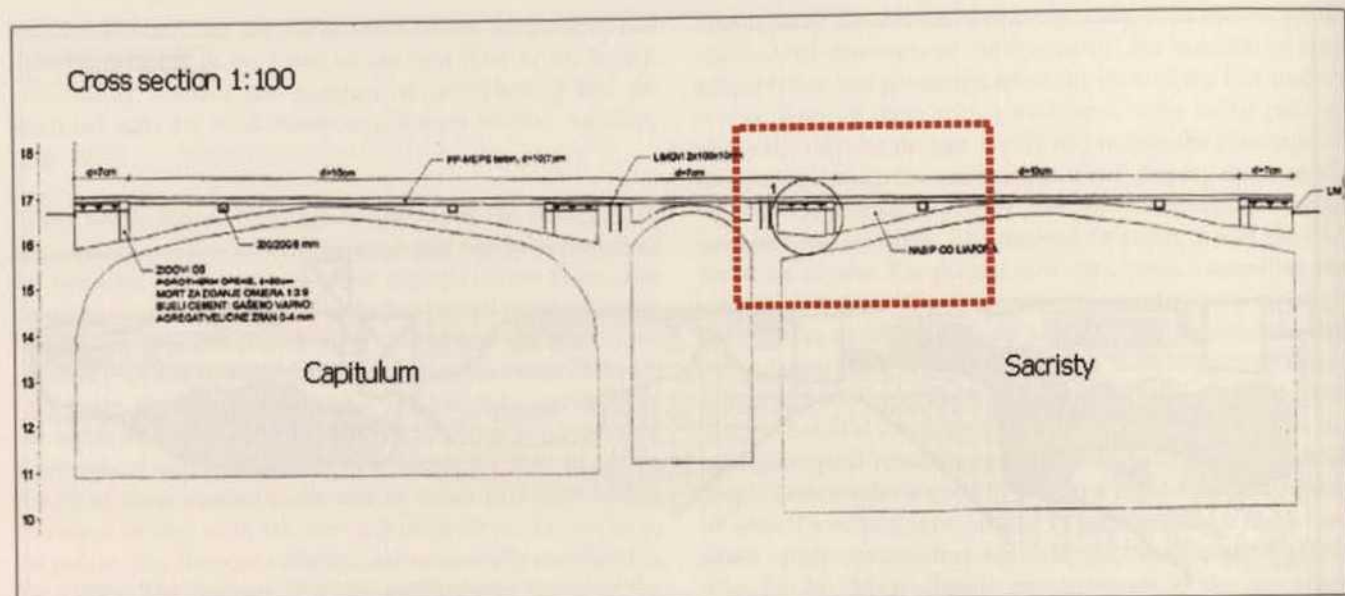
Fig. 24. Dubrovnik, Franciscan Monastery *Mala braća*, capitulum and sacristy: cross section.
