Kazumi Murose

An Example of Conservation Work: A Portable *Namban* Style Altarpiece with *Makie* Design from the Nagoya Municipal Museum

This report is concerned with the process of conservation of a portable *namban* style altarpiece done at the Mejiro Institute of Urushi between June 1997 and March 1998.

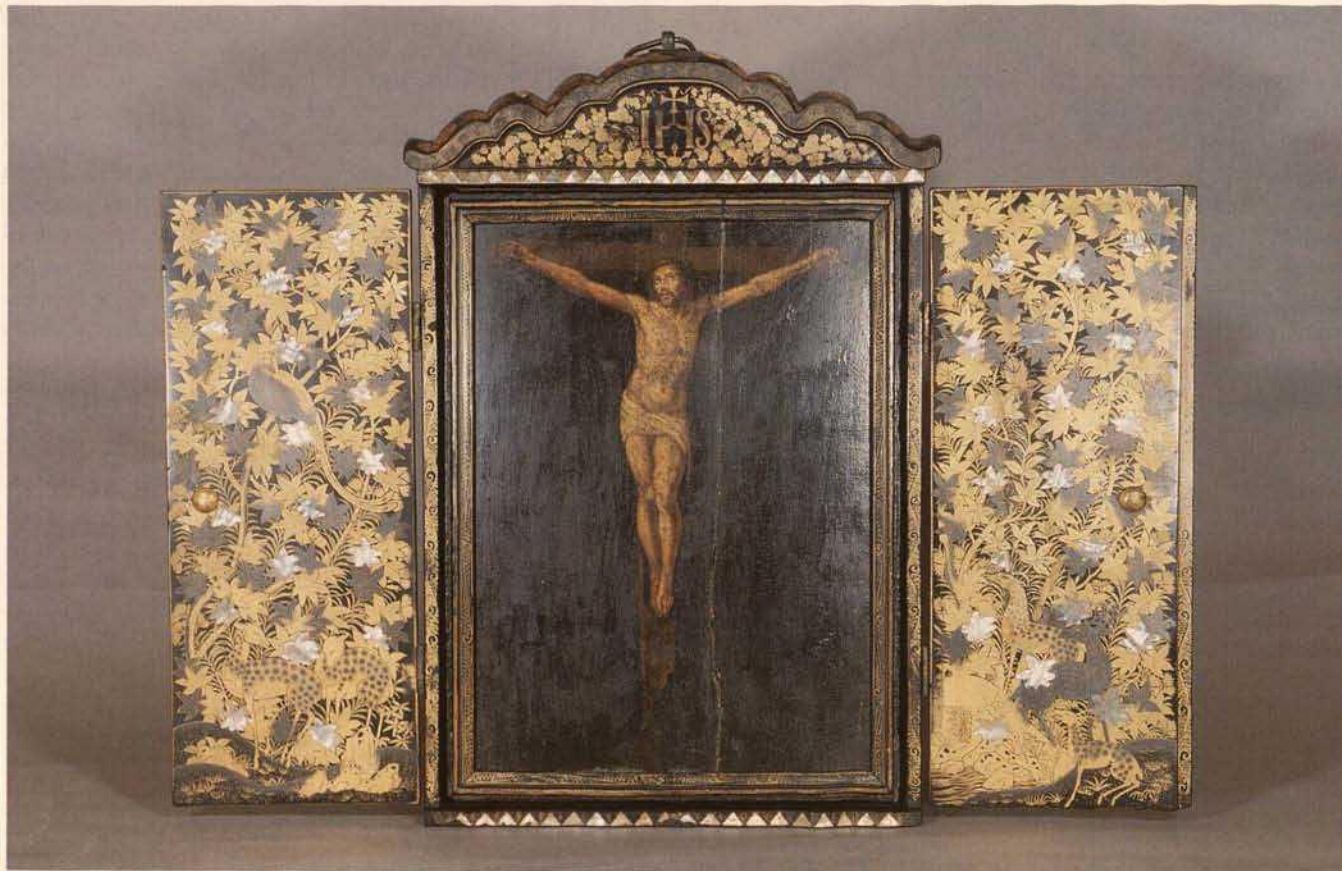
1 Overall view of the front of the portable *namban* altar after treatment

2 Overall view of the portable *namban* altar before treatment
