## Office Buildings of the Chicago School: The Restoration of the Reliance Building

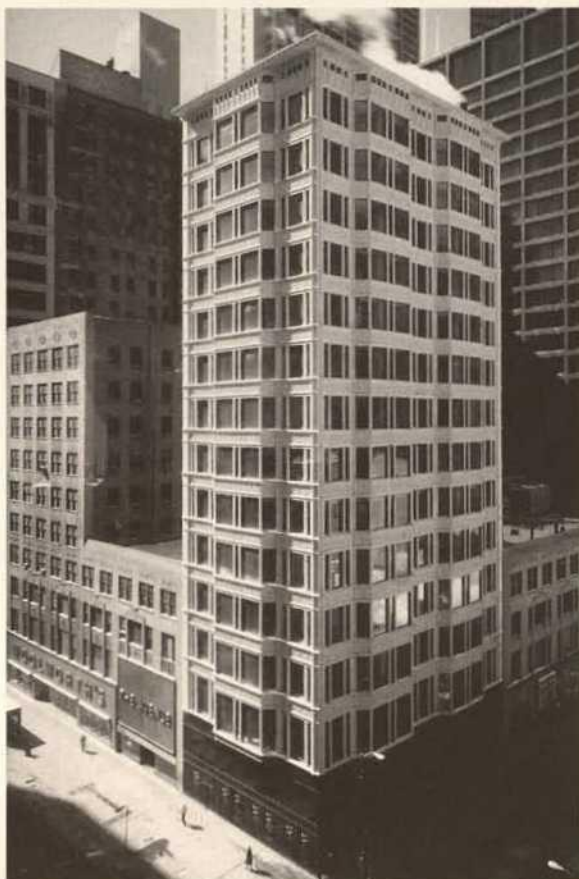
### III. 1

Chicago, view of the construction of the tower portion of the Reliance Building. The foot scaffolding at the foot of the tower was used as the roof of the Department Store that was open for business in the structure directly below. Visible in this photograph is the system of cast iron mullions and rails that would hold the fixed glass and onto which most of the terra cotta was attached.

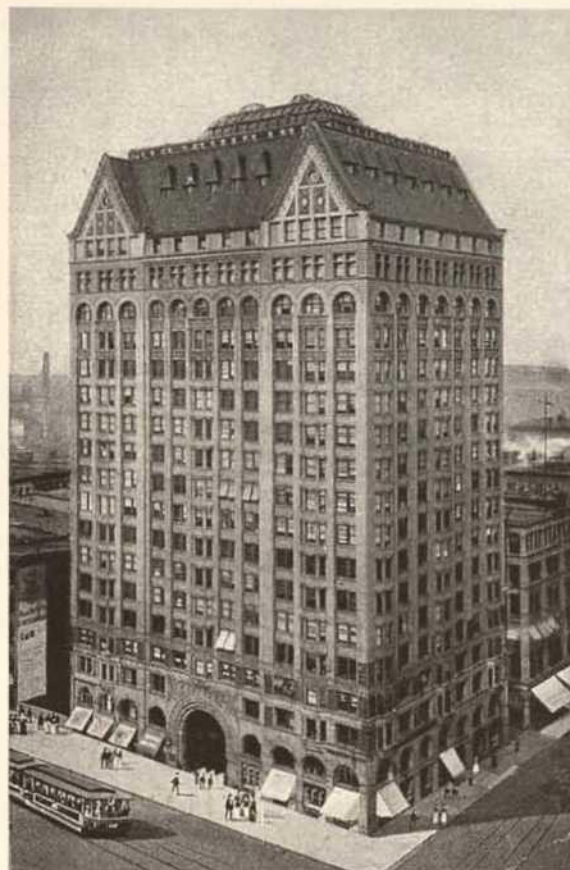
III, 4  
Chicago, historic view of the Masonic Temple (Burnham and Root, 1892). This building, now demolished, utilized a steel frame that was laterally stiffened with a diagonal bracing system and did not rely on the masonry curtain wall for lateral support as had earlier skyscrapers.

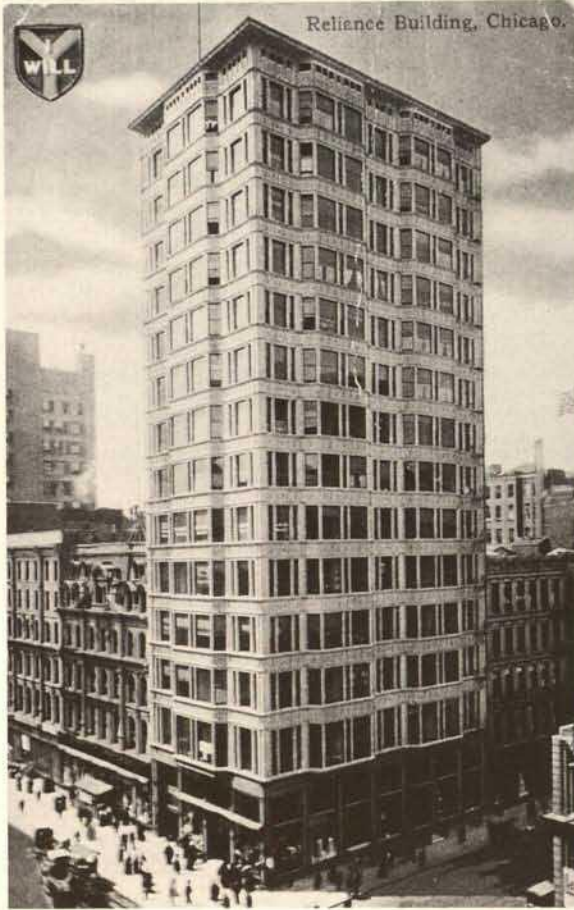
Chicago turn-of-the-century view of the Reliance Building. Once constructed, the building stood prominently on the skyline because of its height and gleaming white appearance in contrast to the shorter and darker surrounding buildings. Advertisements in the windows of historic photographs together with annual city registries helped the architect date many of the alterations to the building façade.
