# Fire-resistance Improvement of Vernacular Timber Architecture in a Historical Dong Village in China: A Case Study in Dali

Fei Du<sup>1</sup> and Kenji Okazaki<sup>2</sup>

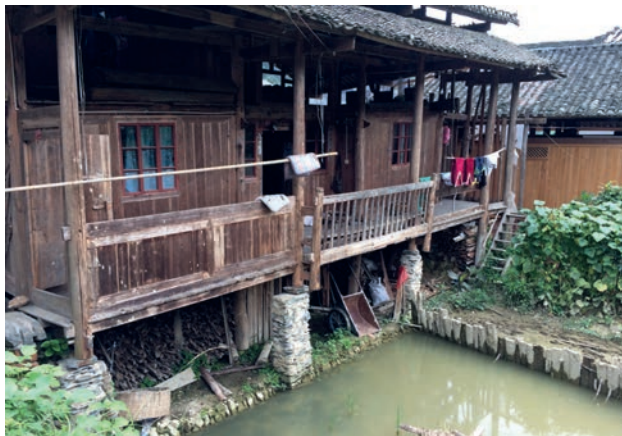
Fig. 2 (a) Residential building  
Fig.2 (c) Drum tower

traditional architecture includes 300 residential buildings (Fig. 2(a)), and public buildings such as the drum tower (Fig. 2(b)), five shelter bridges (Fig. 2(c)), and eight granaries (Fig. 2(d)). The original traditional architecture is composed of tile-paved roofs and of timber structures, walls, floors and ceilings without fire-retardant coating interiorly and exteriorly. Without sufficient firefighting water resources and facilities, Dali Village exhibits the typical vulnerabilities of Dong villages to fire accidents. Moreover, the traditional cooking space with a ground oven surrounded by wooden walls and the aged electrical wiring aggravate the fire risk. Since the Dong ethnic minority had no written language until 1958 [25], Dali Village has no fire accident record, and limited information was collected in interviews based on the memory of the village’s elder people. Within the last 100 years, Dali Village was affected by eight major fire accidents (Fig. 3). Nearly half of the village was burned by fire accidents in the 1940s and 1950s.

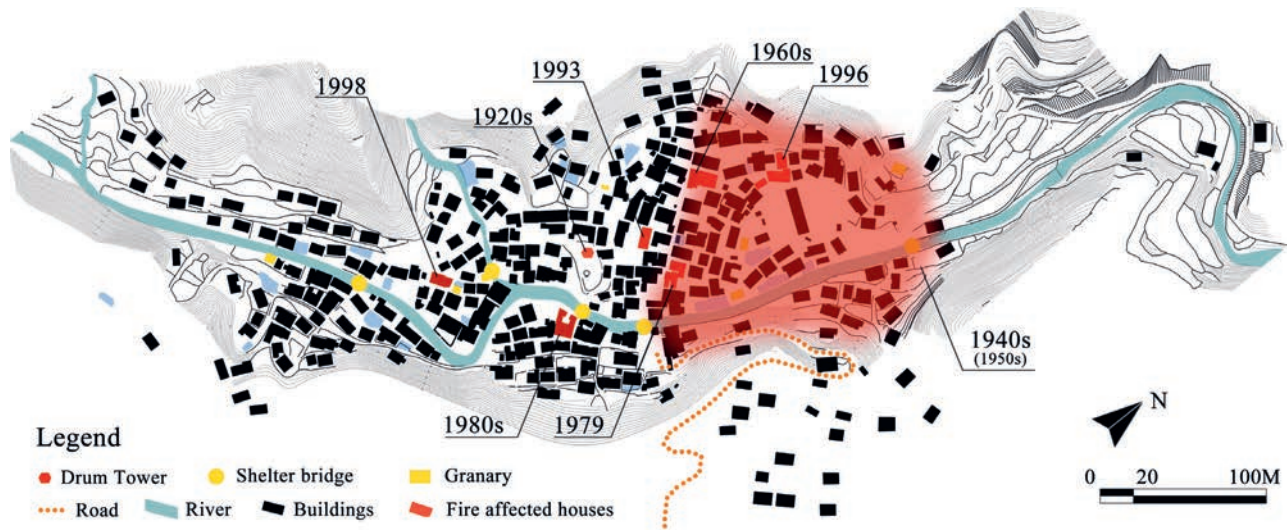
Fig. 3 Layout of Dali Village and fire accident spots (The basic topographic map data was provided by the Dali Conservation Program Office; There are two accounts about the year when the huge fire accident occurred, based on interviews: 1940s and 1950s.)

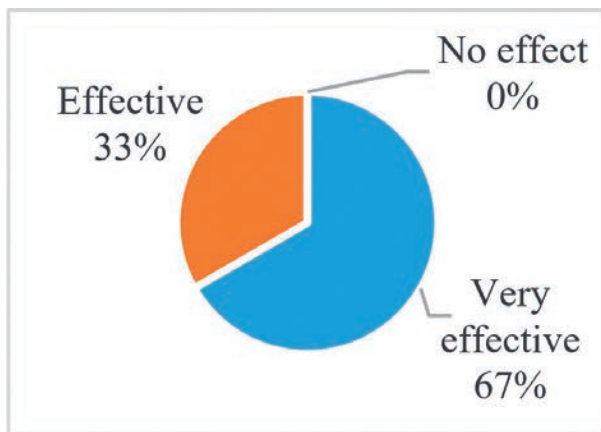
walls in the traditional cooking space (Fig. 4(a)) in each household was replaced by a brick oven surrounded by brick walls (Fig. 4(b)). In addition, the electrical wiring installed in the 1980s was already aged and meandering after modifications by the local people (Fig. 4(c)). Therefore, the local government implemented projects to replace the electrical wiring (Fig. 4(d)) in each household in 2008 and 2015. According to the interview in 24 households, all of them believe that the projects reduced the fire risk (Fig. 4(e)).

Fig. 4 (e) The local people's perspective of the effect of two projects

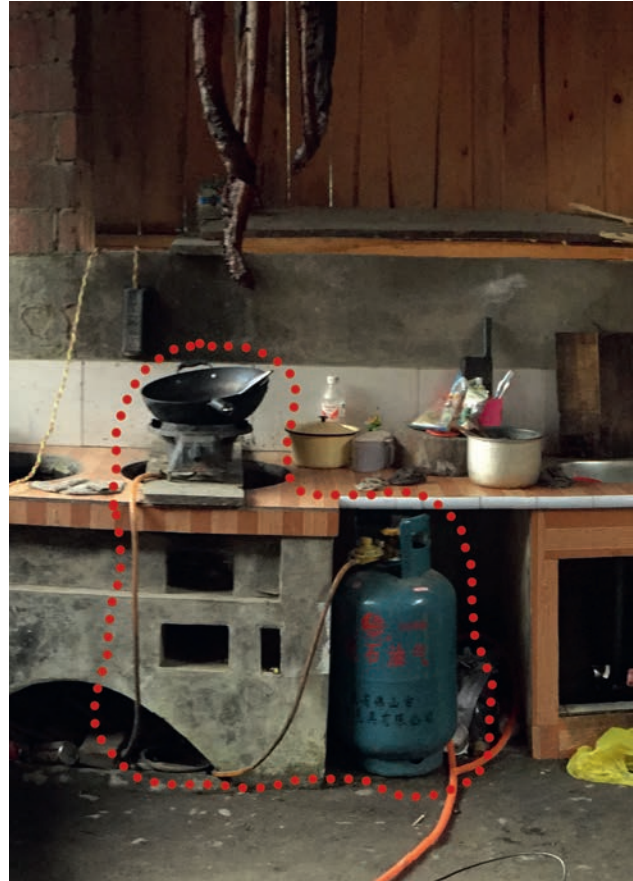
84% of the households surveyed still use a ground oven (Fig. 5(a)), 44% use a gas oven instead of a brick oven (Fig. 5(b)), 32% use an induction cooker instead of a brick oven (Fig. 5(c)), because the brick oven is too big for the needs of most families, since the young members usually leave the village for work. In addition, while the walls surrounding the brick oven were rebuilt with brick in 64% of the households, 36% still have timber walls (Fig. 5(d)).

Fig. 5 (a) Ground oven  
Fig. 5 (c) Induction cooker

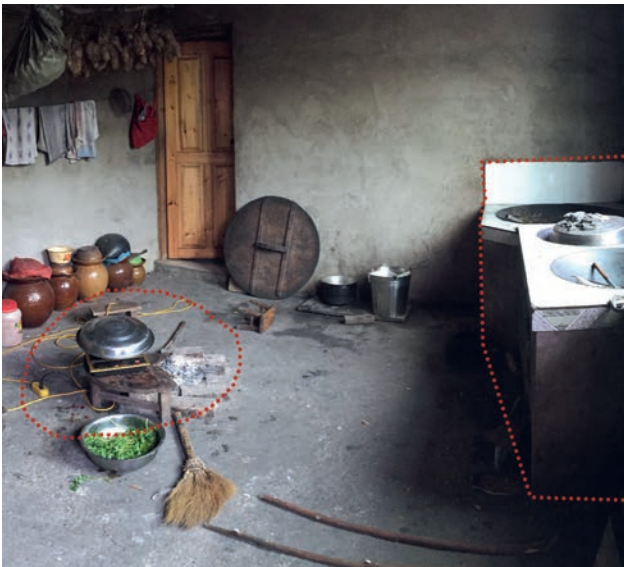
Fig. 5 (b) Gas oven  
Fig. 5 (d) Timber walls
