IV The Consolidation and Stabilization of the Buddha niches and the cliff in Bamiyan (2003/04; 2006)

Claudio Margottini

Abstract

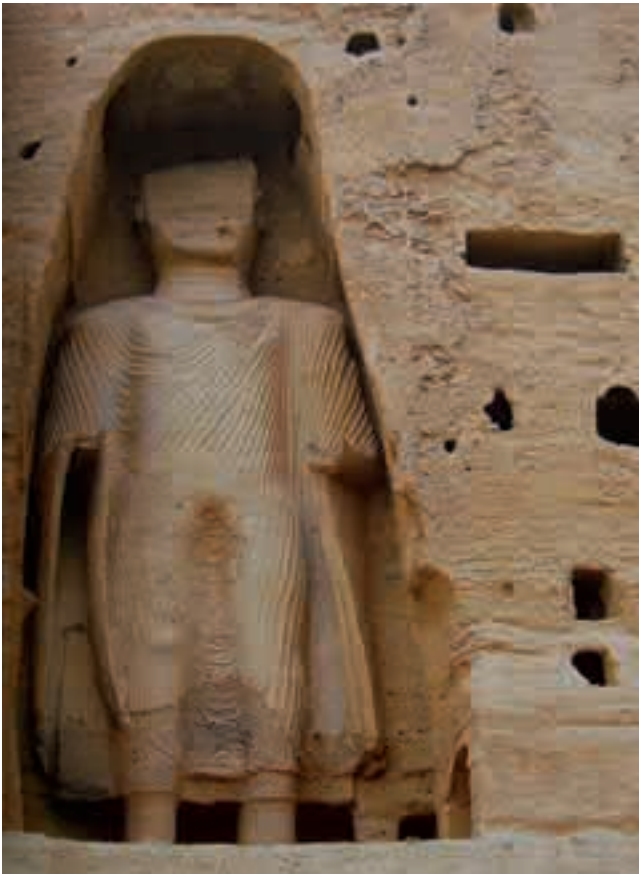
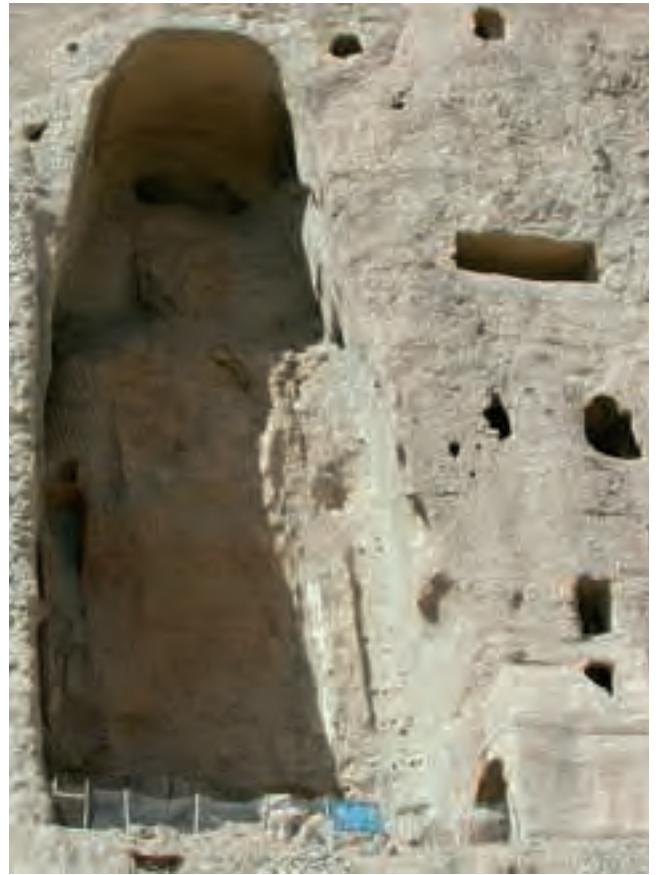
Fig. 2a. The Eastern Giant Buddha before the destruction

Fig. 2b. The Eastern Giant Buddha after the destruction

The two statues were destroyed in March 2001 by the Taliban, using mortars, dynamite, anti-aircraft weapons and rockets (figs. 2 and 3). The Buddhists as well as the world community, UN and UNESCO failed to convince the Taliban to refrain from destroying this unique cultural heritage. Nevertheless, since 2002 UNESCO has been coordinating a large international effort for the protection of the World Heritage site of Bamiyan and the future development of the area.

In the Eastern Giant Buddha niche, in addition to the collapse of the statue, there were three minor rock falls from the top of the niche. The blasting also degraded the upper eastern part of the niche where a stairway is located inside the cliff, and

the wall between the stairs and the niche is quite thin (about 30–50 cm). This part was the most critically unstable site. The western side, as consequence of an existing buttress, suffered less damage. Nevertheless, a rock fall occurred and some instabilities are also evident in the eastern part.

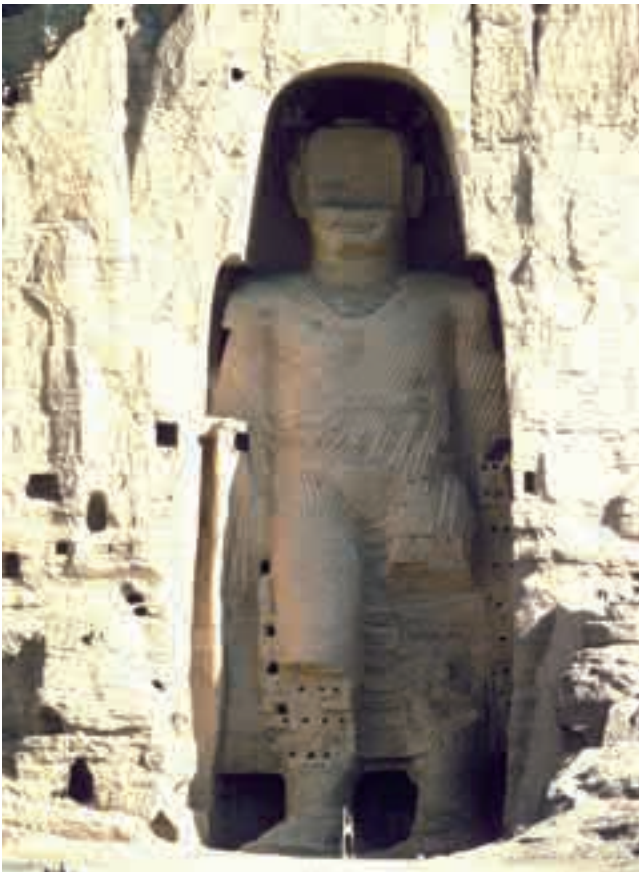
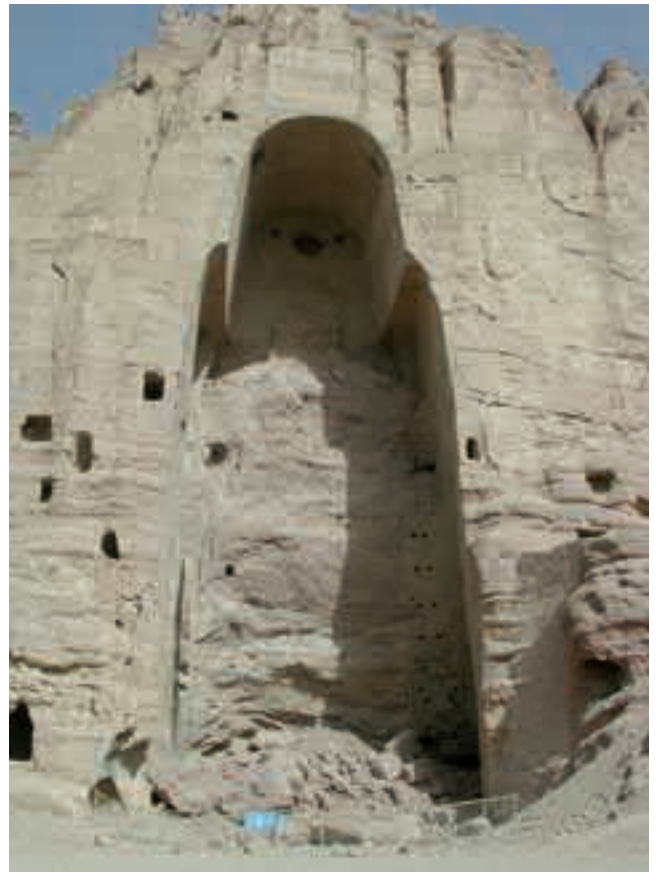
Fig. 3a. The Western Giant Buddha before the destruction

Fig. 3b. The Western Giant Buddha after the destruction

Major effects in the Western Giant Buddha niche were the collapse of the statue and the consequent instability of the rear of the niche. Investigations of the possible long-term stability conditions of the cliff were computed using the explicit-difference-finite code, FLAC (Itasca Consulting Group, 2000). Considering the Hoek and Brown (1980) shear strength criteria for conglomerate and siltstone, and with a major discontinuity ranging from the middle of the cliff to the middle of the niche (only friction value for shear strength) the deformation of the cliff is relatively low and nowadays it seems to be in a stable condition. Since we consider the fracture in the conglomerate reaching the lower sandstone formation and decrease gradually the cohesion of siltstone due to fracturing/weathering, the cliff becomes unstable when the cohesion is near to nil. In such a situation maximum displacement and vector are at the base of the niche (fig. 7).

In the Western Giant Buddha niche, the major blast effects were the collapse of the statue and the consequent instability of the rear of the niche. A small rock fall occurred at the top of the niche (left side). Probably the greater thickness of the wall between the stairway going up into the cliff and the niche (about 1 m) inhibited the propagation of the blasting effects and resulted in less severe damage. A large crack, about 20-30 cm wide, is present in the corridor at the back of the head of the statue. Figure 9 shows the most critical areas found in the field inspection and/or identified by analyzing the different geological aspects investigated in this paper.

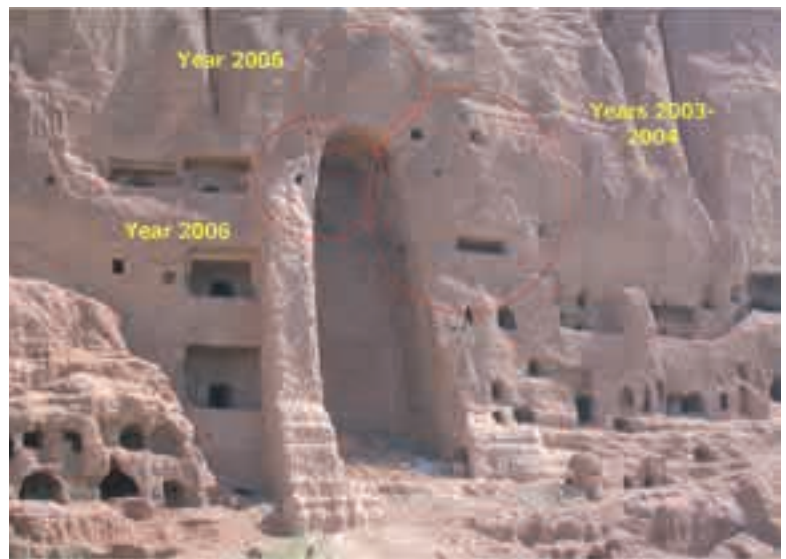
Fig. 11. Localization of the three areas of intervention in the Eastern Giant Buddha niche ▷

Finally, the field data (Colombini & Margottini, 2003/a and 2003/b; Margottini, 2004/a), kinematic analysis, mathematical modeling, caves and crack distribution and detail inspection of the effect of the explosion allow the realization of figures 8 and 9 which show the most endangered sites for both niches. The explosions of March 2001, besides the demolition of the statues, reduced the stability of the shallower parts of the niches. In the Eastern Giant Buddha niche, in addition to the collapse of the statue, three minor rock falls occurred from the top of the niche. Blasting also degraded the strength of the rear of the highest right part of the niche, where a stairway is located inside the cliff and the wall between the stairs and the niche is quite thin (about 30–50 cm). This part presently has the most critical instability (A3 in fig. 8).

and recover the remains of the Buddha statues, still lying on the floor of the niches. The stabilization activities started in October 2003 and continued until the beginning of December 2003 (eastern side). A second operational phase was implemented in the period April – June 2004 (eastern side) and the final one in the period September – November 2006 (western side and top). Figure 11 shows all the study areas and the sites for intervention. Without considering the study phases, the practical activities included four different steps:

3. The final stabilization of the east side of the niche, west upper side and top. In these areas anchors, nails and grouting were executed in order to reduce the risk of rock fall and collapse; particular care was addressed to the problem of grouting material due to the very high slaking capability of siltstone. The anchors placed in 2003 were pre-grouted to avoid any oxidation and then percolation inside the niche. As from 2004 it was decided to use only stainless steel materials, even if not pre-grouted.

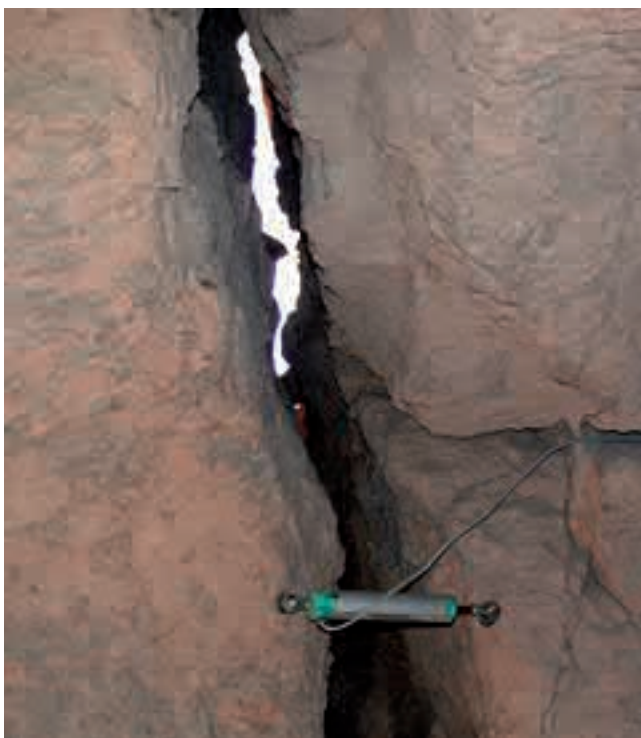
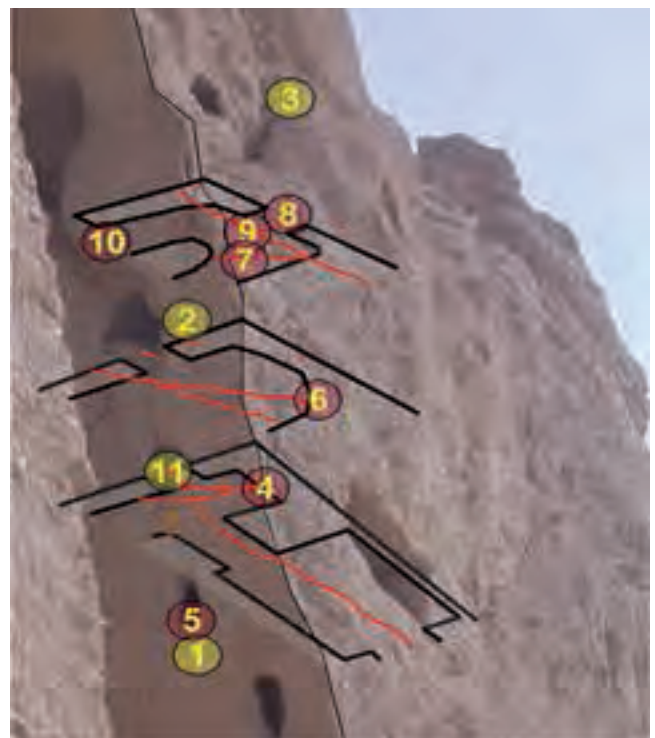
On the eastern side of the niche a large external block was prone to collapse (fig. 10), and many others in the inner part. A real time monitoring network was planned and realized to monitor the most remarkable cracks and discontinuities. 11 potentiometric crack gauges, 0–50 mm, 4–20 mA, fitted with couplings and connecting cable (total length 350 m) were supplied in the first phase in 2003, with acquisition system (data logger) and data management software. An alarm system to detect any deformation (movement) possibly induced by the works on the main cracks present in this part of the cliff was also installed. The accuracy of the gauges was requested in 0.01 mm, to allow an accurate measurement of even a small deformation. The position of sensors is reported in figure 12.

▽ Fig. 12. Distribution of the 11 sensors monitoring the crack's underlining of the most unstable block. On the left a detail of such sensors

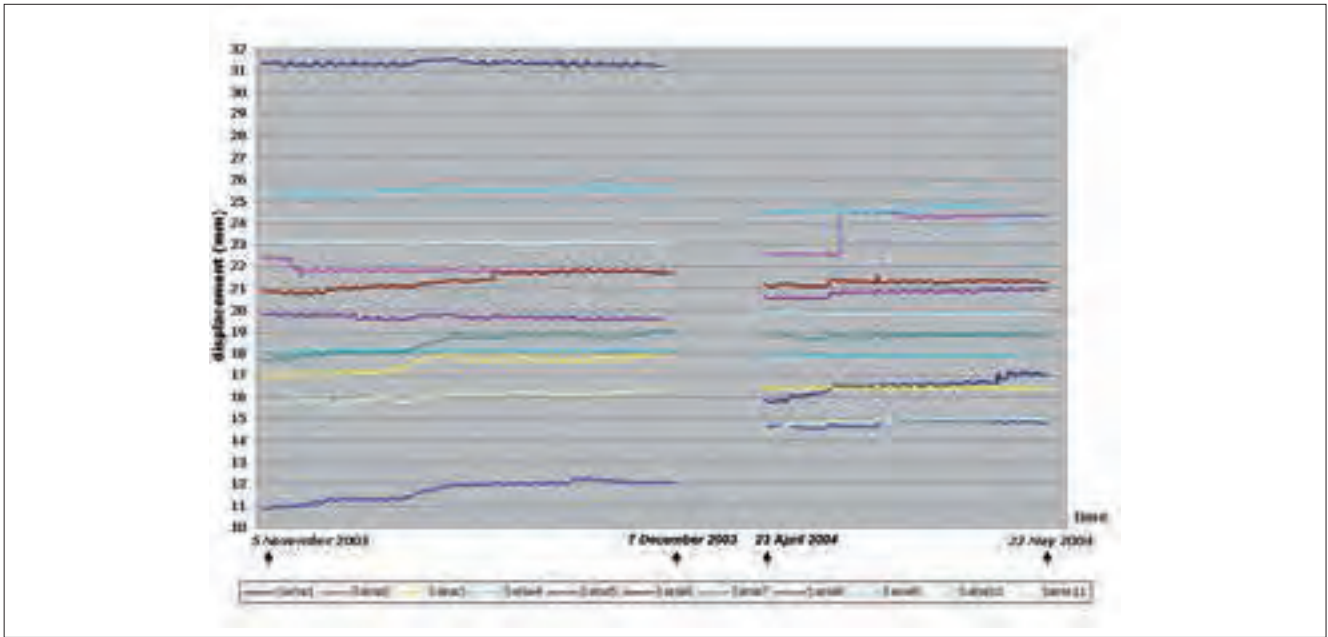
satisfactory, since the monitoring system did not record any remarkable deformation in the unstable blocks throughout the working period (fig. 23).

Fig. 23. Time evolution of the 11 extensometers operating in the period 5–7 December 2003 and 23 April – 23 May 2004 in the eastern wall of the niche, and showing no remarkable movements on the cliff. Some minor steps were caused by climbers, who hit the gauge placed on the cliff

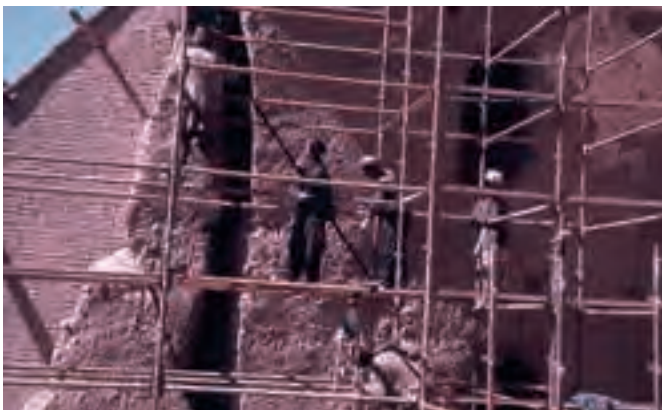
The western side of the niche also suffers from the effect of the explosion. The existing buttress was probably constructed to reduce the risk of collapse of this flank which was considered extremely unstable to justify a very massive intervention by a French archaeological expedition in the late 1950s and early 1960s, finally strengthened and mitigated in the impact by the Archaeological Survey of India in the 1970s. Since the buttress seems to be connected to the cliff with bolts, it is possible that the sunk of this structure may produce a horizontal stress towards the external, inducing additional instability as testified by the intervention of ASI (fig. 24, courtesy Prof. Maeda, Kyoto University). Nowadays, there is some evidence (e.g. widening of small cracks) from which it is possible to hypothesize that the buttress hangs from the cliff, rather than sustaining it. This situation might increase the existing damage.

The effects of the March 2001 explosion are mainly evident at the top of the niche, probably where there is a maximum concentration of stress in consequence of the morphology of the niche (arch and pillar, as described in Colombini & Margottini, 2003/a). In particular (Margottini, 2004/b and Margottini, 2006) there is a small pillar (fig. 25) that needs immediate emergency intervention before collapse, possibly inducing large deformation processes to the whole western part of the niche. This part was also completely restored by the Archaeological Survey of India in the late 1970s.

Fig. 25. The most unstable element (pillar) on the western side of Eastern Giant Buddha niche ▷

no. temporary steel cables have also been installed on the western side of the niche. Four of them were fixed through steel bolts on the inner/outer wall of the niche, whereas nine cables were circular cables embracing horizontally (6 no.), or vertically (3 no.), the rock pillar and the septum at elev. 2570.

3. Emergency intervention includes nails and grouting as follows:
 - a. Prior to starting the drilling works the large cracks in the area of the pillar at the left wall of the Eastern Giant Buddha were thoroughly filled in and grouted with cement. After the preliminary caulking, the main fissures were filled in using 0.96 m³ of low water-release cement grout, with some 1,200 kg of cement. Grout composition utilized was, as usual, C:W= 0.5 with superplasticizer.

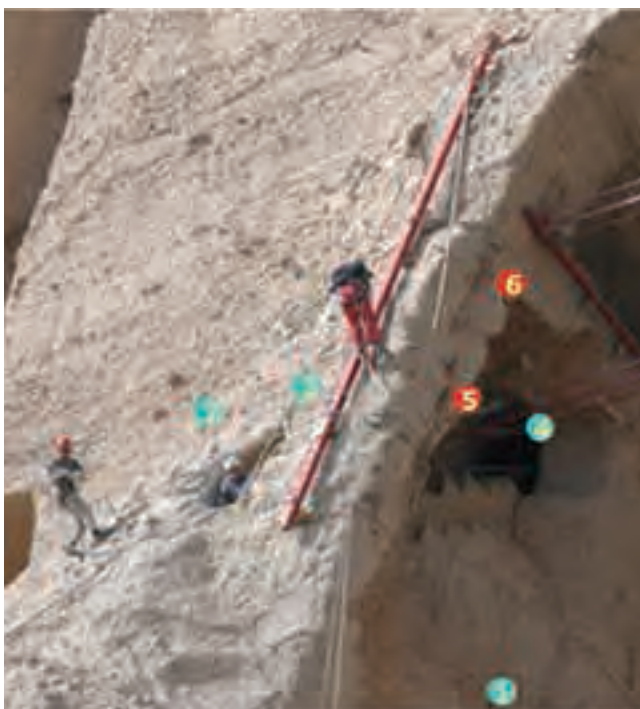
Fig. 26. The location of potentiometric crack gauges for discontinuity monitoring and alarm; in green are external sensors and red are internal to the cave

1. A monitoring system on the most relevant discontinuities. No. 6 potentiometric crack gauges were newly installed and tested on the west wall of the niche of the Eastern Giant Buddha to monitor the cracks identified as being the most dangerous in the area of the drilling and grouting works. The scheme of installation is reported also in figure 26.
2. A temporary support (fig. 27), by means of:
 - a. the two existing long iron beams moved in the upper part of the niche, to provide some lateral support to the niche;
 - b. two iron/wood beams capable of supporting any lateral deformation of the small pillar; the construction details of the beam were finally adapted with the materials actually available in Afghanistan;
 - c. steel ropes bounding completely the pillar and cliff; 13
