The Jewish Catacombs of Rome, especially Villa Torlonia: Synthesis, Diagnosis and Projects for the Restoration and Enhancement

Mariarosaria Barbera and Marina Magnani Cianetti

Synthesis and Diagnosis

Projects for the restoration and enhancement

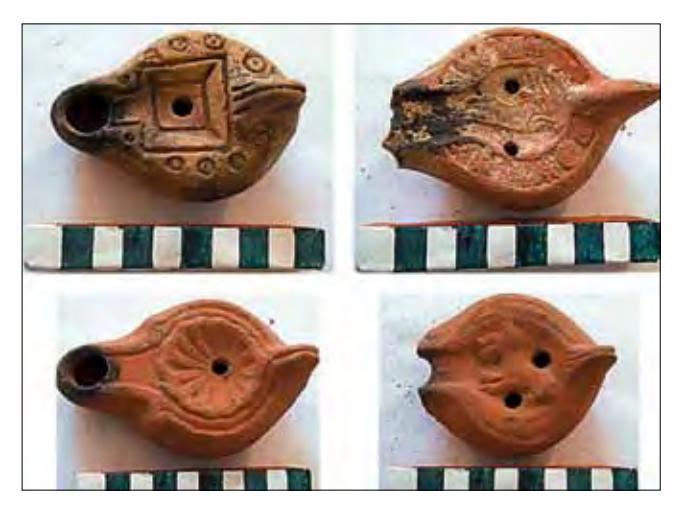
Fig. 1 Oil lamps discovered inside the catacombs (5th century)

According to L. V. Rutgers, the oldest sector E dates to the mid 2nd century, on the basis of a campaign of carbon 14 analysis carried out on carbon fragments mixed in the lime of the niches; and the plan of the Torlonia catacombs was adopted later in those of Calixtus.³ Here I propose the extension of the date well into the 5th century, by the presence of clay lamps both of local production and from Africa Proconsularis dated rather precisely ⁴ (Fig. 1). Sarcophagus fragments from A suggested the presence of a covered terrace area.

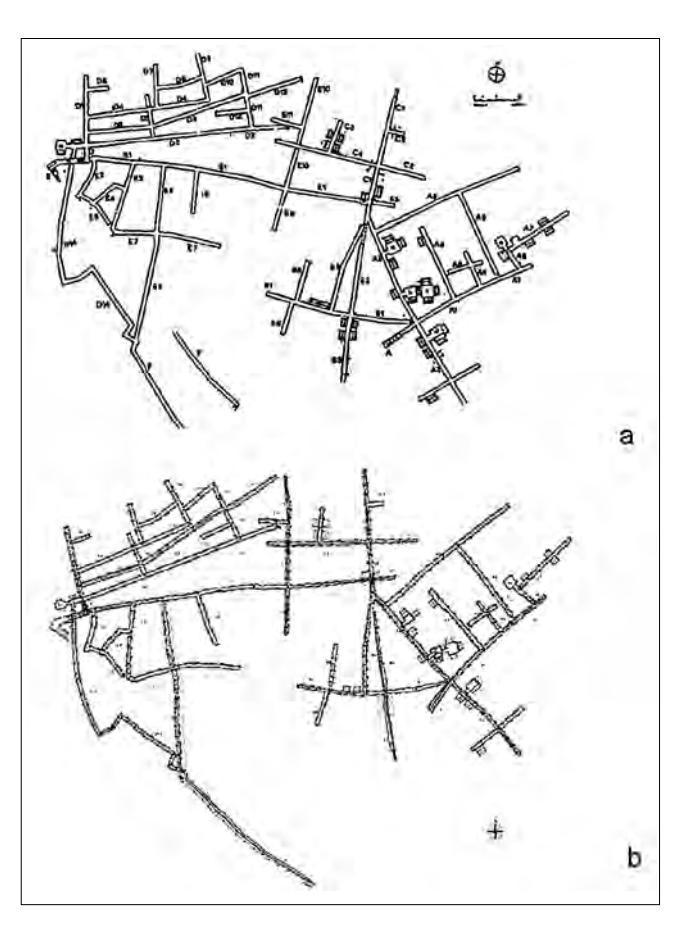
Fig. 2 Planimetries of the catacombs by: a) p. Umberto Fasola 1976, b) Soprintendenza Speciale per i Beni Archeologici di Roma 2003

The older catacomb⁷ (Fig. 2) to the west included the atrium prescribed by the Mishna to receive the bier and its bearers (*hatzarah*).⁸ It is the deepest region (more than 9 m) which grew up around sector E and developed into D, with narrow and low galleries, orderly and uniform burials in niches originally obtained from walls decorated with pilasters. Some 70 of the niches are surmounted by arches forming *arcosolia*, and several of them present dividing elements of inclined tiles in order to prevent contact between the corpses.

- ⁶ FASOLA 1976, pp. 32–34; TOLOTTI 1980: reused D14 (played by Rutgers as a gallery for proof), C1, B1.
- ⁷ The new survey by the ARKGEO soc. confirmed with some changes FASOLA 1976.

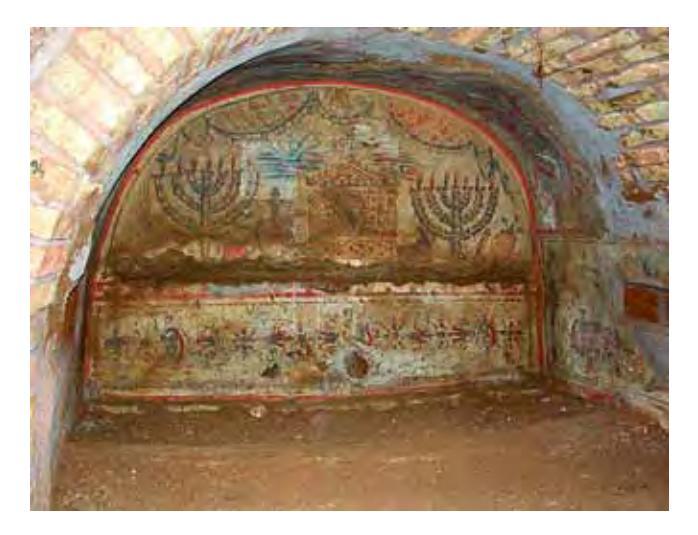
Fig. 3 Painted accosolium with menorah and religious symbols

The frescoes display religious-symbolic subjects, such as the arc of the Covenant, the cupboard with the rolls of the Law, sacrificial instruments and especially the menorah (Fig. 3), framed by an open tent with weighted folds. The heavenly vault recalled the concept of the *paradeisos*, while the interaction with the cultural-artistic *koinè* of the time is attested by more neutral subjects, such as peacocks and dolphins, a flying bird and particularly by painted reproductions of strigilate sarcophagi with lion heads, surmounted however by the inevitable scheme of ritual objects associated with the Jewish religious sphere. Rutgers convincingly dated the frescoes to the 4th century (320/340 the cubiculum, 350/370 the *arcosolia*), because of stylistic comparisons and on the basis of carbon 14 analyses.⁹

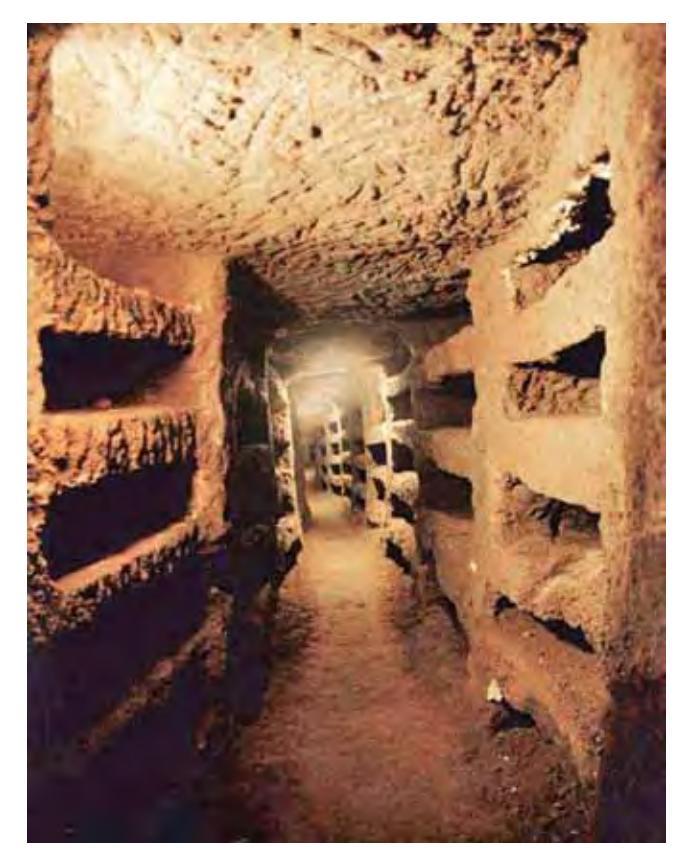
Fig. 4 Main passageway, open to the public

The Catacombs consist of a series of "cunicoli", modest-sized galleries (0.60-1.00 m wide) with overlaying and stratified burial sites along its paths; the vertical walls (2.00-3.00 m high) have been weakened by the excavation of the burial recesses that exploit the walls to their full capacity (Fig. 4). The gallery ceiling can be divided into three types: segmental arch, flatbed arch and inverted arch; here is where the burial recesses were excavated up to the vault springers. The flat vaults are also a cause of concern. The precariousness of the structure is due either to excessive excavation, probably to increase the insufficient number of burial sites, or to irregularities in the vertical separation elements (pillars-pilasters) between the wide and asymmetrical burial recesses.

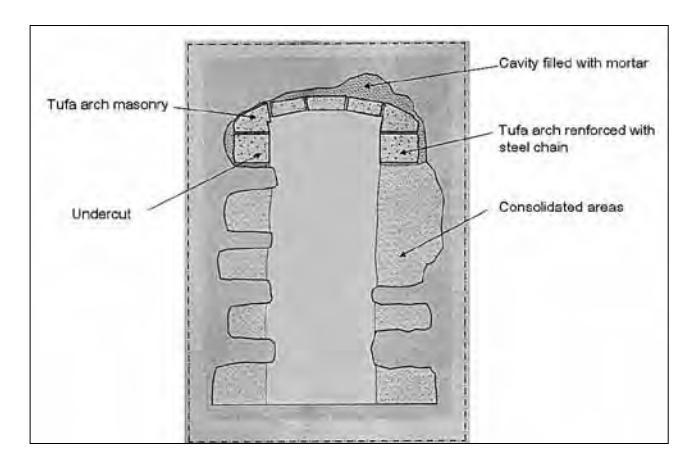
Fig. 5 Project for the restoration and consolidation

The interventions were selected on the basis of technical requirements and potential uses. Important reinforcement works were decided upon to guarantee security in the broadest sense of the term, in the catacomb's main access route while temporary works to block instabilities and permit the permanence of scholars were carried out in the secondary paths (Fig. 5).

Local works were designed to reduce the invasiveness of the restoration without modifying its image, but help stop the deterioration (partial or total substitution of septal slabs, addition of sealing plates to the burial recesses, recovery of portions of tuff materials in the corners of the galleries). Attention and rigour of intervention will also be extended to the tuff structures inserted in the 1970s to support the burial recesses. They will be treated and dulled to reach an adequate colour and texture.

In areas where disorders have caused collapses, reversible structures made from modern materials were inserted, identifiable and compatible with the monument's image (support ribs in the gallery and burial sites' vaulted structures). The path's viability was improved with connecting ramps to limit and eliminate the drops between levels. Termination of the electrical system and installation of a burglar alarm system, integrated to the environment with functional materials (water-resistant illumination and minute copper cables), compatible with the ancient context, will complete the internal works.
