The Christchurch Earthquake of February 2011

Blue Shield Statement, March 3, 2011

Case Study: Canterbury Provincial Council Buildings, Christchurch

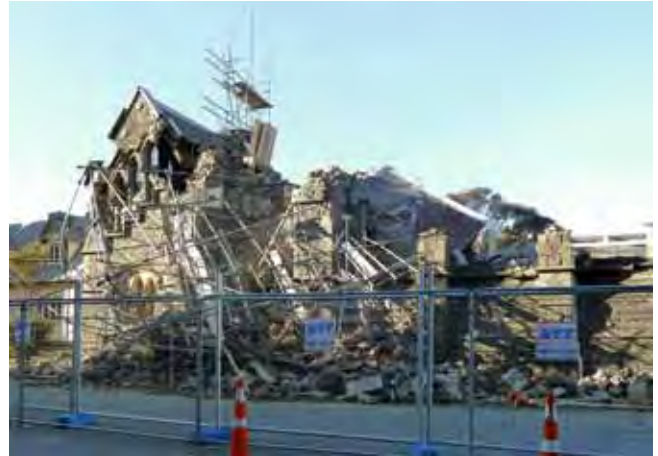
Christchurch, Canterbury Provincial Council Buildings, exterior after the February 2011 earthquake (photos: A. Marriott; O. White)

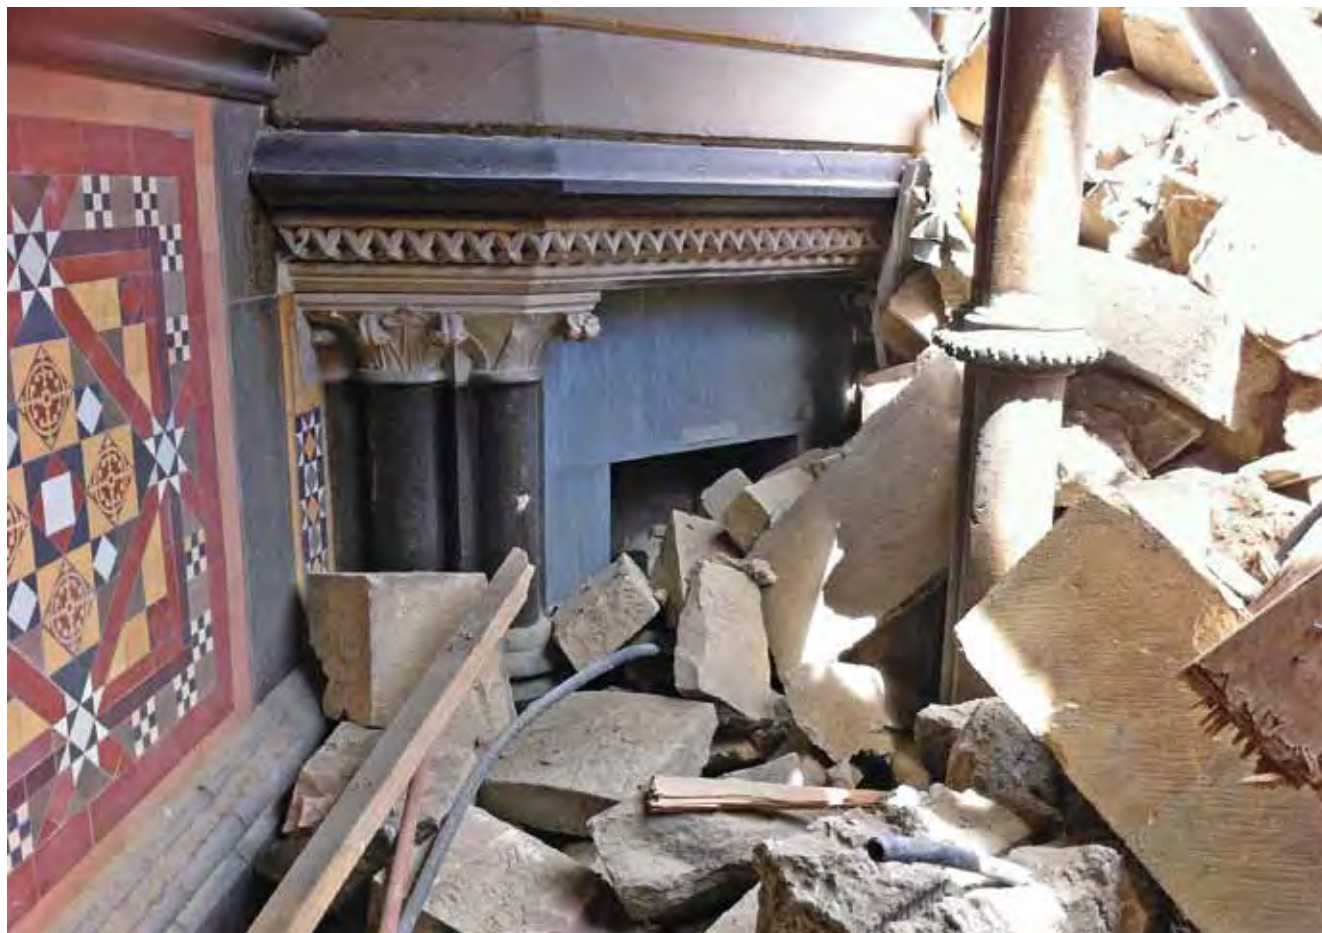
On February 22, 2011 the 1865 Stone Chamber of the Canterbury Provincial Council Buildings collapsed. This earthquake and the subsequent two years of seismic activity have severely damaged other parts of the complex. The Armagh Street stone tower collapsed; the Bellamy’s wing and the Durham Street stone tower were considerably damaged; chimneys fell or had to be removed. The former provincial councillors’ refreshments rooms of 1865,

Canterbury Provincial Council Buildings, damaged interior (photo: Jenny May)

A careful programme of deconstruction and stabilisation to make safe, watertight and retrieve material was undertaken and

neering work has been undertaken to provide the required temporary stabilisation and weather tightness to ensure the buildings will remain well protected until the conservation and restoration programme is developed; a monitoring and securing programme for this period is currently being established.
