SLOVAKIA

Bratislava – Protected Area of Central Urban District at Risk

Risk from Development: Threats to monuments caused by ignoring valid legislation

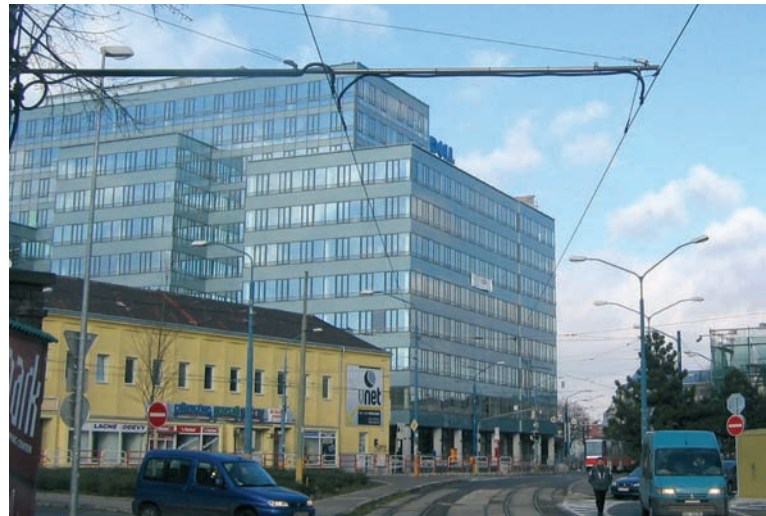
Square of St. Florian – loss of 19th-century character caused by inadequate new constructions

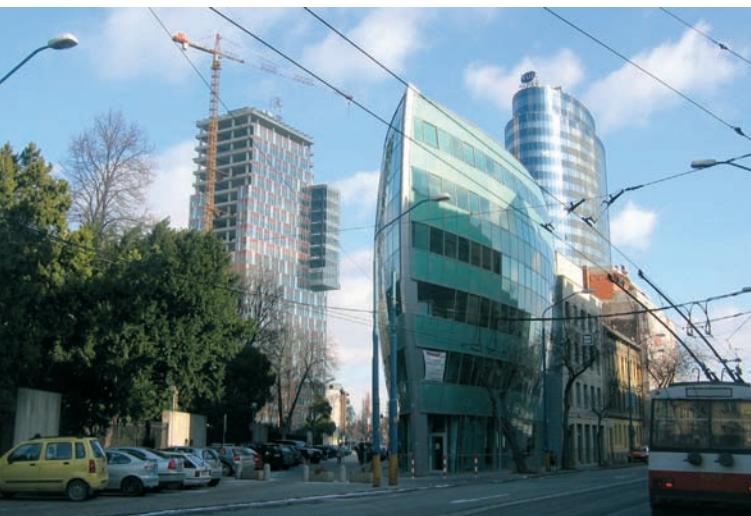
Inadequate modern buildings in the protected area of the central urban district

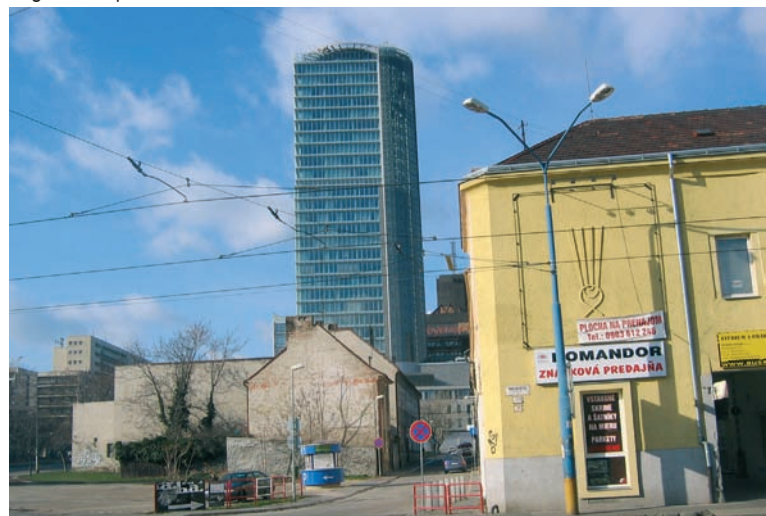
Large-scale demolition and erection of tall buildings on the site of an original compact settlement

- large-scale demolition of historic buildings, substituted by inappropriate new construction;
- out-of-scale new construction damaging the historic character of the original environment;
- loss of authenticity to buildings on the monument list.

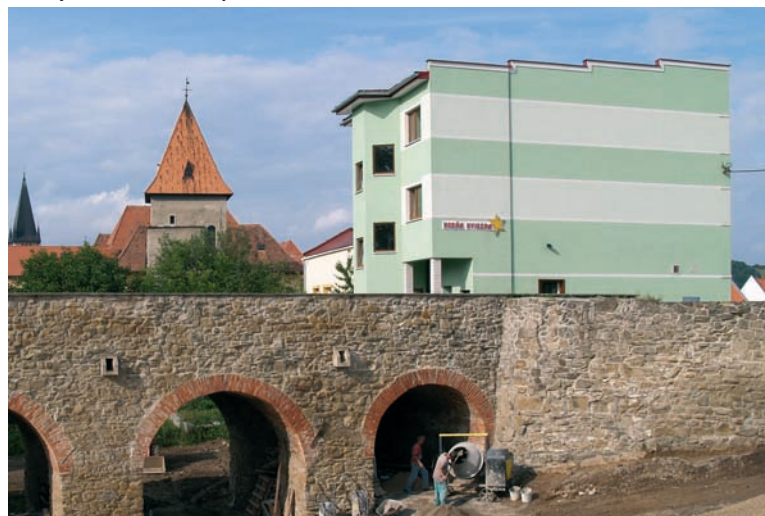
Bardejov, house in Rhody Street 14

The first place is within a World Heritage site: the Bardejov Town Conservation Reserve. Originally a one-storey building, during the registration process the house was evaluated as a contributing element of the World Heritage site and was identified for retention. Only its maintenance was allowed. In spite of opposition from the Slovak Monument Office and the lack of building permission, an investor restored the ground floor three years ago and later added two floors. This illegal construction is situated near the castle moat and the arch bridge which are close to the southern gate and damages the authenticity of the fortified castle and of the town silhouette with its dominant landmark, the St. Giles Church, as viewed from the south? These building activities are incompatible both with the legislation and the conditions of protection of World Heritage sites. Other institutions as well drew attention to this incident, but without any positive result so far.

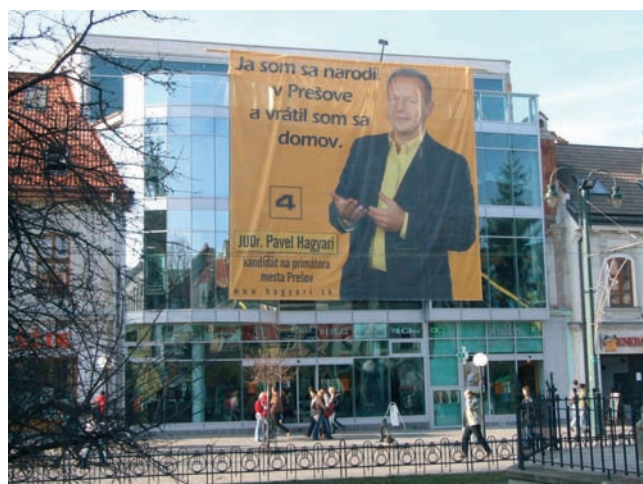
Prešov, house in Hlavna Street 107B and 109

Although the originally approved project documentation contains these conditions, a house has been built which does not respect them. Its main facade was extended by one floor, the ground plan measure of the third floor was changed, no indication whatsoever of a roof plane was realised and a project documentation was not approved. This illegal building is in use today. The owner applied for retrospective approval, but the Slovak Monuments Office did not authorise it. A solution still has to be found.

- is not in harmony with the approved project documentation;
- exceeds the bulk and scale of housing in the area;
- does not respect the accepted territorial plan;
- is not adapted to the historic environment; and
- disturbs the panorama of the west side of the dominant square inside the ensemble.
