## AUSTRIA

### Rural Architectural Heritage at Risk

### The Survival Problems for Unused Palace Complexes

#### Ebenfurth Castle

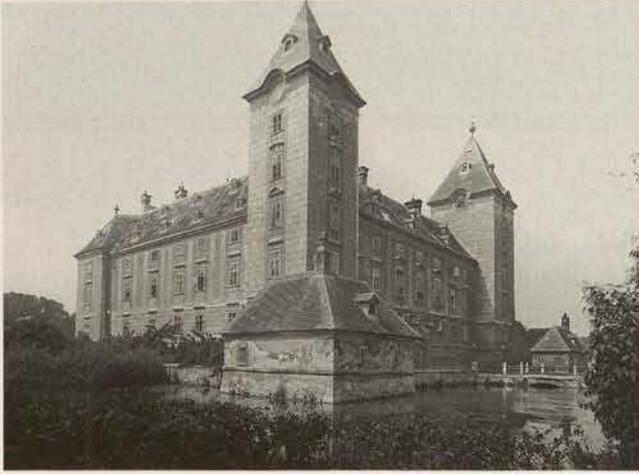
Ebenfurth Castle

Schloß Ebenfurth (Ebenfurth Castle) in Lower Austria represents a tangible illustration of this problem. The once splendid, but now alas dismal and dilapidated moated castle dates back to the mid-17<sup>th</sup> century. However, the origins of the massive three-storey building, the four sides of which enclose a centre court, go back to a rambling mediaeval border fortification, of which the corner towers still dominate the shape of the building. After 1754 the interior was magnificently decorated with paintings, particularly the chapel, of which Franz Anton Maulpertsch's ceiling frescoes depicting the *Apotheosis of St Leopold* are among the major works of Austrian Baroque art. In addition, a significant picture gallery, a collection of 17<sup>th</sup>-century Gobelin tapestries, sumptuous interior decorations including Chinoiserie wallpapers and early Neoclassical paintings, richly ornamented furniture, tiled stoves, plaster-work and some intarsio parquet flooring were among the original refurbishments.

Unoccupied after the war, the castle's north-east wing was used as a chicken farm, the neo-Baroque styled great room turned into a

granary. The buildings were empty for a long time; by the end of the war and during the Russian occupation, parts of the remaining furnishings were either stolen or destroyed. Ongoing plundering of remaining furniture and architectural elements transferred inlaid flooring, flagstones and other movable parts of the building into other hands.

Despite new ownership in 1973, hopes for the appropriate measures to prevent further losses were not realised after several false starts. In 1982/83 and 1990/91 the most urgent repairs to safeguard valuable painted ceilings with roofing work and static measures were undertaken as part of two costly restoration campaigns – the result of initiatives and funding on the part of the Province of Lower Austria and the *Bundesdenkmalamt*/Federal Office for the Preservation of Monuments.

Nonetheless, the process of deterioration could not be successfully halted and by the Winter of 2000 it was again necessary to erect emergency roofing over the chapel area and to do urgent repairs in other areas of the roof.
