MYANMAR

Case Study: Bagan (Pagan)

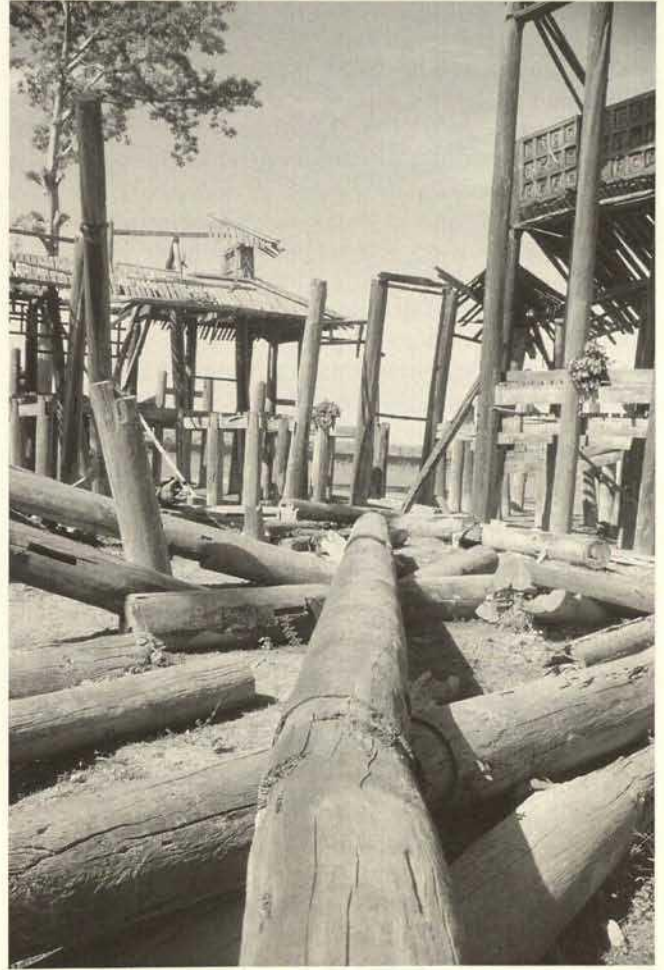
Bagan, Pakang gyi monastery

Some of the wooden monasteries of later periods are also suffering from devastating damage. Pakang gye and Pankang gyi are both located on the other side of the Ayeyarwaddy River, some 20 kilometres northeast of Bagan, and are examples of these critically endangered monuments. Pakang gye, the larger monastery consisting of 332 massive teak columns, stands with tilted columns and no roof or floor. Pakang gyi, the smaller monastery consisting of 156 huge columns, is barely standing.

According the Archaeological Department, these two monuments are now in a relatively better situation, with upright columns at Pakang gye and a restored roof and floor at Pakang gyi. However, lack of the proper maintenance and skilled carpenters may result in possible future risks to both monasteries and to similar structures.
