JORDAN – HERITAGE @ RISK!

Case Study – Petra

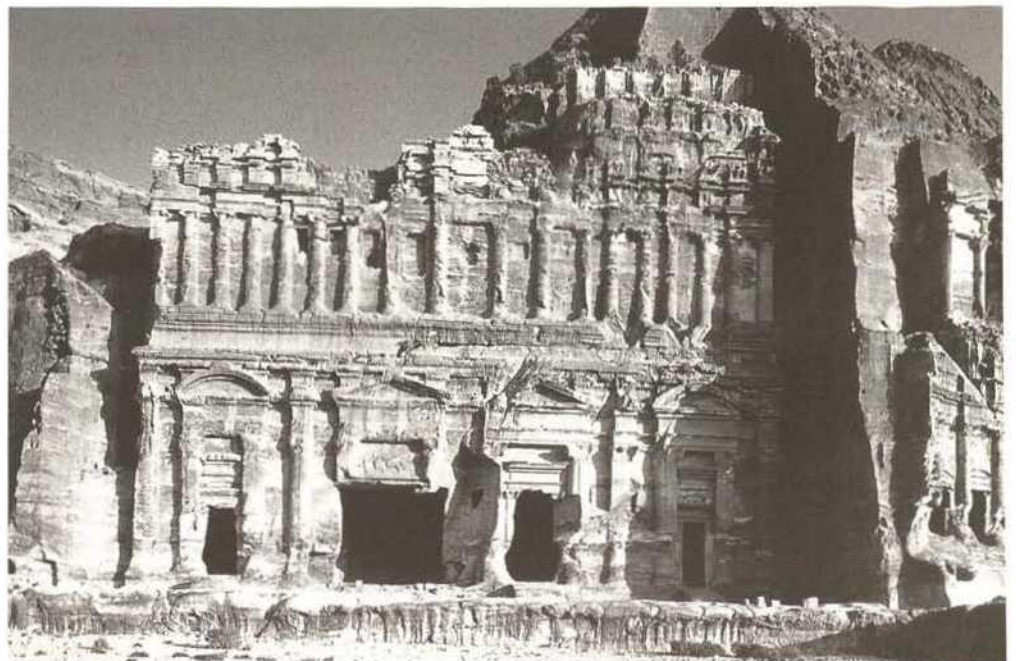
Petra, Palace Tomb, condition of 1998

To make things worse, the few and surely honourable attempts that have been made to save parts of some of the monuments, eg at al-Khazna and the Palace tomb, were actually failures. They were well-intended efforts in their time, but now we know that they were futile and in fact in the long run may be more harmful to the monuments than if nothing had been done at all. It is above all because of the repeated and excessive use of Portland cement with its entirely different properties that forms an incompatible mix with the sandstone from which the tombs

are carved. This is extremely detrimental to the monuments and for many other reasons cement should have no place in Petra.

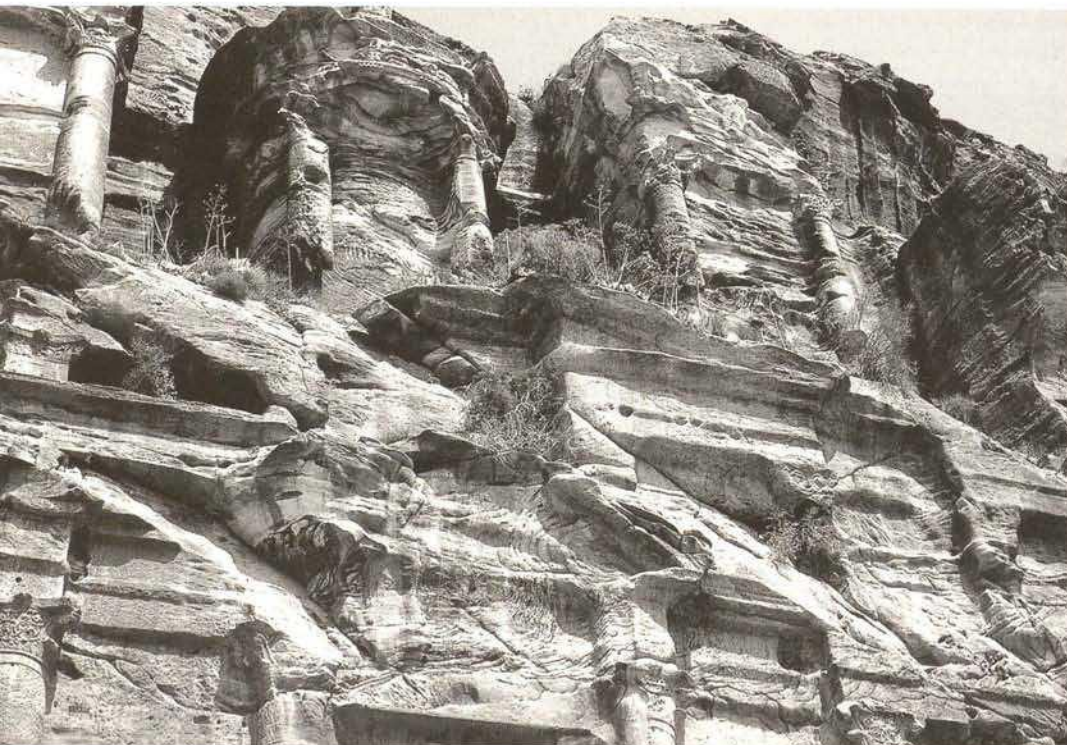
Petra, Corinthian Tomb: the detail shows the severe damage.
